Release Notes and Update Instructions

RoboSHOT 12E/30E CAT5 and RoboSHOT 12/30 Cameras

RoboSHOT® 12E/30E CAT5 3.4.0

RoboSHOT 12/30 3.4.0

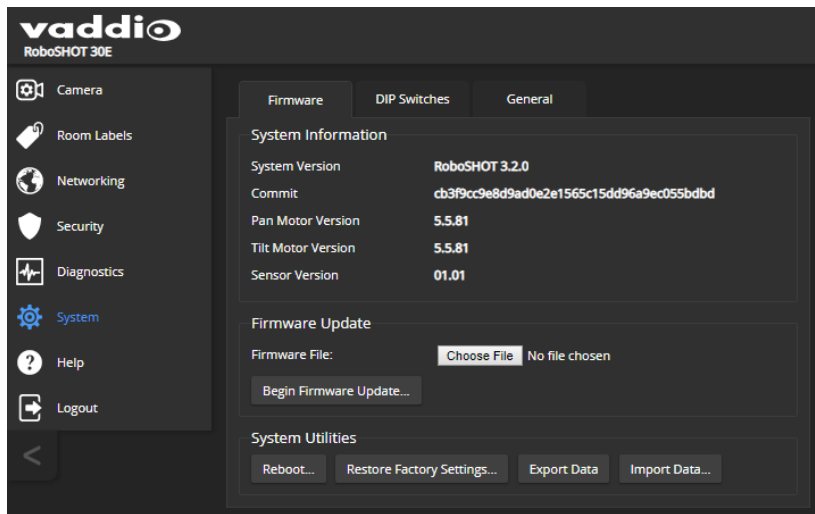
1. Download the firmware file if you have not done so already.
2. Access the device's web interface and log in as `admin`.
3. On the System page, select Choose File and select the file you downloaded. Then select Begin Firmware Update.

4. Read the Confirm dialog box, then select Continue. You will be prompted to log in again when the process is complete.
