Technical Case Study – Ref 5.1.1d

Improvements in water infiltration and rooting depth of Bloempoot Delta Valencias at HN Pieterse Farming - 2013 to 2016

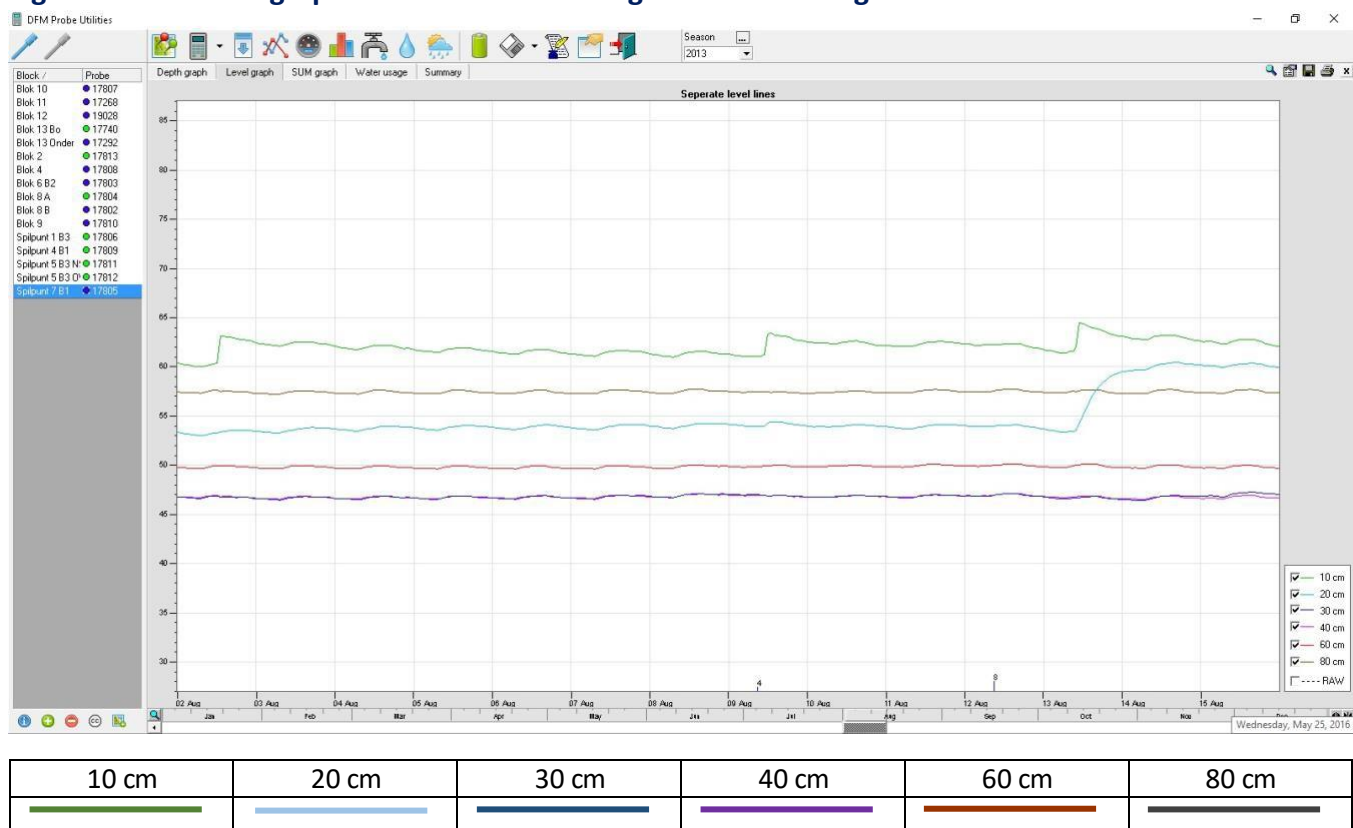
At the end of July 2013, the first RainBox was installed on S7. Almost immediately slight improvements in transpiration cycles, water withdrawals and root activity could be seen at 10 and 20 cm. This was due to better aeration and feeder roots extracting water and nutrients more efficiently at 20 cm. See the green and blue lines in Fig. 2 below.

Figure 2. DFM level graph on S7 from 2 – 15 August 2013 after Agriwater installation

In comparing Fig. 1, 2 & 3 the improvements in both daily transpiration cycles and active rooting depth were clearly evident. The same trend continued over time, with transpiration cycles being more evident down the soil profile. By 2014 daily cycles and movement at 40 cm (purple) were clearly visible and this was still the same in 2016 (Fig. 4). Probes in other orchards with similar soil problems recorded daily transpiration cycles that moved progressively down from 10 cm to >60 cm over time, while others moved from 10 cm to 80 cm.

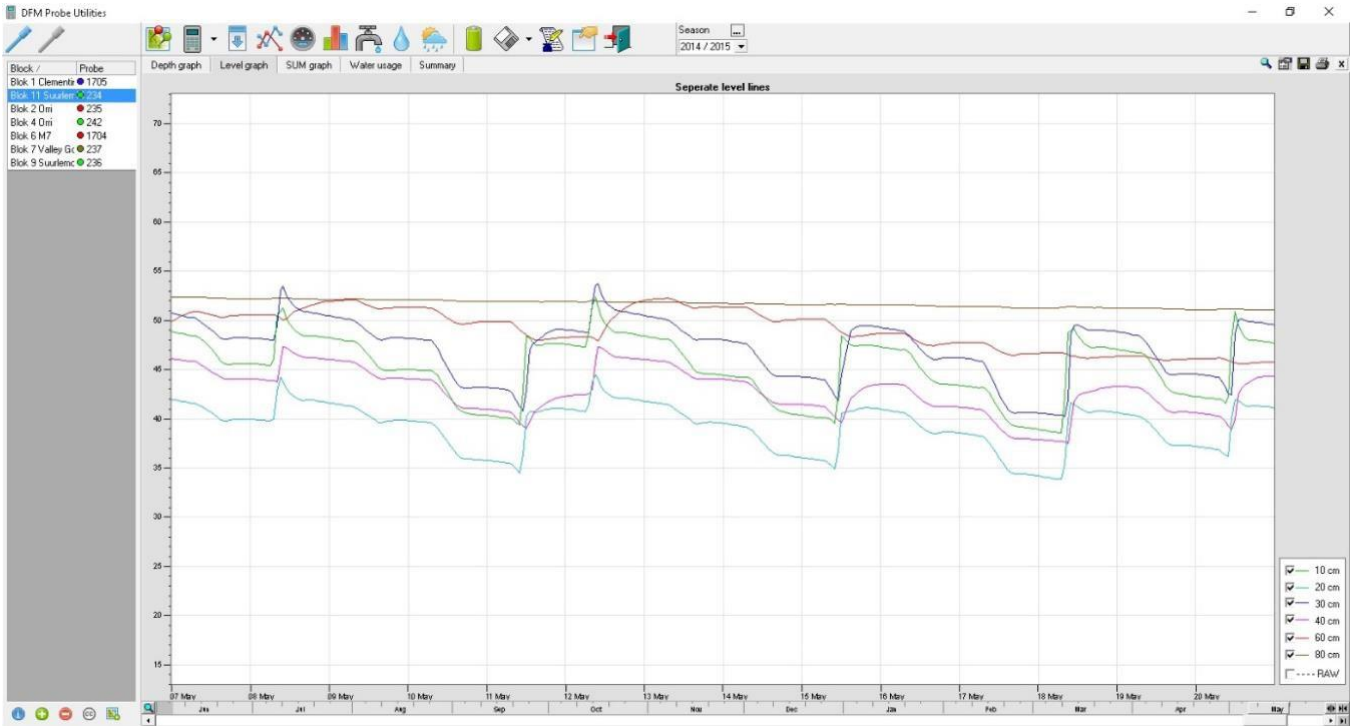
10 cm	20 cm	30 cm	40 cm	60 cm	80 cm
<div></div>	<div></div>	<div></div>	<div></div>	<div></div>	<div></div>

It could be argued that the 1st probe readings on S7 were done in May/June when transpiration levels were lower and thus explains the minimal transpiration activity or steps. This is simply not true, as well aerated soils with good rooting depth and activity will still show clear evidence of transpiration cycles (steps) at this time of year in this milder winter area. To illustrate this point, see the observations after more RainBoxes were installed and Fig. 6 below from Lemons in Block 11 in May 2015. This was once again a classic portrayal of how Agriwater Water Treatment Technology improved soil and aeration and subsequently water infiltration and rooting depths, with clear steps evident in May 2015, during the colder period.

Figure 6. DFM level graph on Lemons in Block 11 from 7 – 28 May 2015 after Agriwater installation
