No. 1453431.7

SAMPLE DESCRIPTION:
Flooring planks assembly with glue sealant (Clicseal) in the joints and standard Arriba underlay attached to the bottom as a complete system: Regal Oak GH Engineered 14.2mm.
Code: 632000

ISO 4760:2022(E) - LAMINATE FLOORING – TOPICAL MOISTURE RESISTANCE – ASSEMBLED JOINT (MODIFIED)

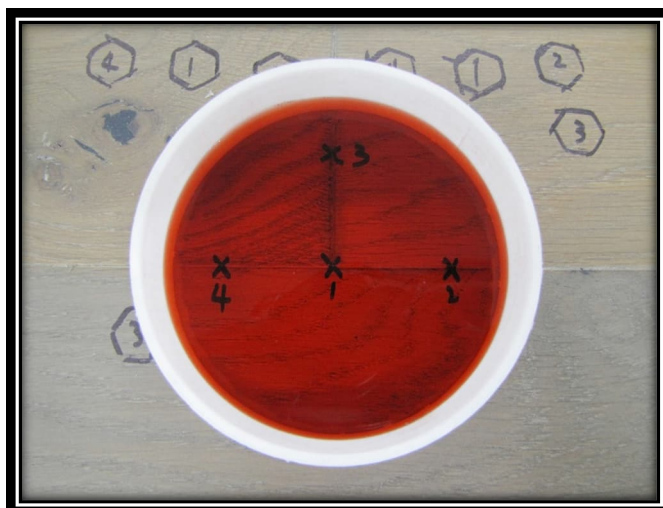
24 hrs With Water

100 mls of dye solution was applied onto the sample surface. It was poured into a cylinder 100mm diameter placed in the centre of the sample at the "T joint." Sealant was used at the plank/cylinder interface to avoid leakage.

The sample was left at 20°C, 65% Relative Humidity room conditions for 24 hours after the dye was added and then examined for dye penetration through the backing (not 23°C, 50% RH as stated in the method).

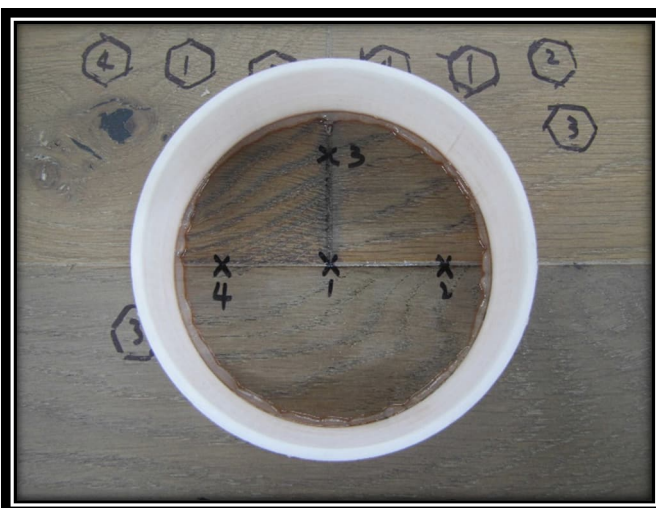
Wet Swell

- 1 = No change - Little to no noticeable change in edge swell or panel surface lift
- 2 = Slight swelling - Slight swelling, small ridge along one or more joints, very little if any panel surface lift
- 3 = Moderate - Noticeable edge swelling and some panel surface lift extending away from joint
- 4 = Objectional - Severely raise edge and swelling extending noticeably under the panel surface
- 5 = Failed test - Water leaked out of the ring, leaving no continuous film of water inside the ring
(this grade is given even if there is no swell of the edge joint)
