CLIENT: Godfrey Hirst New Zealand Ltd. PO Box 97 145	SAMPLE RECEIVED FROM: Godfrey Hirst New Zealand Ltd.	Date Received:	7.12.22
SAMC, Manukau	SAMPLE DESCRIPTION:		
Attn.: Marty Veele	Laminate flooring planks assembly with stands underlay attached to the bottom as a complete GHLAML126x192 laminate flooring, Code: 465205.		
Client Order No.: 1552213 OP	Client Reference:		1 of 4

ISO 4760:2022(E) - LAMINATE FLOORING – TOPICAL MOISTURE RESISTANCE – ASSEMBLED JOINT (MODIFIED)

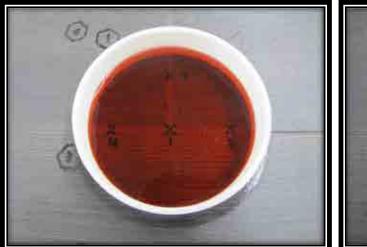
24 hrs With Water

100 mls of dye solution was applied onto the sample surface. It was poured into a cylinder 100mm diameter placed in the centre of the sample at the "T joint." Sealant was used at the plank/cylinder interface to avoid leakage.

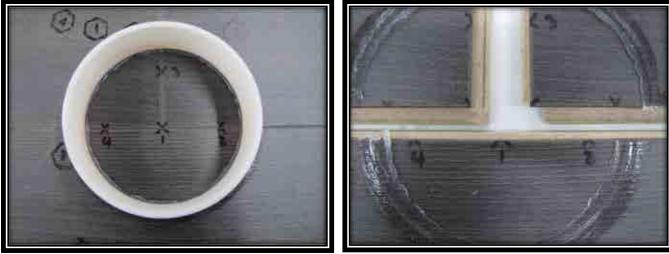
Wet Swell

Recovered Swell

Quantitative measurements are used to calculate surface swell in mm (within 15 minutes after water removal) and recovery swell (24 hours after removal of water).
