No. 1470622.0

SAMPLE DESCRIPTION:
 Flooring Planks – Code 632600 GH-Wood C 1900x190
 Engineered 14.2mm fixed to a clear Perspex base using
 1-part Polyurethane wood adhesive and Clicseal
 applied in the joins.

ISO 4760:2022(E) - LAMINATE FLOORING – TOPICAL MOISTURE RESISTANCE – ASSEMBLED JOINT (MODIFIED)

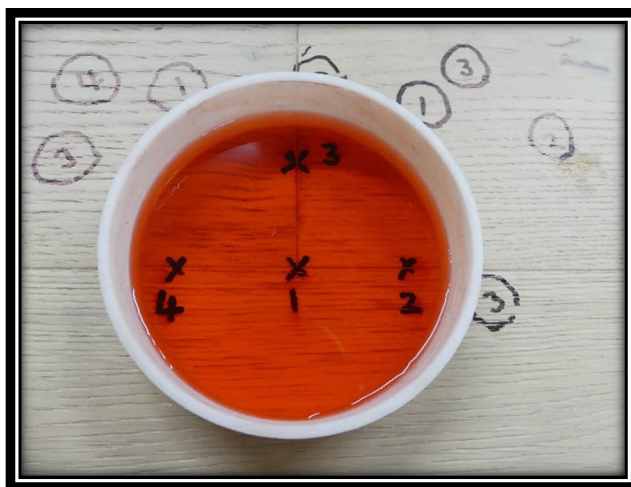
After 24 hrs With Water

100 mls of dye solution was applied onto the sample surface. It was poured into a cylinder 100mm diameter placed in the centre of the sample at the “T joint.” Sealant was used at the plank/cylinder interface to avoid leakage.

The sample was left at 20°C, 65% Relative Humidity room conditions for 24 hours after the dye was added and then examined for dye penetration through the backing (not 23°C, 50% RH as stated in the method).

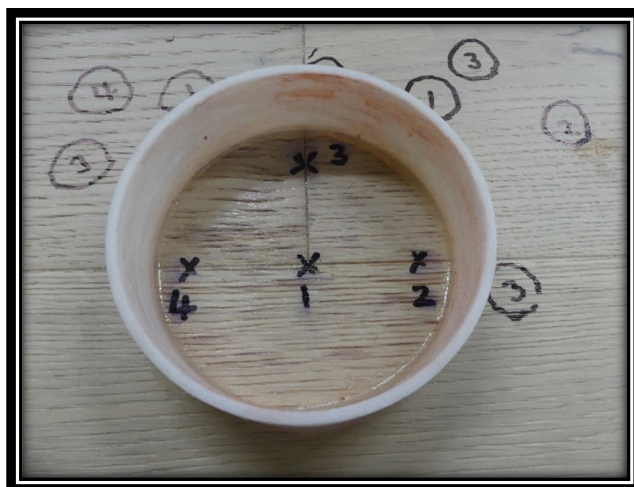
Wet Swell

- 1 = No change - Little to no noticeable change in edge swell or panel surface lift
- 2 = Slight swelling - Slight swelling, small ridge along one or more joints, very little if any panel surface lift
- 3 = Moderate - Noticeable edge swelling and some panel surface lift extending away from joint
- 4 = Objectional - Severely raise edge and swelling extending noticeably under the panel surface
- 5 = Failed test - Water leaked out of the ring, leaving no continuous film of water inside the ring
(this grade is given even if there is no swell of the edge joint)

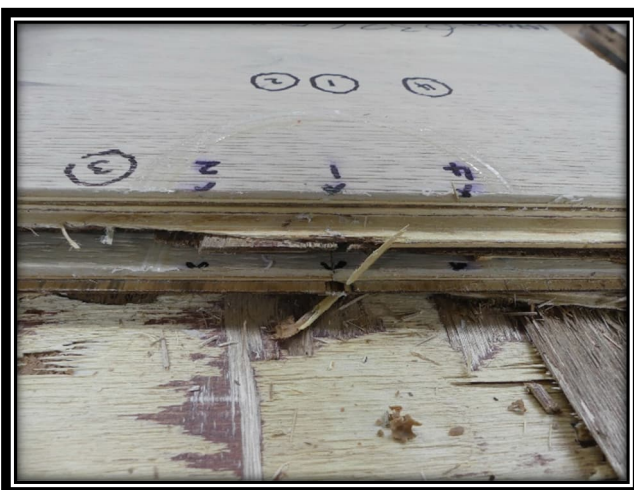
Recovered Swell (Disassembled)
