No. 1453432.5

SAMPLE DESCRIPTION:
Flooring planks assembly with glue sealant (Clicseal) in the joints and standard Arriba underlay attached to the bottom as a complete system: GH-Wood 1820x190 – Engineered 14.2mm.
Code: 632650

ISO 4760:2022(E) - LAMINATE FLOORING – TOPICAL MOISTURE RESISTANCE – ASSEMBLED JOINT (MODIFIED)

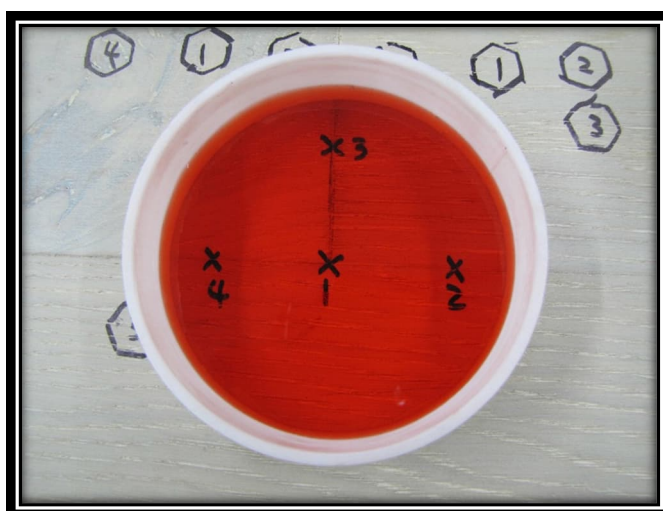
24 hrs With Water

100 mls of dye solution was applied onto the sample surface. It was poured into a cylinder 100mm diameter placed in the centre of the sample at the "T joint." Sealant was used at the plank/cylinder interface to avoid leakage.

The sample was left at 20°C, 65% Relative Humidity room conditions for 24 hours after the dye was added and then examined for dye penetration through the backing (not 23°C, 50% RH as stated in the method).
