Spot Thermometers VS. Thermal Imaging Cameras

Ed Kochanek, FLIR Systems

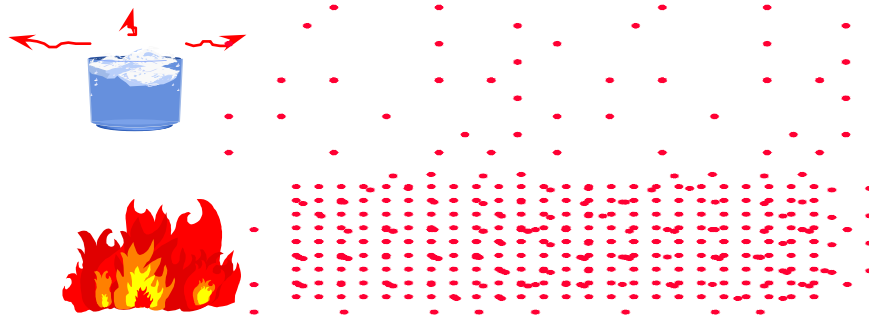
How does it work?

- IR waves are emitted by all objects
- IR radiation increases with temperature
- Mechanical items because of friction
- Electrical items because of resistance
- Moisture because of evaporation
- Energy

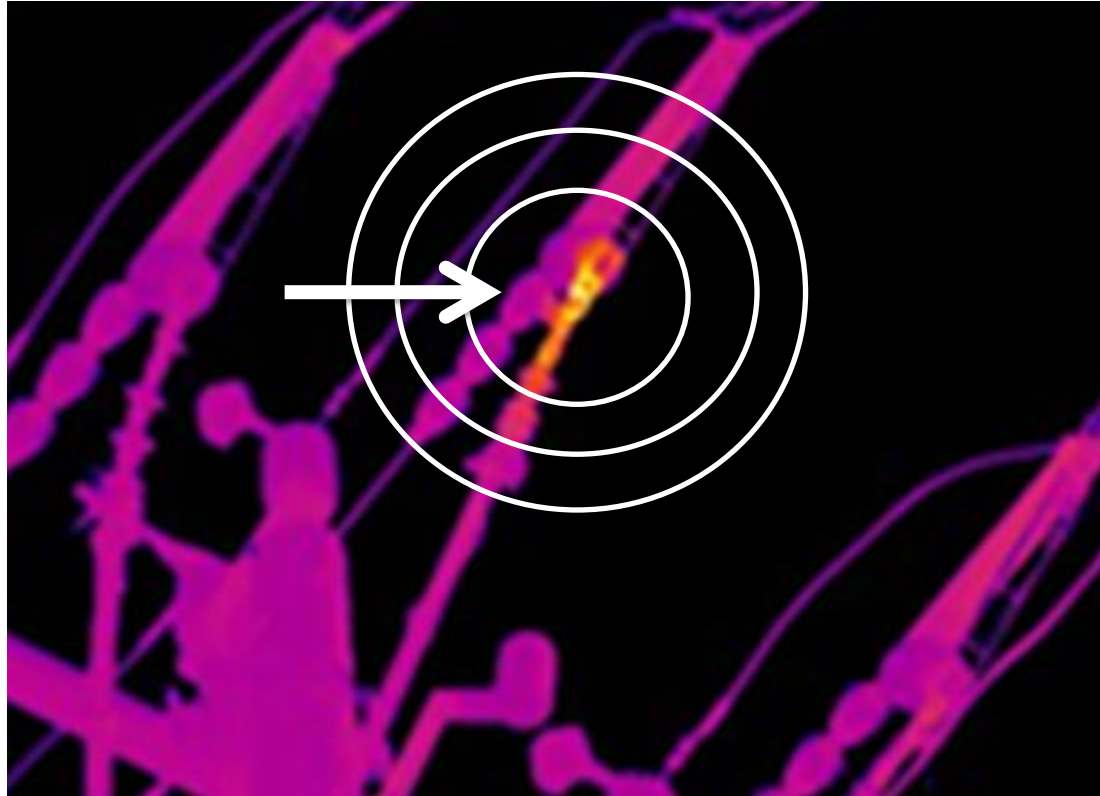
Disconnect Switch

Tmax =173

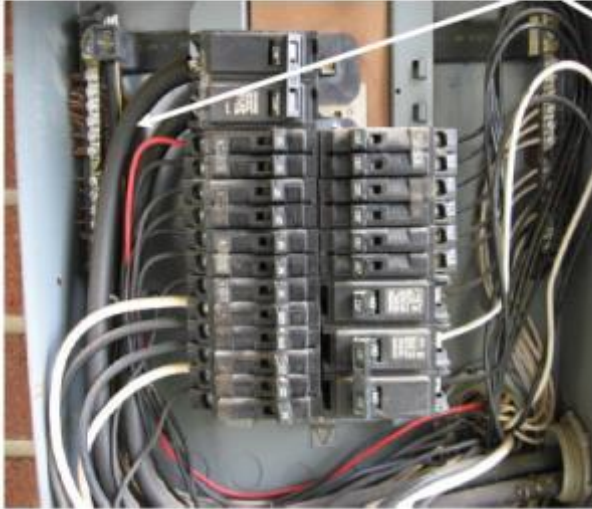
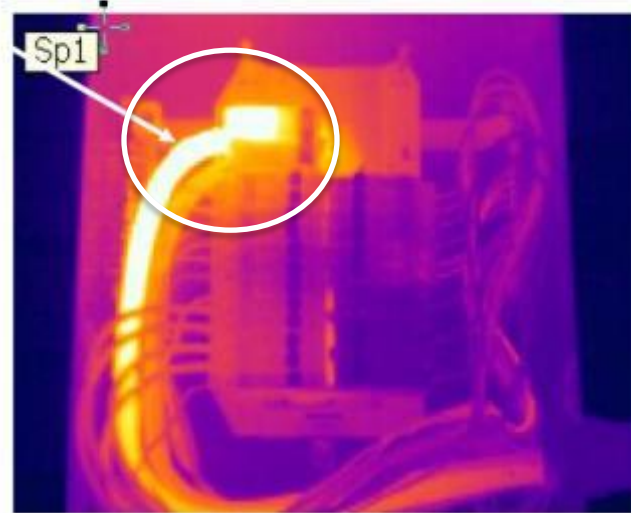
Load effect on Temperature

This main conductor over-heated to more than 220° with only a nominal load.

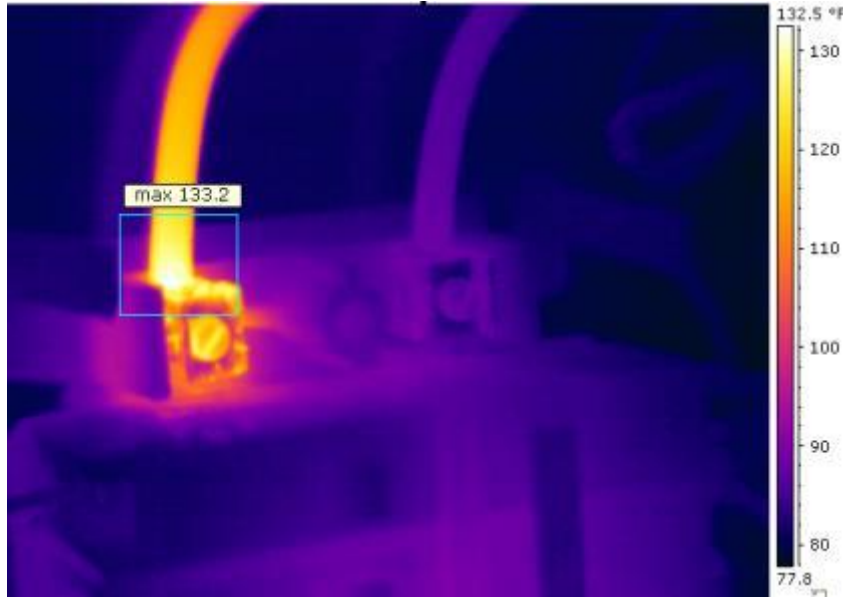
Termination

Problem= 133

Reference=87

Delta = 46

**Make this a
monitor.**

Temperature difference (ΔT) based on comparisons between similar components under similar loading.	Temperature difference (ΔT) based upon comparisons between component and ambient air temperatures.	Recommended Action
2°F - 5°F	2°F - 18°F	Possible deficiency; warrants investigation
5°F - 27°F	18°F - 36°F	Indicates probable deficiency; repair as time permits
-----	36°F - 72°F	Monitor until corrective measures can be accomplished
>27°F	>72°F	Major discrepancy; repair immediately

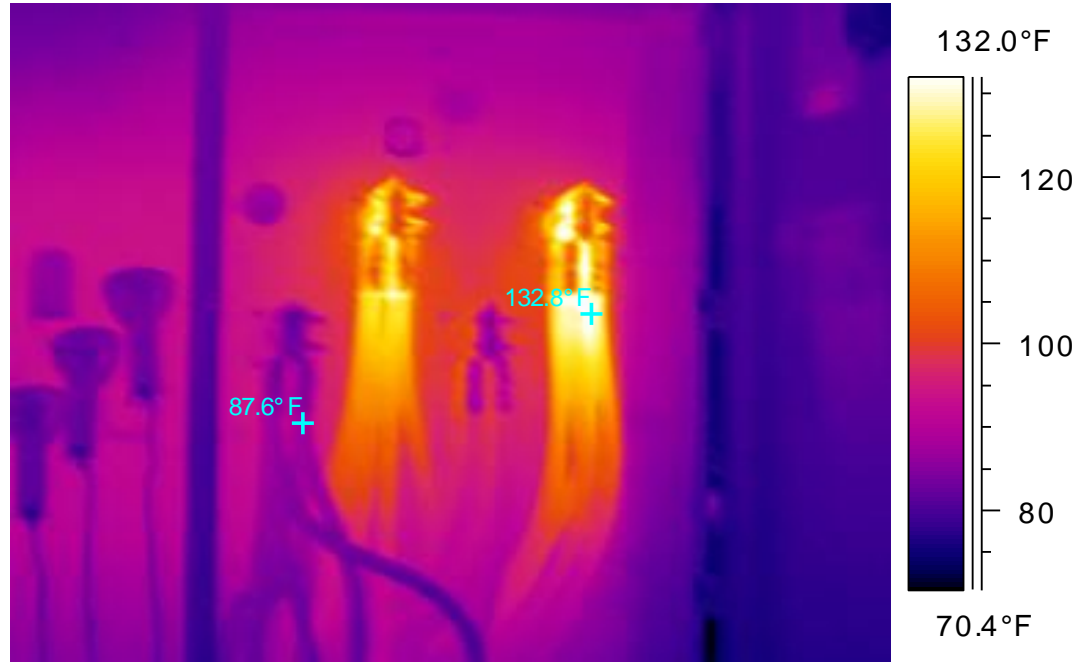
Conductors / Terminations

Improper Tightening

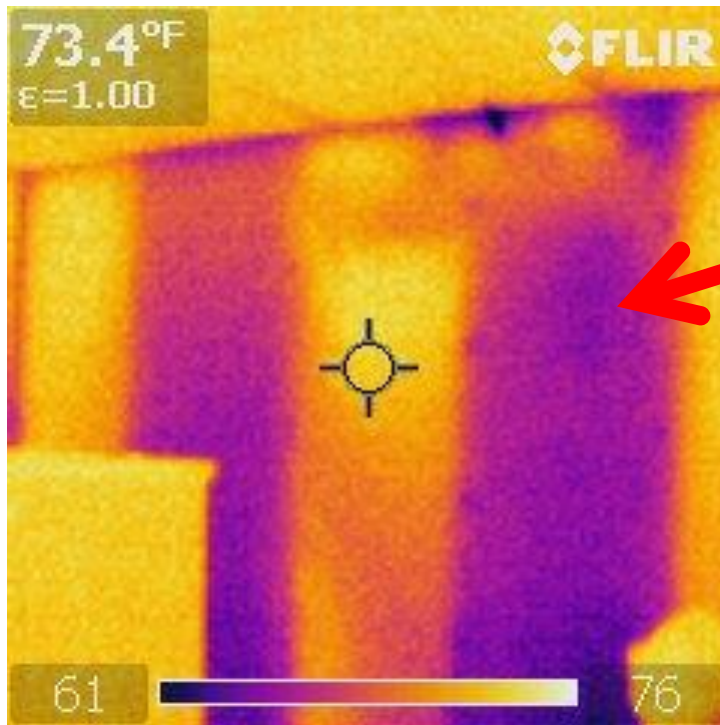
Why do we want to see the lack of heat?

Missing insulation

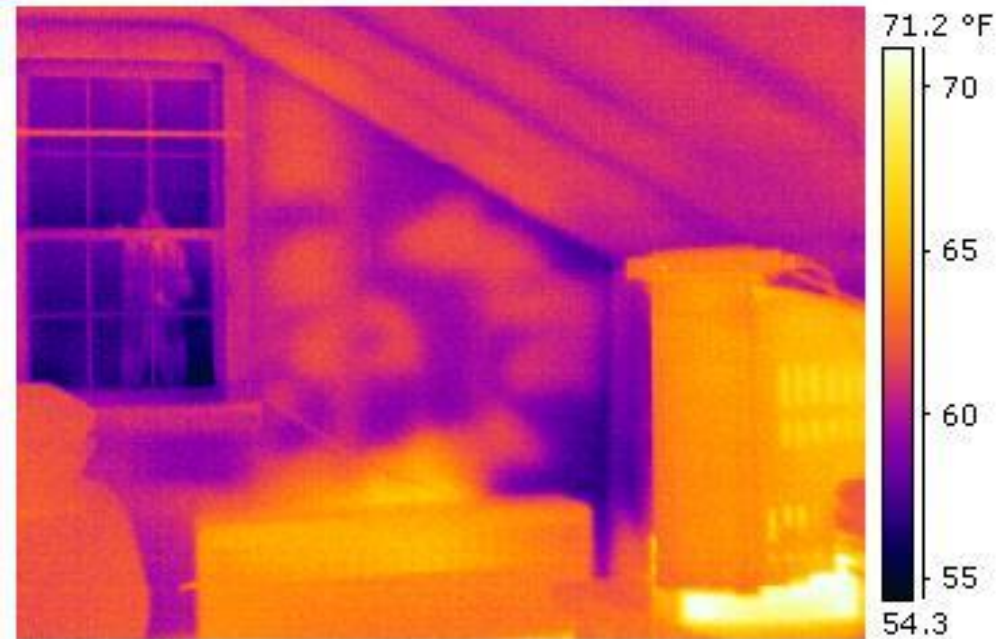
Blown Insulation- Poorly done

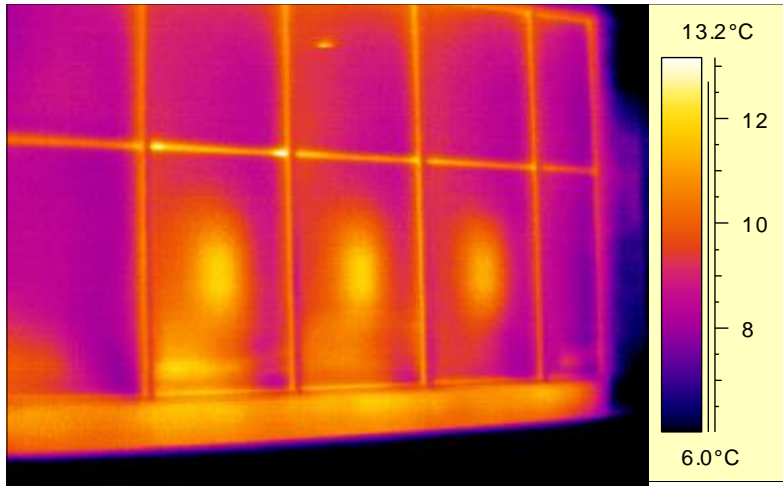
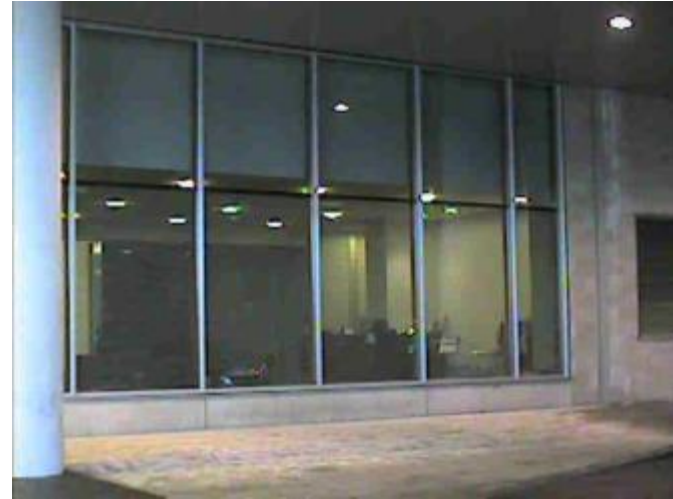
Argon Leaks

- Argon has leaked out of the three windows in the center
- Heat transfer by convection is occurring inside the window

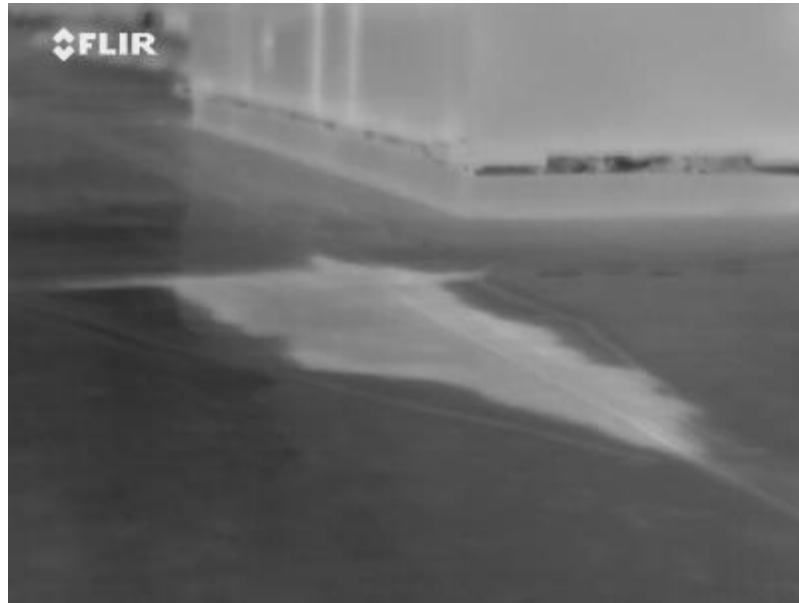
Roof Moisture

Water in the insulation from a seam leak

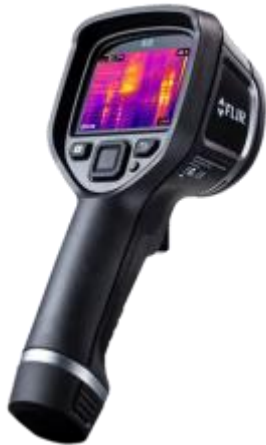
FLIR Ex Series – Spot Gun Replacement

- Radiometric JPEG image storage
- MSX Technology
- Fixed Focus (focus free)
- 3” Color LCD
- -4°F to 482°F Temperature Range
- Cost \$995 to \$3,995

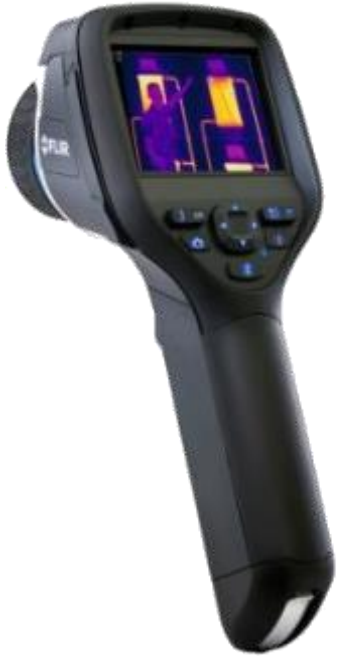
FLIR Exx-Series- Performance Cameras

- Large Touch screen
- Wi-Fi and Blue Tooth for remote viewing/reporting
- MSX Technology
- Laser, video light
- Accessory Lenses, wide angle, telephoto
- Temp ranges up to 650C
- Cost \$3,995 to \$7,995

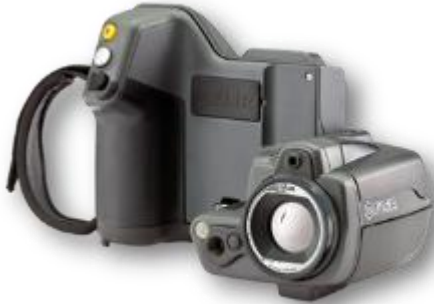
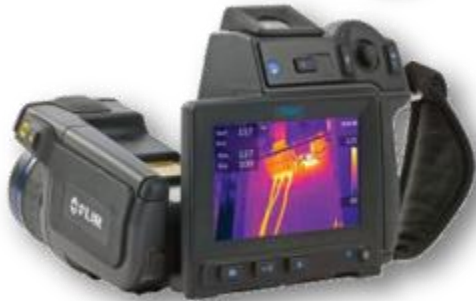
FLIR T Series- High Performance

- Ergonomics/Outdoor App's
- High Temperature, up to 2000c
- High Resolution up to (640 x 480)
- Remote Controls
- \$8,750 to \$26,950
