Repairing instead of Replacing

Process for Repairing CFRP Components without Machining

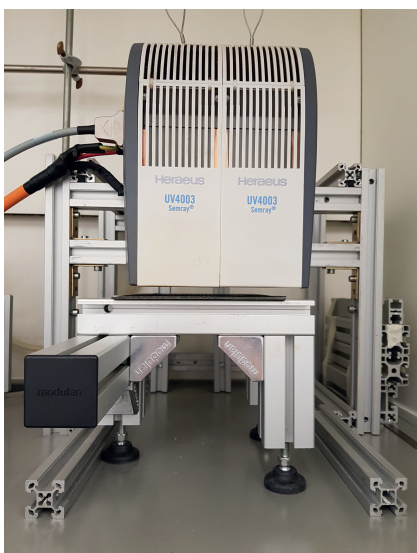
Fig. 3. Matrix removal in the repair area is carried out with the help of an UV LED lamp. Compared to conventional processes, the manual effort is highly reduced, which ensures higher reproducibility © ITM

A Semray 4103 UV LED emitter from Heraeus with an emitter area of 45 mm x 154 mm and a wavelength of 395 nm was used for the project (Fig. 3). This allowed almost complete exposure of the filaments in the damaged area [8]. However, in order to successfully perform complete, localized matrix degradation in the damaged area of thin-walled CFRP components, the irradiation parameters of power and irradiation area, as well as the installation space of the emitter, must be »

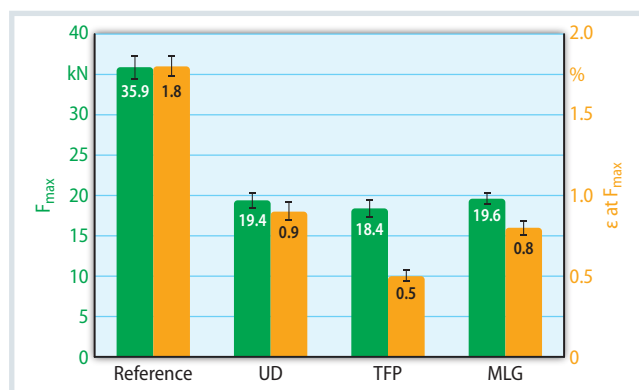
Fig. 5. Rupture force (F_{\max}) and elongation at F_{\max} for the different patch variants: the UD and MLG patches achieve the best values Source: ITM; graphic: © Hanser

demonstrators. The flat composite panels were damaged in a defined manner by CNC milling, i.e. all fibers were cut in the direction of loading (0°), which caused a residual load-bearing capacity of 0%. The specimens repaired with the aid of the process were characterized in tensile test according to DIN EN ISO 527–4. Irrespective of the textile manufacturing process of the repair patch, a breaking strength in the 0° direction of approx. 55% of the undamaged CFRP reference material could be achieved (Fig. 5).
