4L60E-AFL-OS Fits: 1993up With OE Bore Size only
Requires 4L60E-AFL-TK Tool kit, Sold Separately

Actuator Feed System Malfunctions due to excessive bore wear in high mileage units. Provides a stable oil pressure feed to Shift, EPC, 3-2 & TCC PWM solenoids.

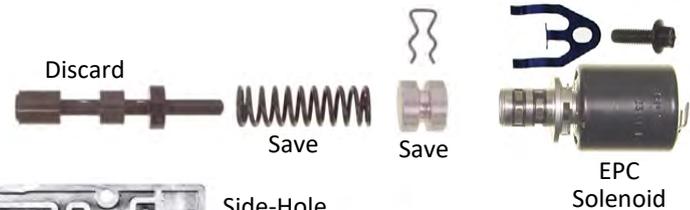
Step 1. Remove EPC Solenoid (Force Motor). Remove AFL Bore Plug Retainer, Bore Plug & Spring. Discard original valve.

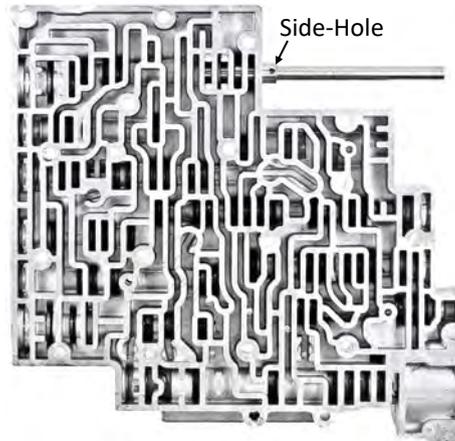
Assembled Reamer & Guide

Assemble reamer into guide from **4L60E-AFL-TK** as shown. Insert reamer & guide into the bore till it stops with the side-hole end out. Use lots of WD-40 and **low speed** on your favorite portable drill. Let the reamer do the cutting until it bottoms in the bore. Don't force the reamer! Bore finish & reamer life require a slow inward movement and lots of WD 40.

"Side Hole" is provided for removing guide with a hooked scribe if needed.

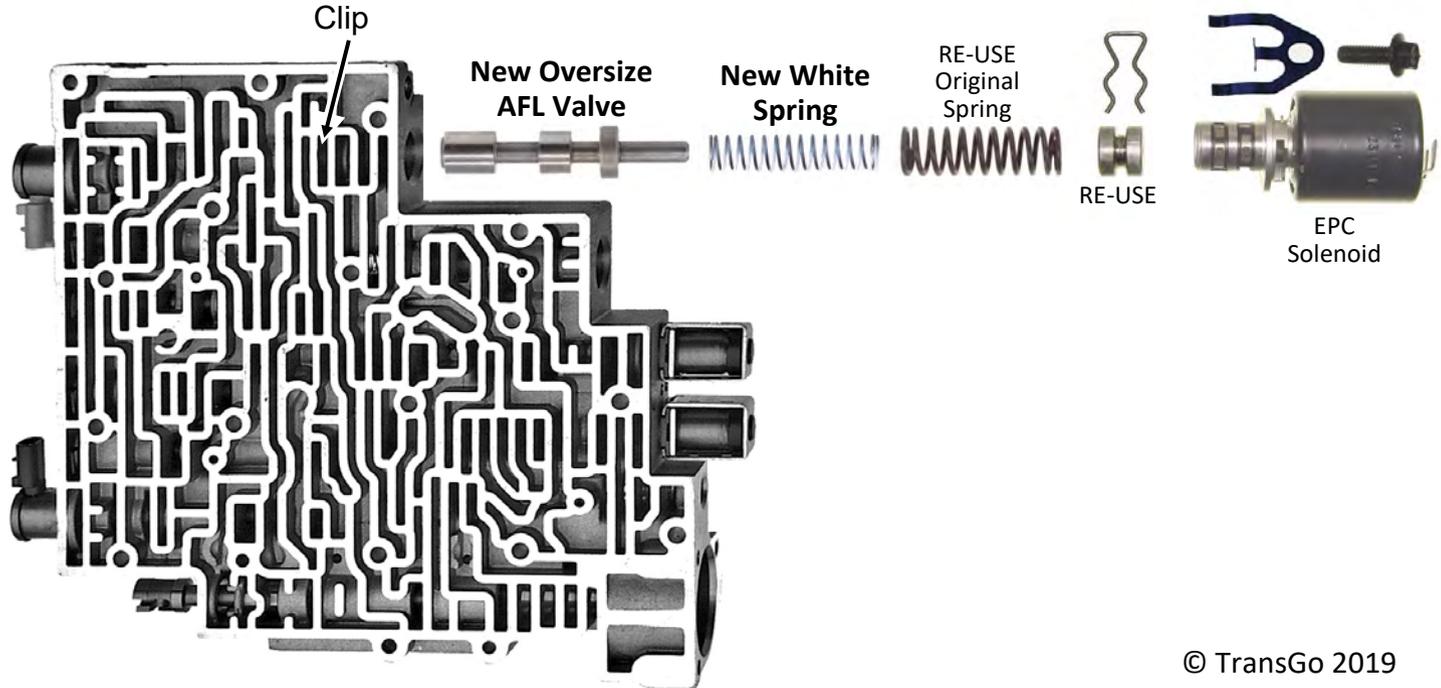
After reaming, clean the bore and the **New AFL Valve** furnished in this kit. Make sure the valve is free in the bore. Install the **New AFL Valve & New White Inner Spring** provided. Re-use original Outer Spring discarding any original inner spring if it had one. Re-use original bore plug & retainer. See correct Clip location. Reinstall EPC solenoid, clamp & bolt.
