SHIFT KIT[®] TURBO HYDRA-MATIC

Mechanic: We thought you might like to know what the kit does and how it does it.

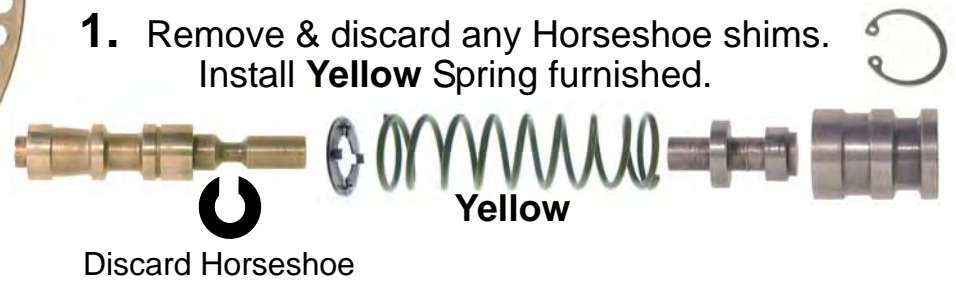
1. Remove & discard any Horseshoe shims. Install **Yellow** Spring furnished.

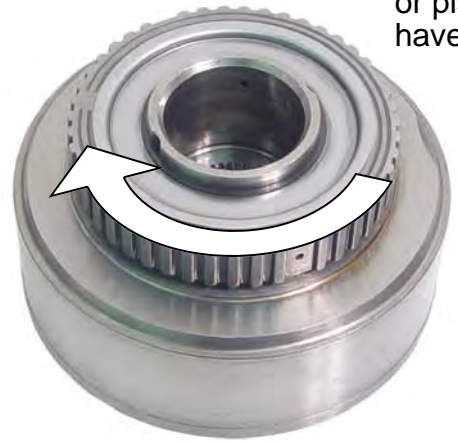
Direct Drum or piston must have check ball.

Intermediate Sprag
Outer race must freewheel as shown
