SK[®] 440-Jr[™] Shift Kit[®]

Durability Upgrade

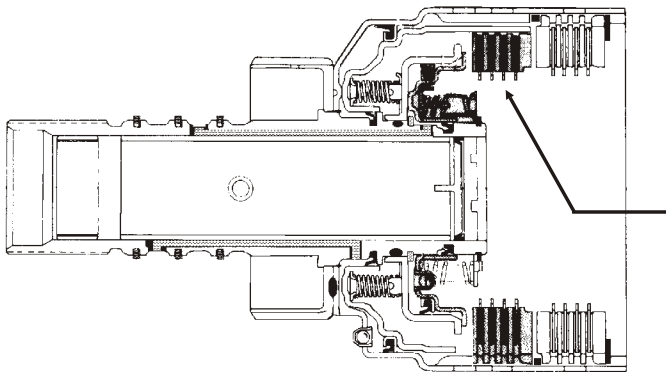
Step 1. While the trans is apart see if the 3rd clutch pack has a waved cushion plate.

The trans will work OK with or without a waved plate, but a larger 3rd clutch feed hole is required if the trans has a waved plate.

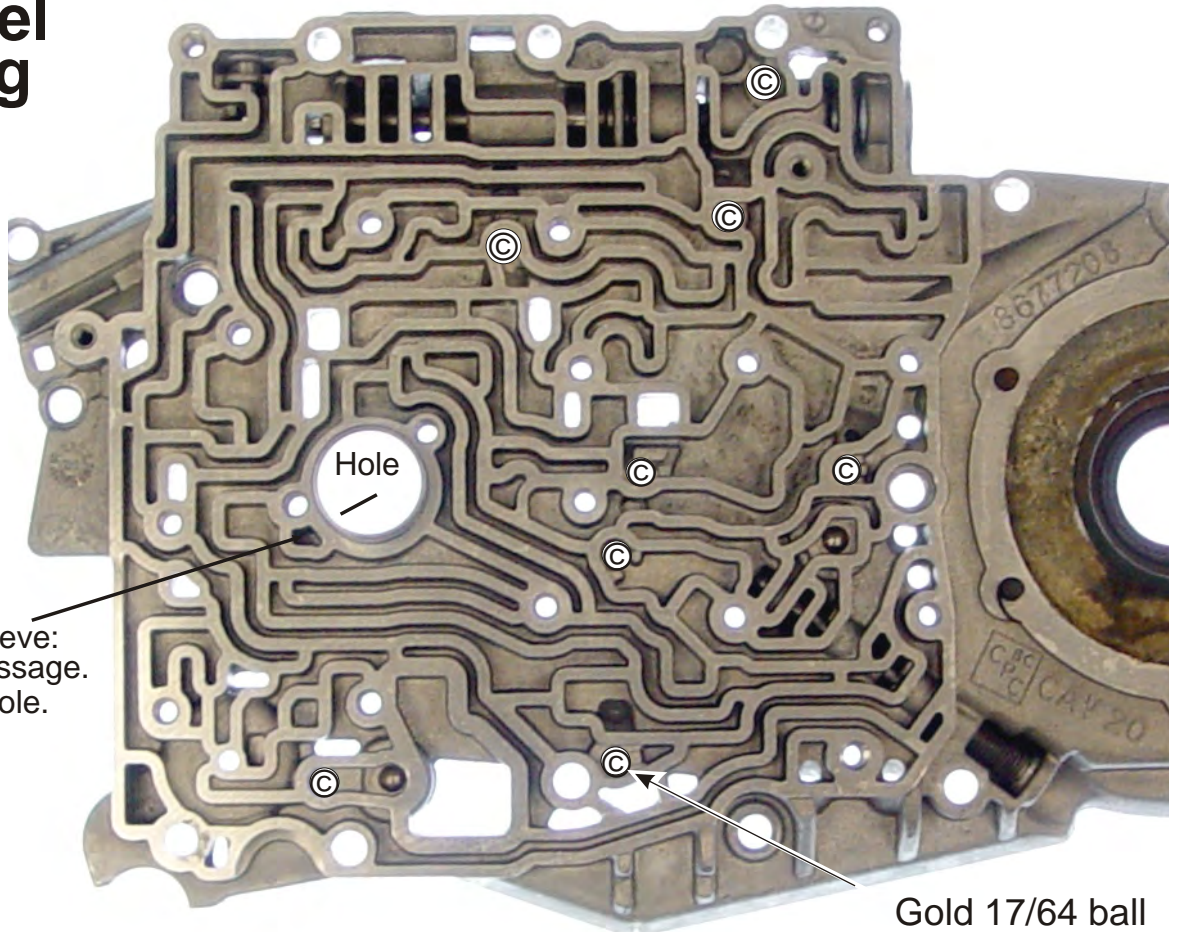
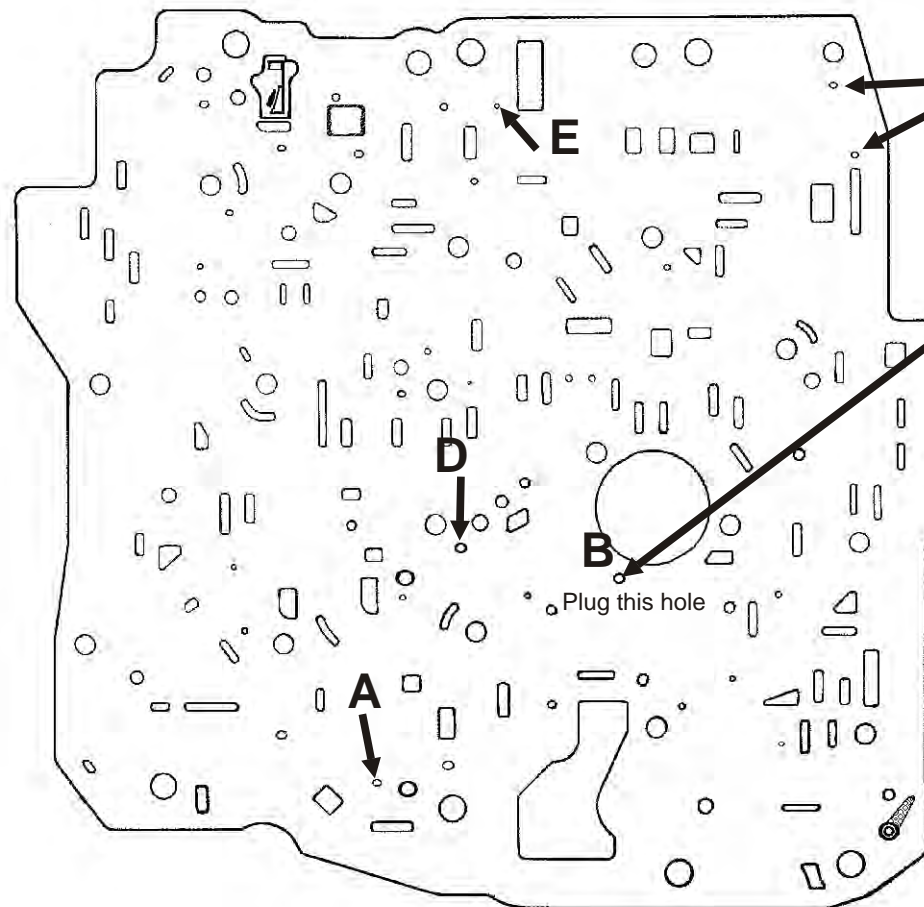
Checkballs

Seven 1/4 checkballs

1 GOLD 17/64 bottom at right

Conv Delivery Sleeve:
Blow air in this passage.
It must blast out hole.

C. Plate will have one of these holes.

Hole Sizes

“A” = .091 furnished.

“B” = Drill hole .091—Then place plate on cement floor. Install alum plug into hole and hit it once smartly with light hammer to plug the hole.

“C” = .091 to .116

“D” = If 3rd clutch has waved plate enlarge “D” with .100 to .106 drill.
Without waved plate: .091

“E” .063 to .076

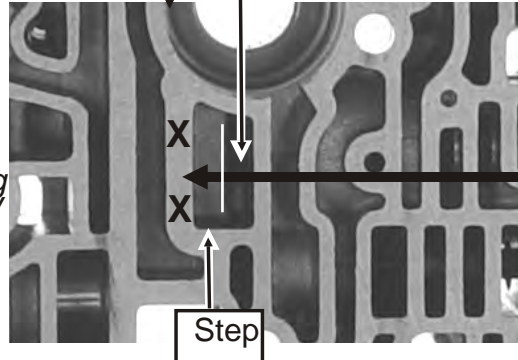
Note: If VB has a hole down thru the step, plug it with a screw and RTV or Locktite.

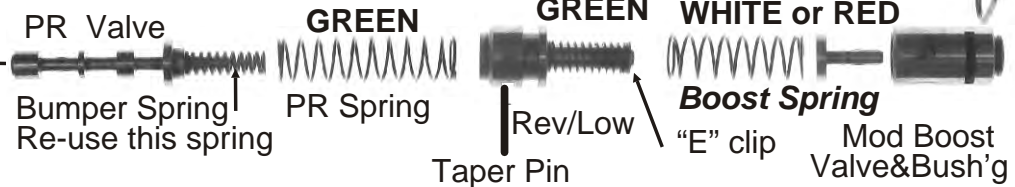
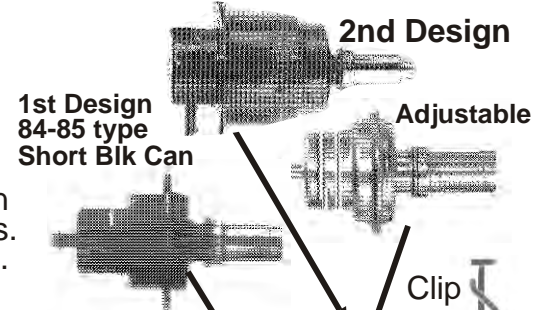
C. Pressure Rise/Regulation

Boost Spring matches modulator. If you don't know which modulator will be installed, use RED spring. If the trans has never been worked on you don't have to install green springs. If you don't know for sure install them.

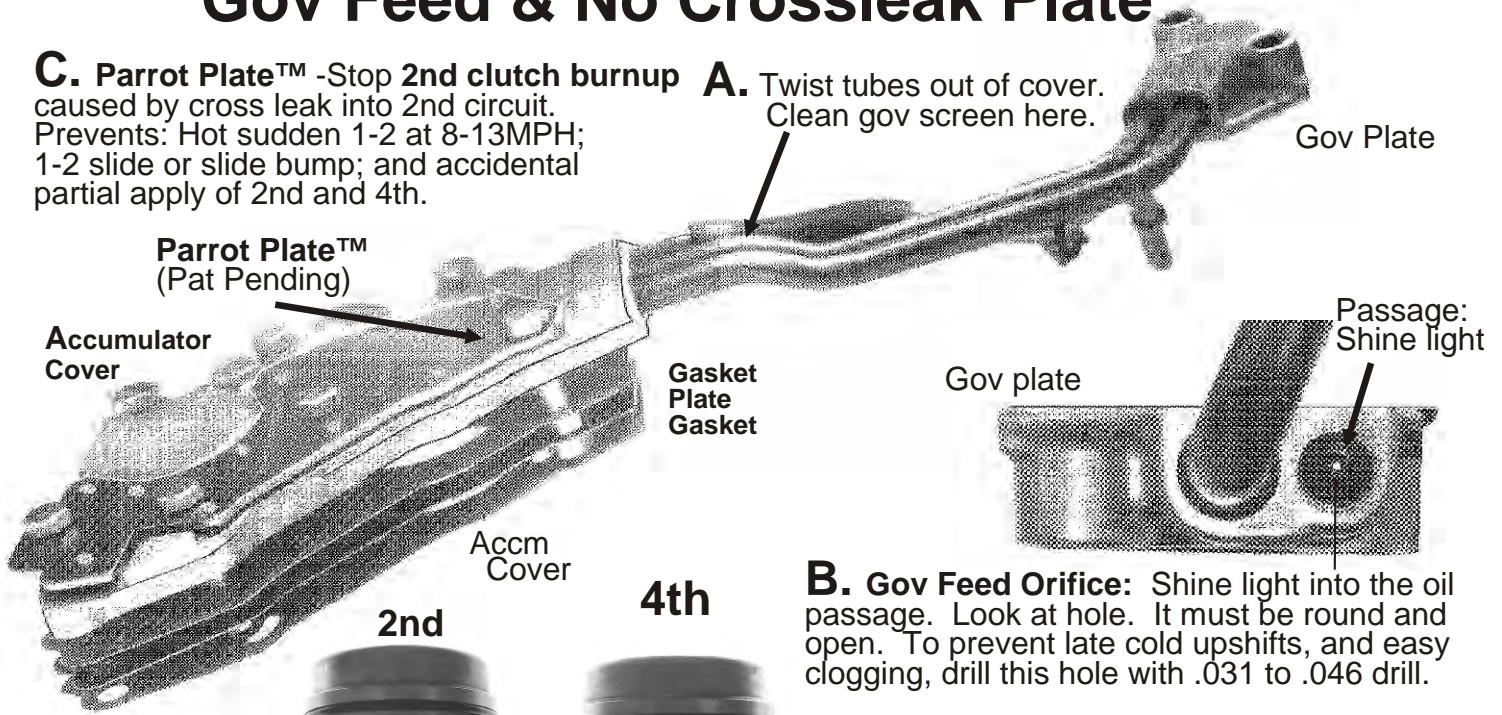
C. Parrot Plate™ -Stop 2nd clutch burnup caused by cross leak into 2nd circuit. Prevents: Hot sudden 1-2 at 8-13MPH; 1-2 slide or slide bump; and accidental partial apply of 2nd and 4th.

A. Twist tubes out of cover. Clean gov screen here.

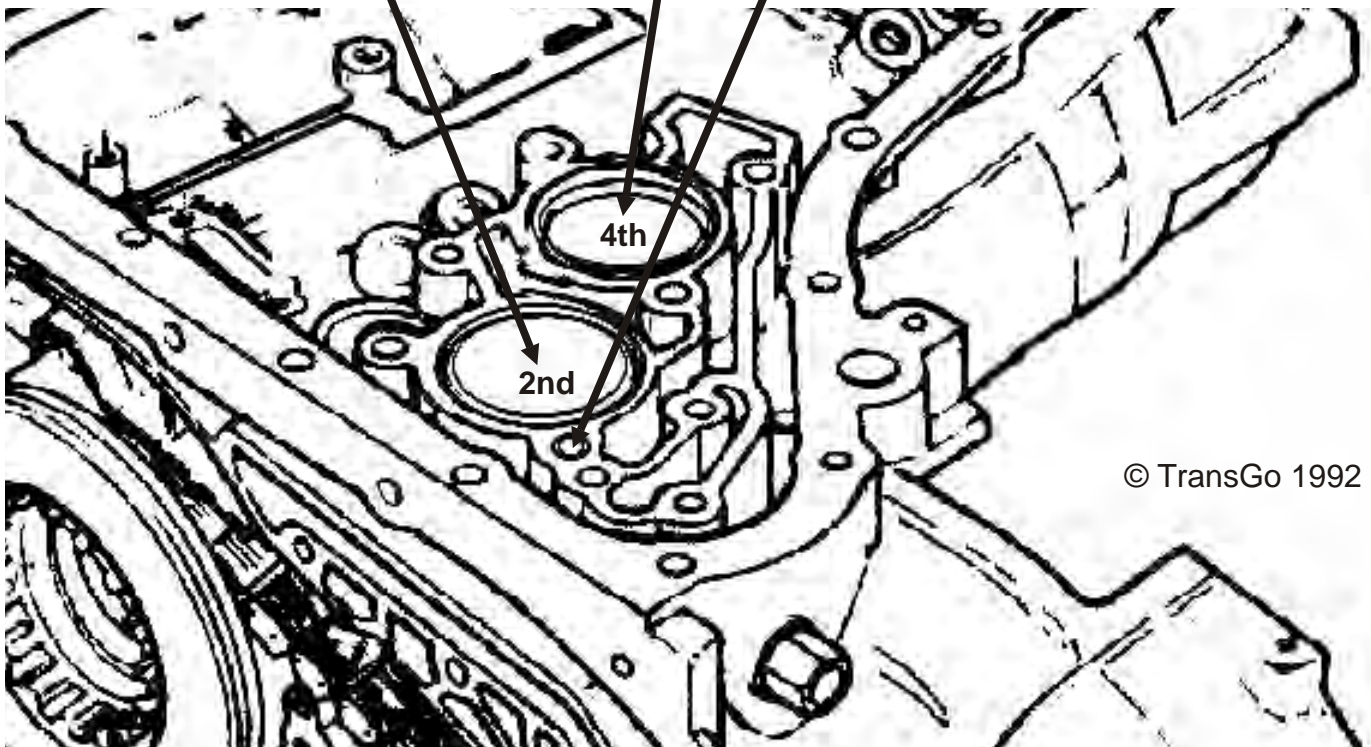
2nd & 4th Accumulators

PLAIN Tough Seals

Install threaded tapered Orifice: Station Wagons, 4dr sedans, Cadillac.

Don't install Orifice: 4cyl, or 2.8, 3.1 and sport coupes: [Threaded tapered Orifice: makes 1-2 shift slightly firmer.]

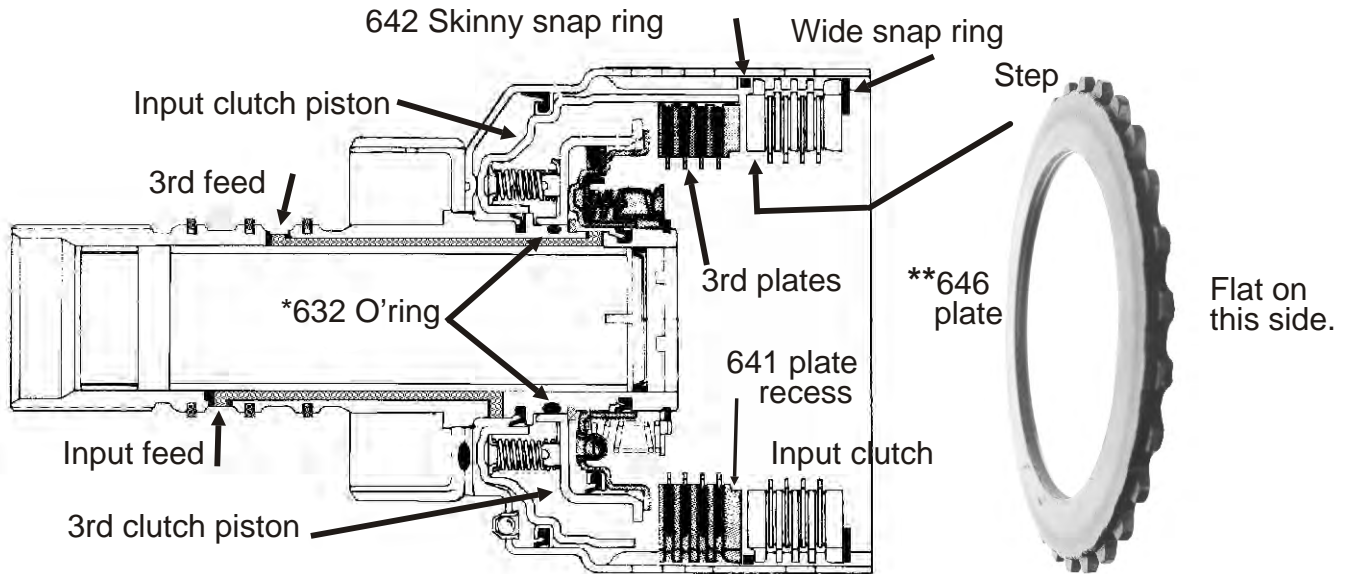
Input Drum Assembly

* 632 O'ring: Missing or undersize will cause 3rd slip, 2-3 cutloose or 2-3 bindup.

** 646 Input pressure plate: Has a step on one side of the teeth. Step installs against skinny snap ring 642. **646 installed backwards burns 4th clutch and other bad stuff.**

3rd clutch stackup: If stackup space leaves you a choice between 8 plates and a waved plate or 10 plates without a waved plate, it is better to have 10 plates.

641 plate can be machined up to .040 thinner to gain additional space for clutch plates.

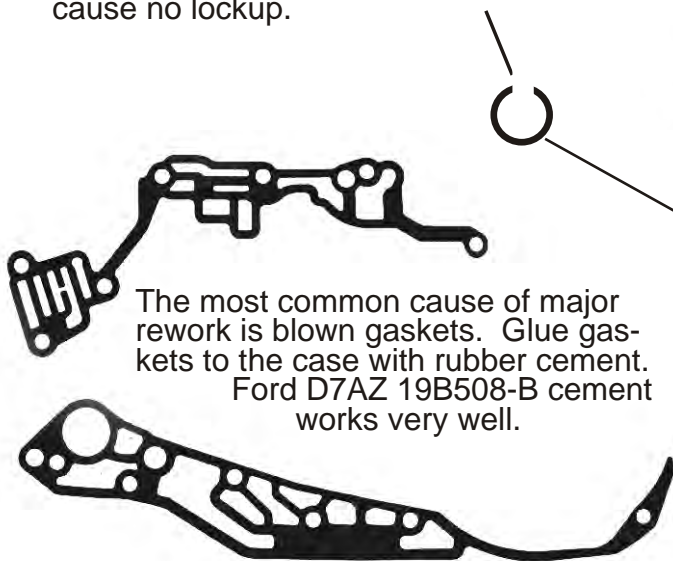
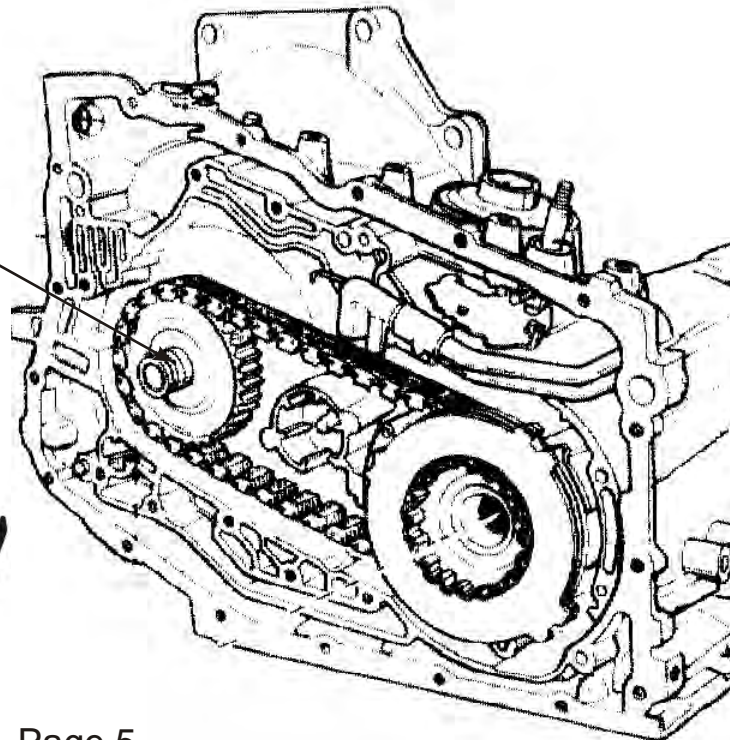
Chain Cover Assembly

The snap ring must be all the way down into the groove. Not down in groove will cause no lockup.

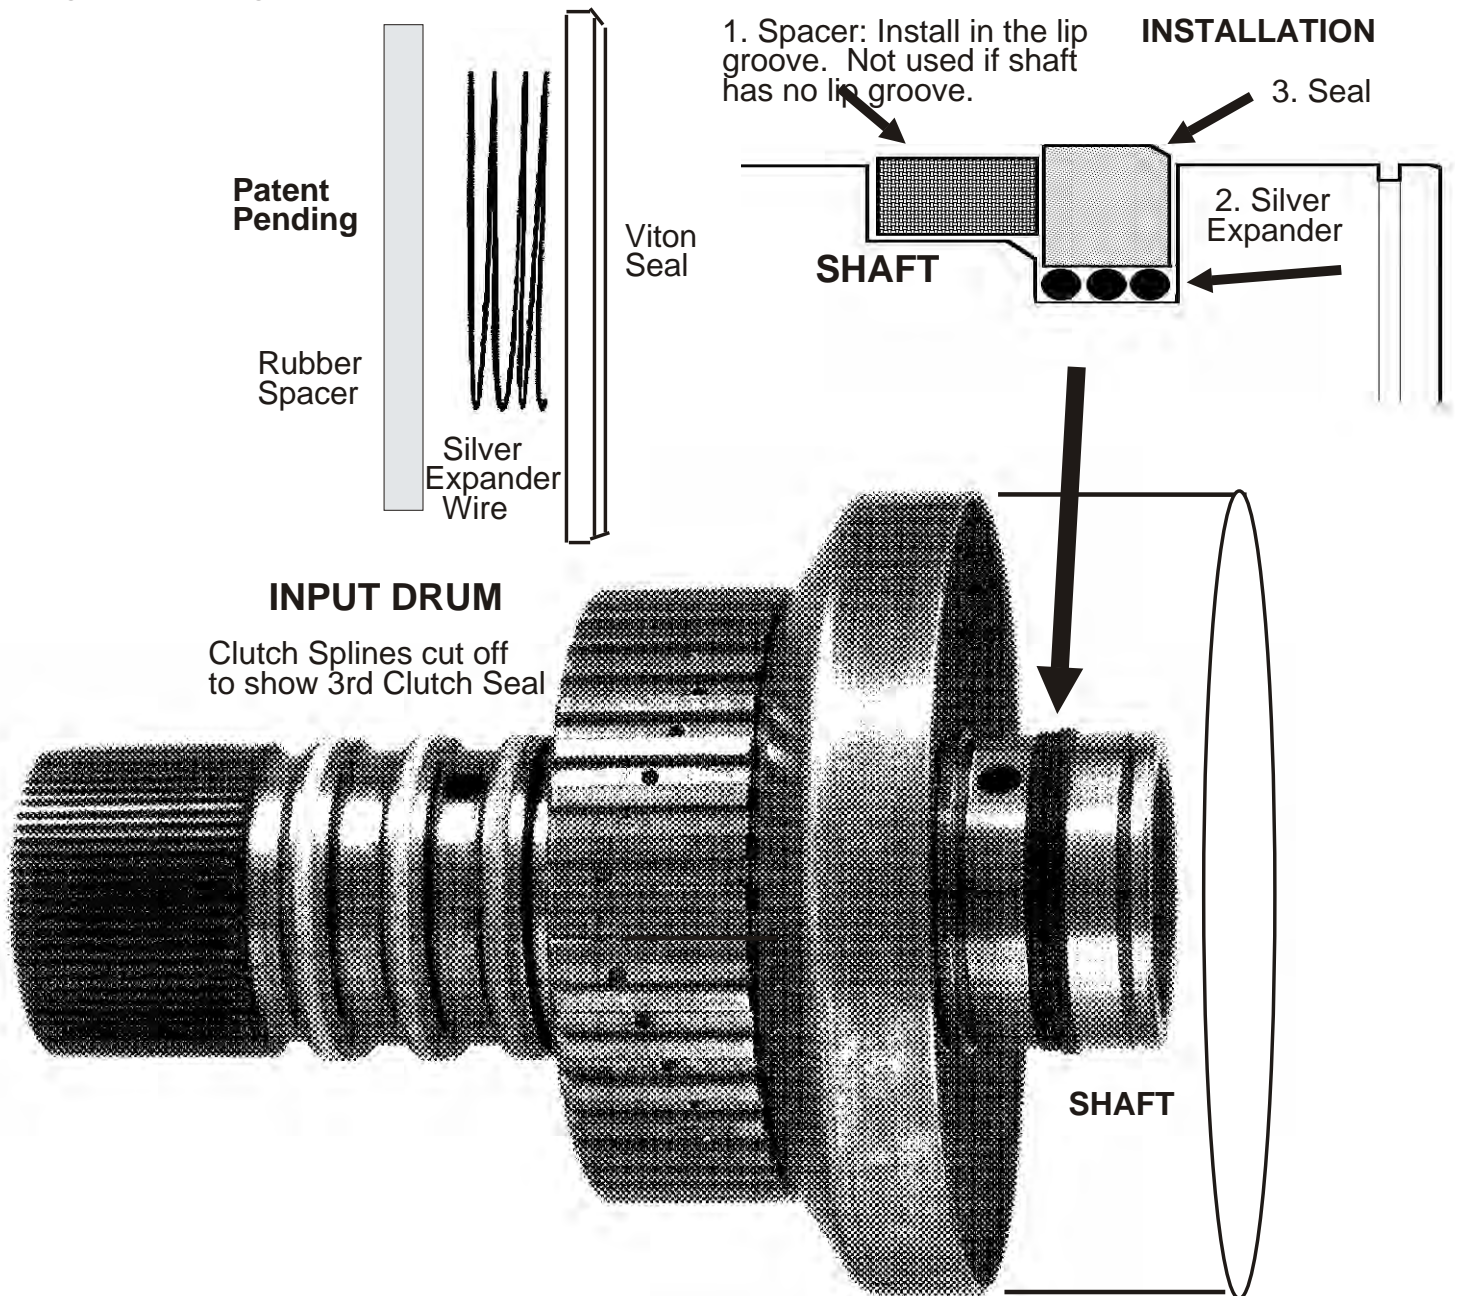
440-NoYoYo®

CORRECTS: No 2-3 upshift cold — Delayed 2-3 cold — 2-3 slide or runaway during warmup — Seal splits or tears — Seal flips sideways — 3rd clutch failure
We know of four seal design and spec changes. The problem of lip breaking off, delayed or no 3rd cold and 3rd clutch failure persists. 88 input drum reduces the clearance between the piston and the seal shaft, but broken lip, delay and 3rd clutch failure continues.

Field tests indicate it's a total fix for 3rd seal failure and leakage, regardless of which design input drum or piston is used. It's self-centering, and doesn't care if the piston is off center. It's self-expanding and automatically resizes or reshapes to fit any use/cure off-setting or hot/cold expansion conditions. Best of all, it won't flip over while installing it or during use.
