# SK® 4T60E-Jr Shift Kit®

## **Prevent/Reduce/Corrects:**

Converter shudder/slip. Lockup on top of 2nd.  
Won't unlock - Falls in and out of lockup.  
No lockup and/or 4th with hot Code(s):740, 85, 39, 80/90.  
2nd clutch burn up due to pin wear or seal nibble.  
Delayed 3rd or No 3rd cold.

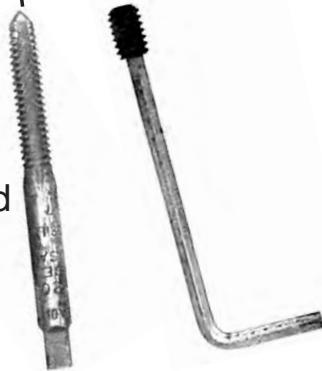
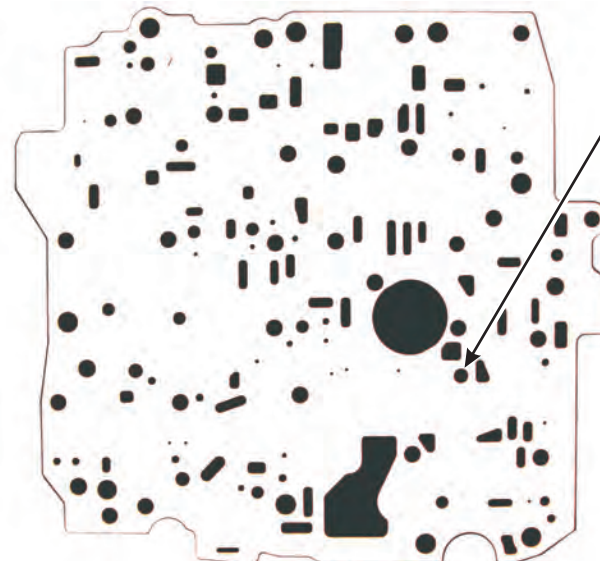
**Step D** By hand with 5/16 or larger drill. Slightly chamfer this hole on both sides of plate. Place plate on cement floor. Insert solid alum plug into hole. Hit it 3 times with a light hammer. Then file plug flush both sides.

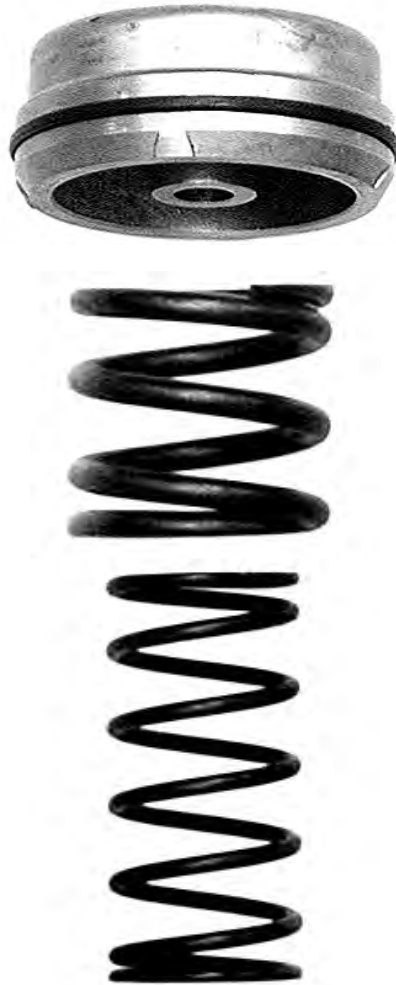
2-3 Accm

Note: There are other spring set ups. Put it back like it came in.

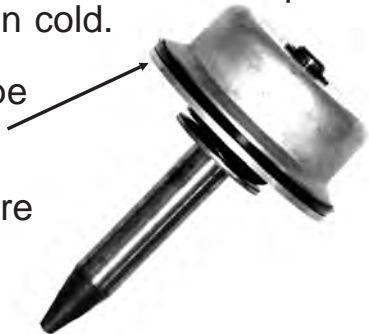
Long type  
lip seal

This special seal will correct/prevent complaint of no reverse or slips in reverse when cold.
