SK 700-G™ Shift Kit®

TransGo® COMPLETE SYSTEM CORRECTION SysKo® Kit The Genuine Fix: Even for the “Authorized Complaints” VALVEBODY, SERVO, ACCUM, GOVNR, PUMP PARTS/DATA

PARTS AND INFO— FOR PREVENTION/CORRECTION OF THE FOLLOWING COMPLAINTS AND FAILURES:

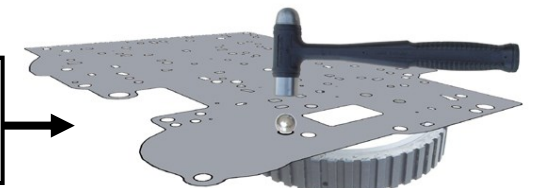
Assembly: To align plate & gaskets, start Z bolts first.

If plate has these 2 holes: Install #9 check ball (82-87)
Don't install check ball: If plate has only 1 hole. (88up)

Got a hole too big? Place the hole that's too big onto the face of a sprag race. (Hardened Surface) Place 5/16 steel ball on the hole and hit it with a small hammer. Redrill to correct size.

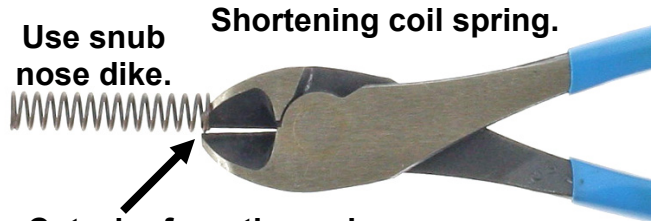
With 1st design 3-4 Shift Valve: Use smaller diameter of the two unpainted springs furnished in small plastic bag.

With 2nd design 3-4 Shift Valve: Use the larger diameter of the two unpainted springs furnished in the small plastic bag.

**Cut wire from the end.
Don't cut between the coils.**
