SK 700-G™ Shift Kit®

TransGo® COMPLETE SYSTEM CORRECTION SysKo® Kit The Genuine Fix: Even for the “Authorized Complaints” VALVEBODY, SERVO, ACCUM, GOVNR, PUMP PARTS/DATA

PARTS AND INFO— FOR PREVENTION/CORRECTION OF THE FOLLOWING COMPLAINTS AND FAILURES:

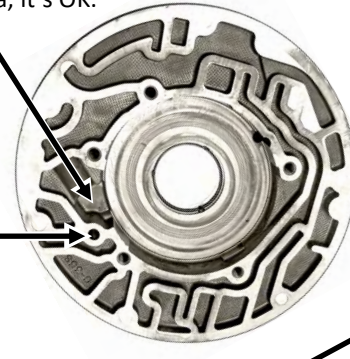
Use the same drill to check or enlarge the holes shown in the pump and pump cover.

Don't worry if your drill breaks into the priming spring area, it's OK.

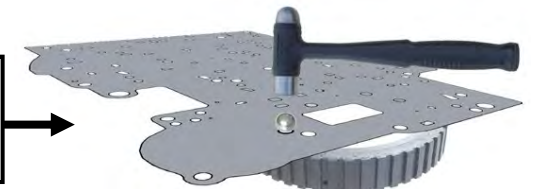
Got a hole too big? Place the hole that's too big onto the face of a sprag race. (Hardened Surface) Place 5/16 steel ball on the hole and hit it with a small hammer. Redrill to correct size.

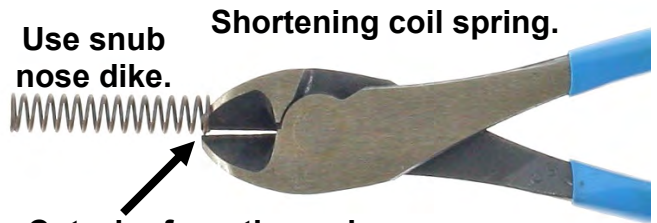
With 1st design 3-4 Shift Valve: Use smaller diameter of the two unpainted springs furnished in small plastic bag.

With 2nd design 3-4 Shift Valve: Use the larger diameter of the two unpainted springs furnished in the small plastic bag.

Use snub nose dike. Shortening coil spring.
Cut wire from the end.
Don't cut between the coils.
