AXODE Shift Kit[®]

1991up AXODE & AX4S

Reduces/Corrects/Prevents

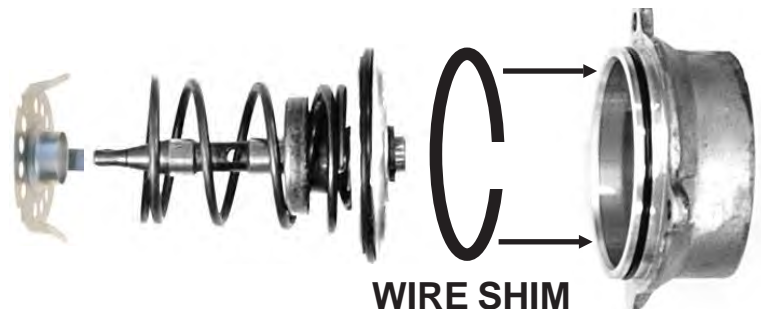
D 1-2 Servo (on side of trans)
Install **WIRE SHIM** in cover.

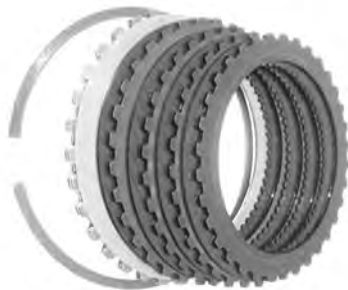
(Green) Hi-Energy 3rd plates with Kolene steels.

1996-01 Vehicles: Came with Hi-Energy (Green) 2nd and 3rd clutches. During light acceleration the ECM commands pressure of 140 to 160 psi. Using brown clutches in these applications will cause rough shift complaint.

Even if the 2nd & 3rd plates look OK, Don't reuse them. They become glazed, hard, and lose their ability to hold which creates a long soft apply. Always install new friction plates. Hi-Energy does not mean the plate has more friction capacity, it means the plate will handle higher temperature without burning.

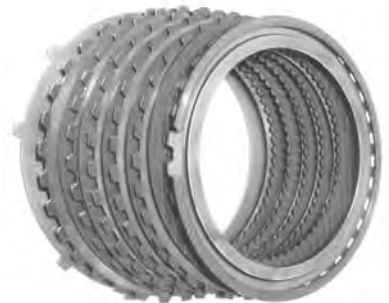
(Green) Hi-Energy 2nd plates with Kolene steels.
