# SK<sup>®</sup> AXODE/AX4S-Jr Shift Kit<sup>®</sup>

Fits: Taurus/Sable/Continental 1996 to 2003

Fits: Windstar 1995 to 2002

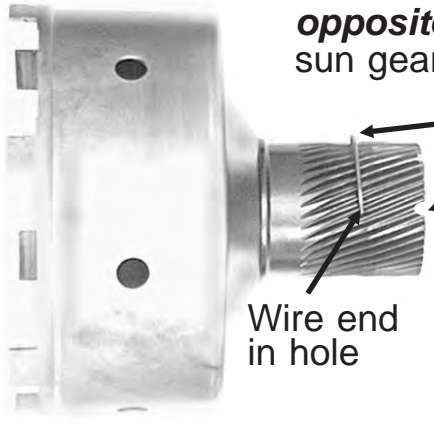
### Sun Gear

**A** Grind *two* notches  $\frac{1}{32}$ " to  $\frac{1}{16}$ " deep *opposite* each other on the *end* of the sun gear. It's not fussy.

Grind notches

Wire end in hole

**B** Slide the **WIRE CLIP** over the end of the sun gear. Insert the ends into lube holes located in the middle of the gear teeth.

**Positive lube flow** now squirts out of the notches on end of sun gear directly onto the planetary gear teeth and the needle bearing.

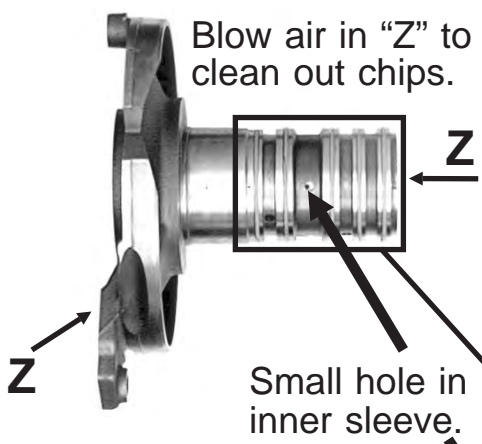
### Sprocket Support

Blow air in "Z" to clean out chips.

Small hole in inner sleeve.

**C** Re-drill the small hole in the *inner sleeve*, use .187 to .196 drill. De-burr hole inside the support with a file.

**D** With a punch install bushing furnished into lube hole and *re-drill* hole in **BUSHING** .073 to .086.

Take care when drilling the small hole in inner sleeve. Do not disturb existing outer support hole. The **BUSHING** furnished must be able to press fit into the existing outer hole.

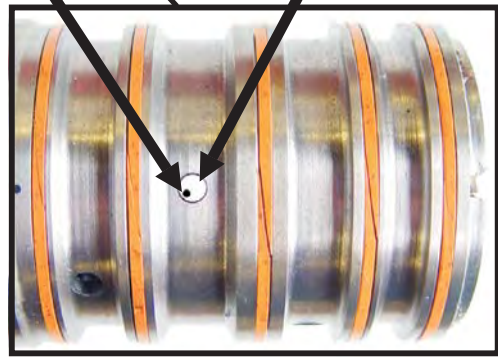
### Sprocket Shaft

**E** Drill both sides  $\frac{1}{4}$ " to  $\frac{3}{8}$ ". De-burr inside with a file.

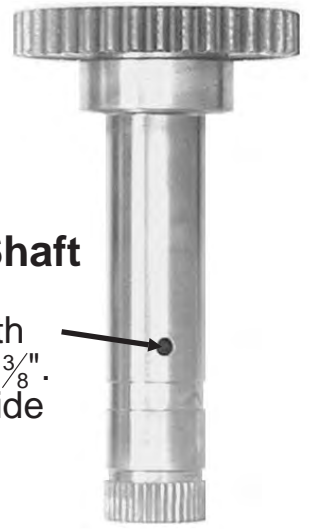
## Front Planetary

**A** Enlarge the two holes just below the needle bearing with the .110 drill furnished. Insert drill from the side between the pinion gear and housing.

If you can't line up with the holes to drill them, it's **OK** to drill two new .110 holes.

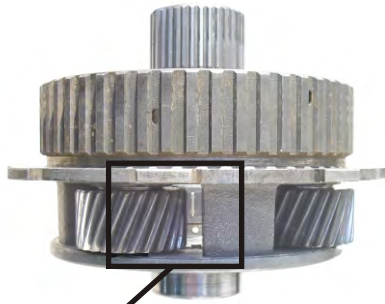
**B** Find the lube hole just above the bearing. Drill a 1/4" hole through a clutch groove in line with the lube hole. Then enlarge the lube hole to 1/4".

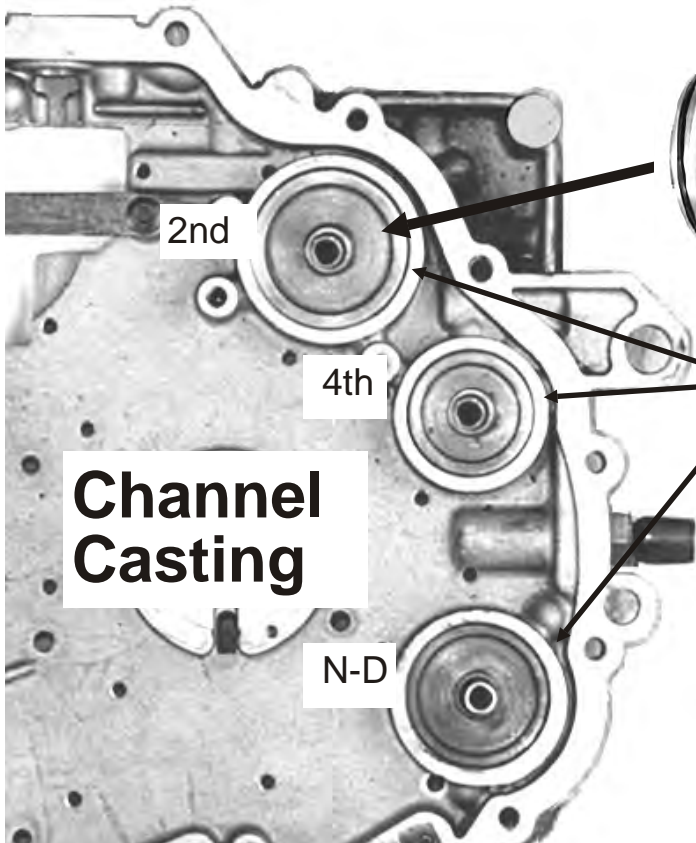
## Channel Casting

2nd

4th

N-D

WIRE RING

**C 2nd Accum Piston**  
Install **WIRE** then **RING**.  
pat 6,575,472

**Reuse original accum springs.**  
See spring ID page 6.

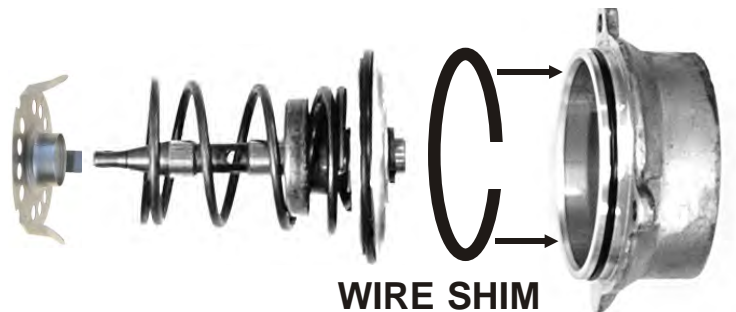
WIRE SHIM

**D 1-2 Servo** (on side of trans)  
Install **WIRE SHIM** in cover.

**Avoid Gasket Blowout:** Glue the gasket to chain cover and to case with a good, quick drying **rubber or contact cement**. Tighten the cover bolts several times to compress gasket.

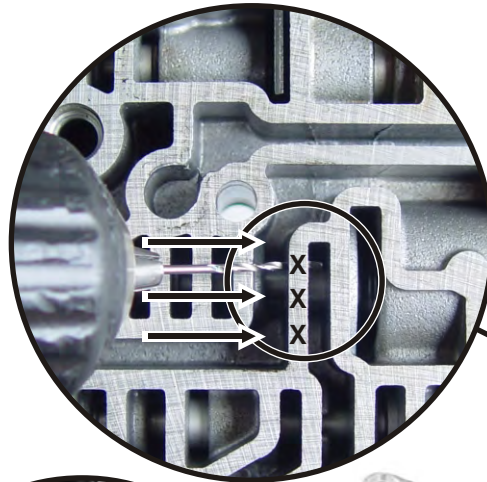
**A** Drill three .055 holes, in the direction of the arrows through partition under **X**'s.

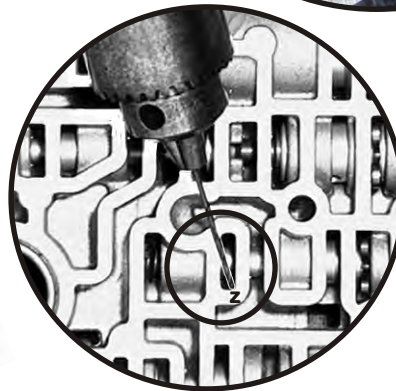
**B** Drill .055 hole through VB passage at angle shown, just under gasket surface at location **Z**. Install **Cotter pin** furnished through hole and spread out ends.

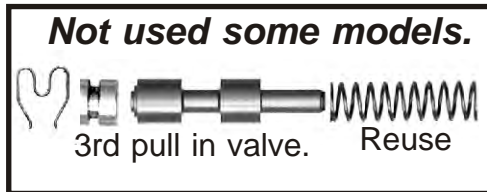
**C** Install **ORANGE** spring on the 3-2 control valve.

Retainer clip

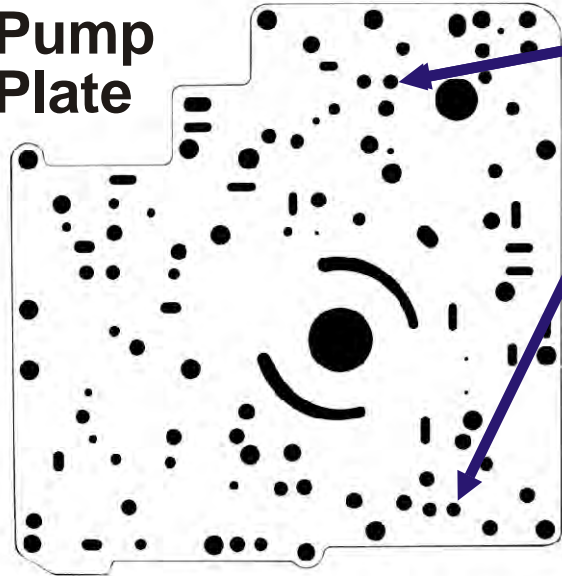
# Pump Plate

No hole here: **No Ball A** in pump.  
 Has hole: Pump **must have** Ball A

No hole here: **No Ball B** in pump.  
 Has hole: Pump **must have** Ball B

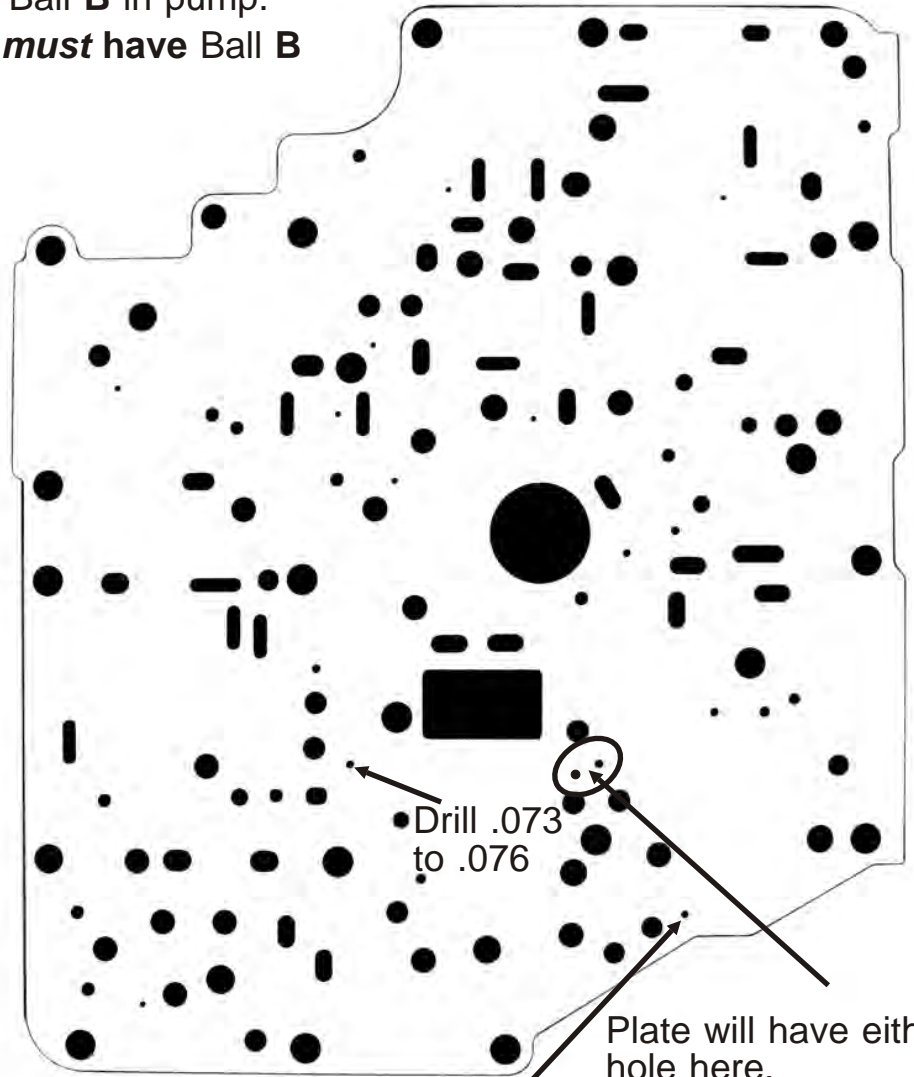
# Valve Body Plate

Drill .073 to .076

If plate has this hole. Re-drill it .040 to .055

Plate will have either hole here. Re-drill .081 to .086. **Don't drill new hole.**

Checkballs (C) (no) Do not install.

(A) & (B) See Pump Plate.

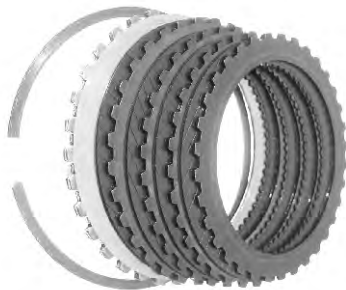
(Green) Hi-Energy 3rd plates with Kolene steels.

1996-01 Vehicles: Came with Hi-Energy (Green) 2nd and 3rd clutches. During light acceleration the ECM commands pressure of 140 to 160 psi. Using brown clutches in these applications will cause rough shift complaint.

Even if the 2nd & 3rd plates look OK, Don't reuse them. They become glazed, hard, and lose their ability to hold which creates a long soft apply. Always install new friction plates. Hi-Energy does not mean the plate has more friction capacity, it does mean the plate will handle higher temperature without burning.

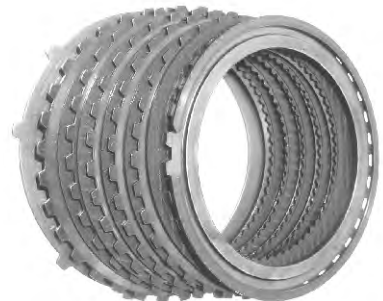
(Green) Hi-Energy 2nd plates with Kolene steels.
