ClearVIEW HD-19 Version 01.02.06

Release Notes – March 1, 2017

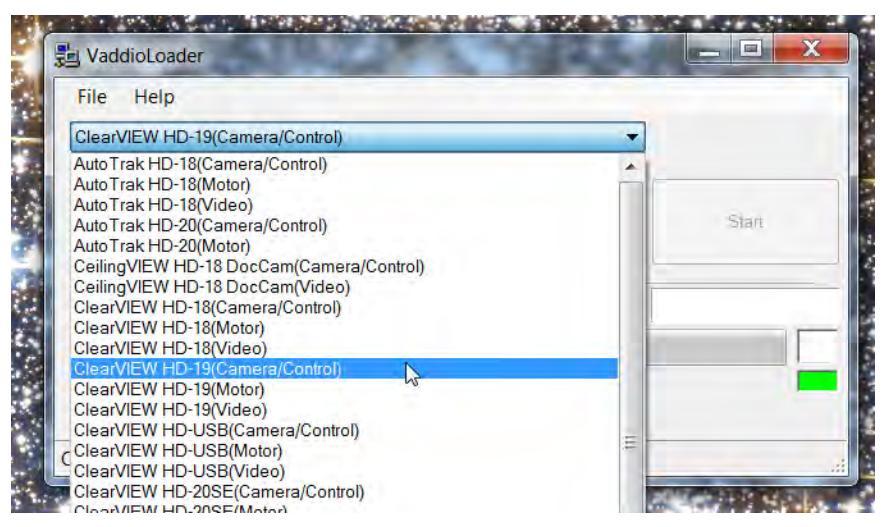
- 1. Open the Vaddio Loader.
- 2. Select the appropriate COM port if necessary.
- 3. Select Camera as the Product Type.
- 4. Select your camera and update type from the product list. It's likely to be a different item than what this screen shot shows.

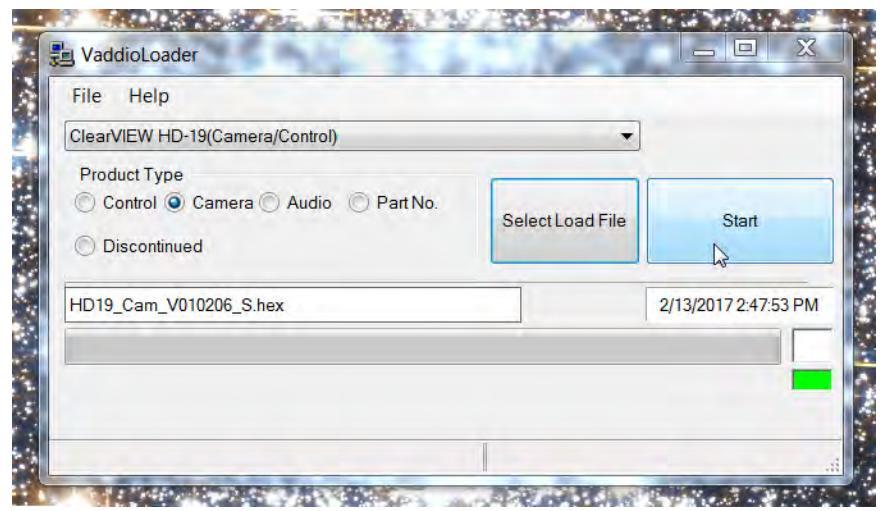
- 5. Click Select Load File, browse to the firmware update file that you downloaded, and select it.
- 6. Check the filename in the box to be sure it's the right one. (This is likely to be a different file than what is shown in the screenshot.)
- 7. Click Start. The colored box at the lower right flickers green and red, and the progress bar indicates progress.
