62TE-HP

High Pressure Tuneless[™] Reprogramming[™] Kit

An essential performance and durability upgrade for hard-working ProMaster and passenger vans to prevent 2-4 clutch failures, especially in shift busy delivery vehicles. A recalibrated pressure curve delivers increased clutch and TCC holding capacity with short, clean shifts at all throttle openings. A 26% overall increase in line pressure takes this unit from (stock OEM) 60-135 psi to (TransGo) 75-170 psi.

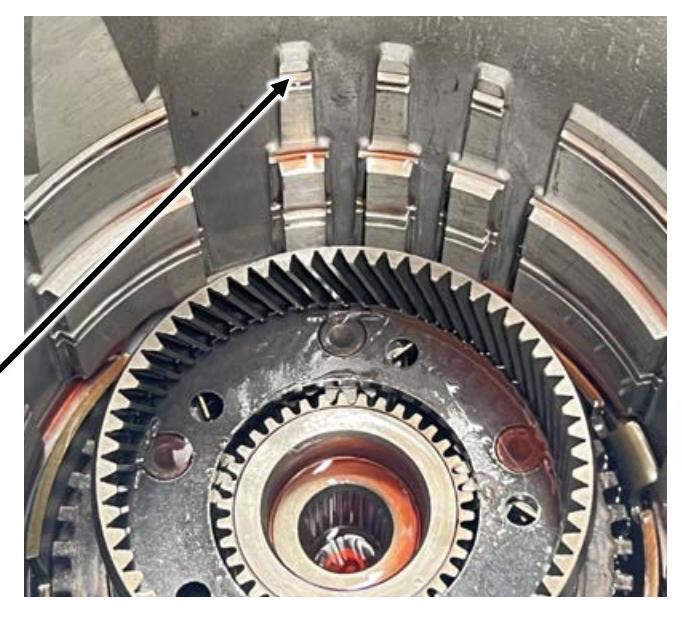
New, wider 2-4 clutch piston retainer snap ring

Step 2. After you've installed your clutches and piston housing, fit the new, wider 2-4 clutch piston retainer snap ring into the top groove.

This snap ring was re-engineered to significantly reduce deflection upon 2-4 clutch apply.

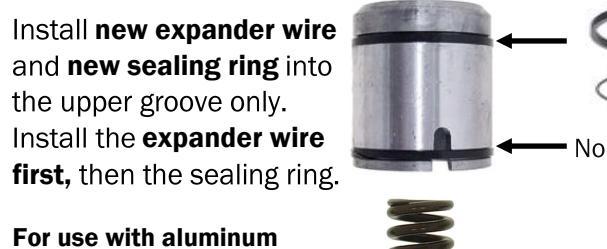
Install **new expanders and sealing rings** on the closed end of the UD, LR, OD, DC and LC aluminum accumulator pistons.

pistons only. Reuse original springs.

Assembly installs **spring-first** into the case.

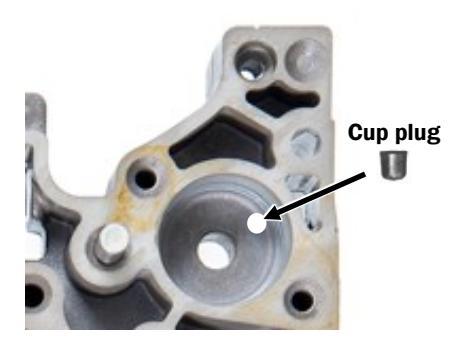
Step 5. Using the existing guide pin and a 6mm bolt in the holes of **index tool** as shown. Next carefully and slowly drill through the casting with 0.156" drill bit provided **just enough to break through the pocket floor, then stop.**

Existing guide pin

Drill here

Insert a 6mm

bolt here

Index

Listen up! There must be **no air gap** between cup plug and hole. If for any reason the hole you drilled does not look perfectly round, use a little bit of Loctite[®] 518 flange sealant or alike on the cup plug. When done, clean any excess sealant, making sure none of it made it in the orifice.

Step 6. Using a **flat punch**, insert **furnished cup plug** from the transducer side into the drilled hole until **flush** with the top of the casting.

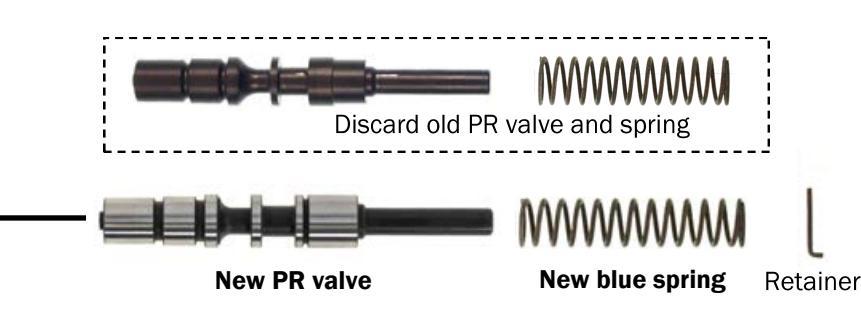
Step 7. Install **new PR valve**, ensuring it travels freely, then the **new blue PR spring**, and reuse the retainer.

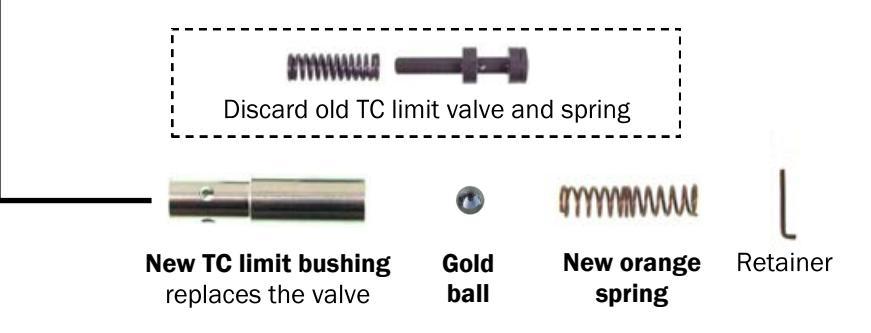
Step 8. Install **new TC limit bushing, gold ball, orange spring,** and reuse the retainer. *Regardless of the amount of bore wear this system works perfectly!*

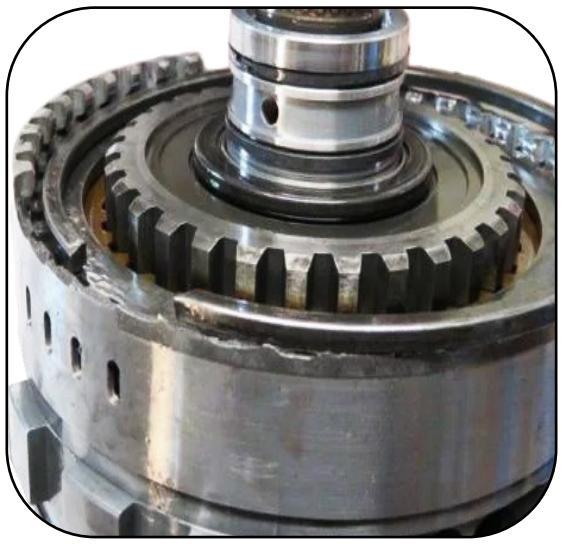
Figure 1

The low drum and case are prone to wear causing the snap ring to blow out the top of the drum. (Figure 1 and 2)

Always inspect the drum (Figure 3) and the case (Figure 4) closely for wear. The low drum should have an interference fit in the case. Removing the drum should be difficult and require the use of a slide hammer.

If the drum comes out easily without the need to use a slide hammer, the drum is bad, and must be replaced. Inspect the case for excessive wear as well.

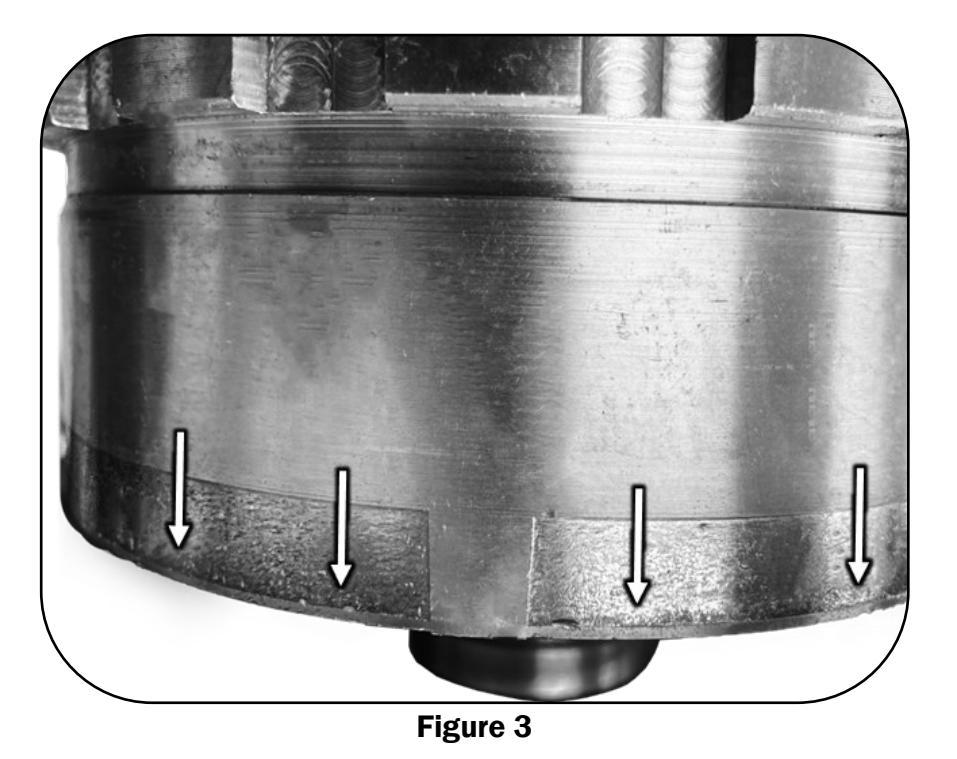
Look closely for low drum wear (as shown in the example above) where the arrows point on the side of the drum as well as where the drum sits against the lip in the case.

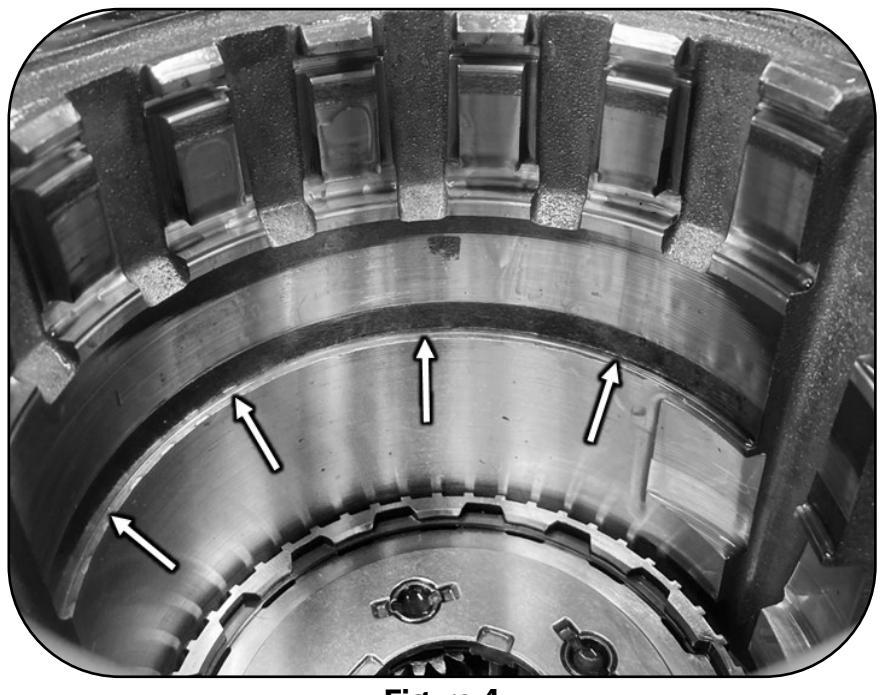
Figure 4

Look closely for case wear (as shown in the example above) where the arrows point at the lip where the low drum stops in the case as well as the area above it.

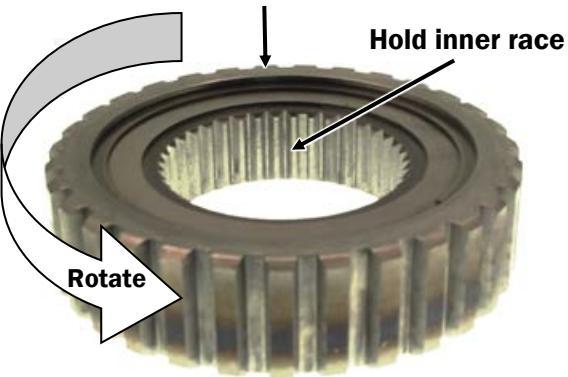
The stepped side of the outer race faces into the low drum. When sprag assembly is installed in the low drum, the outer race must rotate counterclockwise while the drum held stationary.

Flat side of outer race faces up when installed in low drum

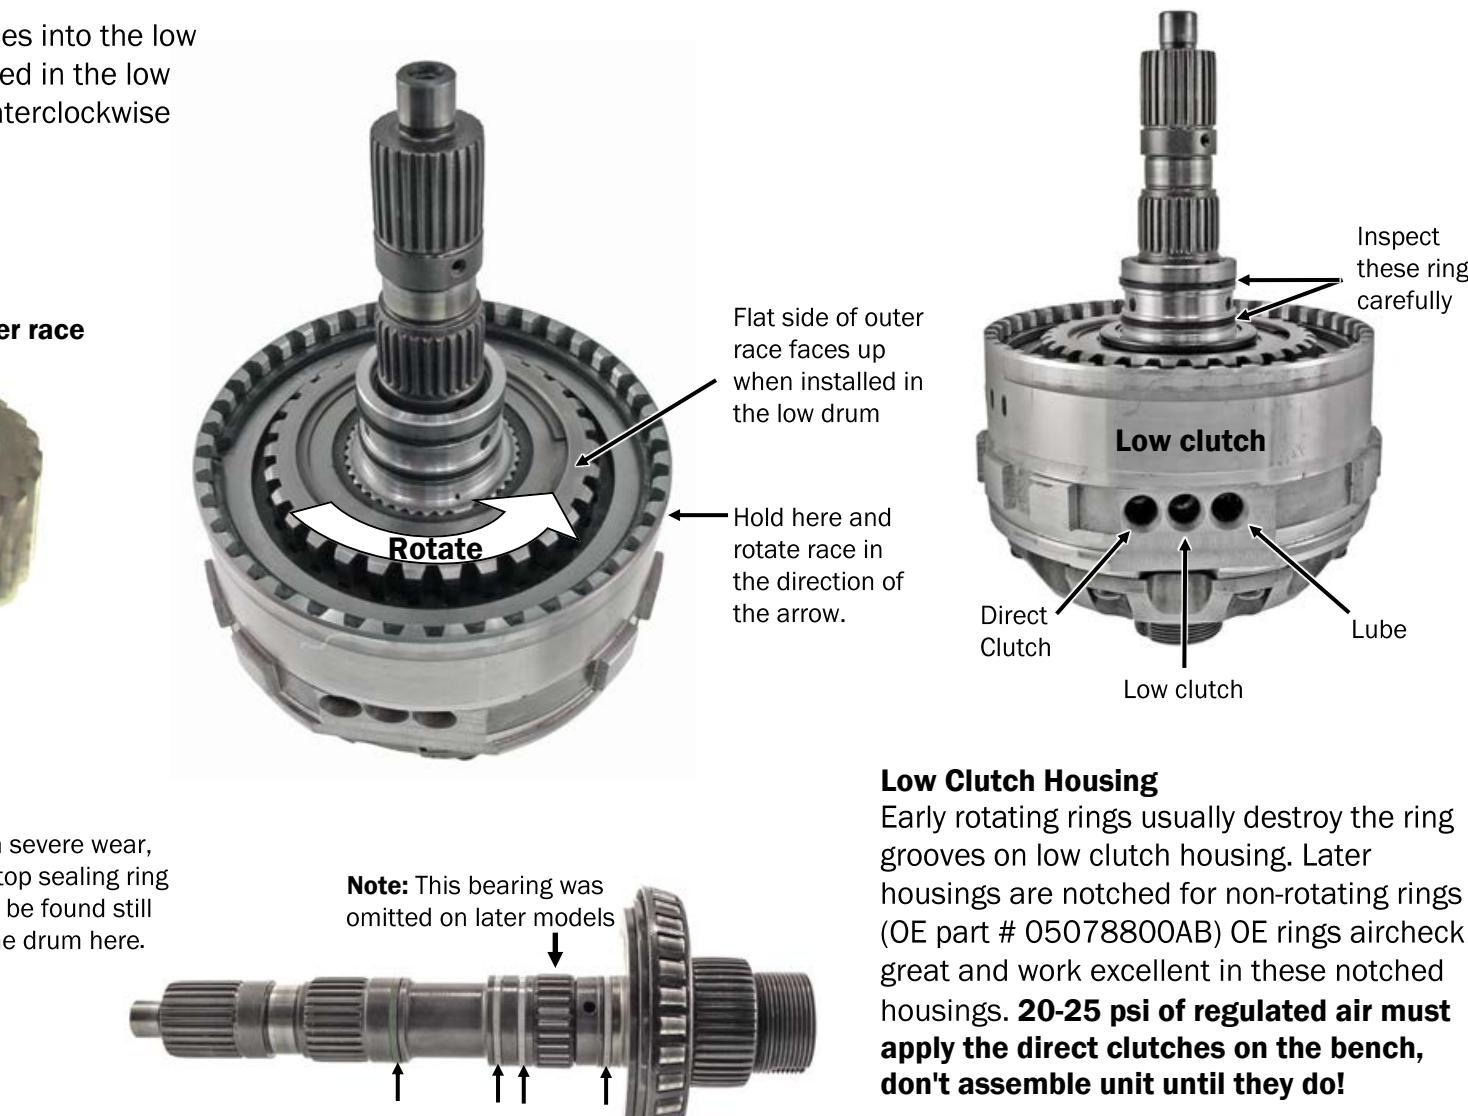
Loss of lube from shrunk sealing rings on the transfer shaft will accelerate wear on the ring tower causing direct drum rings to leak.

These 4 rings like to shrink dumping lube oil that can lower main line and accelerate ring land wear on the low clutch housing. OE part # 68018615AA

Updating the low clutch housing to the latest non-rotating ring type housing during overhaul is an great way to prevent rework due to ring groove damage. Even though it may not be damaged at time of overhaul, be warned, it does have a known high failure rate. Remember the customer pays for the parts now, you pay for them later.

these rings carefully
