2014 BROCE BROOM KR350 / 0

Specifications	
Year	2014
Make	Broce
Model	KR350
Date of Inspection	03/26/2024
Location of Inspection	612 Kaye Lani Avenue , Monroe, MI, 48161, USA
Serial Number	408514
Cylinders	No Damages Observed
Engine Hours	1,684
EMS Warning Lights	No Active Warnings
Transmission Type	Automatic
Operator's Seat	No Damages Observed
Mirrors	N/A
Radio	No
A/C	Yes
Steering Wheel	No Damages Observed
Pedals	No Damages Observed
Floorboard	No Damages Observed
Power Mirrors	No
Heated Mirrors	No
Switches and Controls	See Notes
Steps	No Damages Observed
Handrails	No Damages Observed
Oil Dipstick	Good Level / Good Color
Engine Compartment	See Notes
Exhaust	No Damages Observed
Axles	No Damages Observed
ROPS	No Damages Observed
Front Lights	No Damages Observed
Rear Lights	No Damages Observed
Front Left Tire Condition	See Notes
Front Left Tire Brand	Could Not Be Located
Front Left Tire Size	LT225/75R16 115/112S
Rear Left Tire Condition	No Damages Observed

Job #: 69631 /

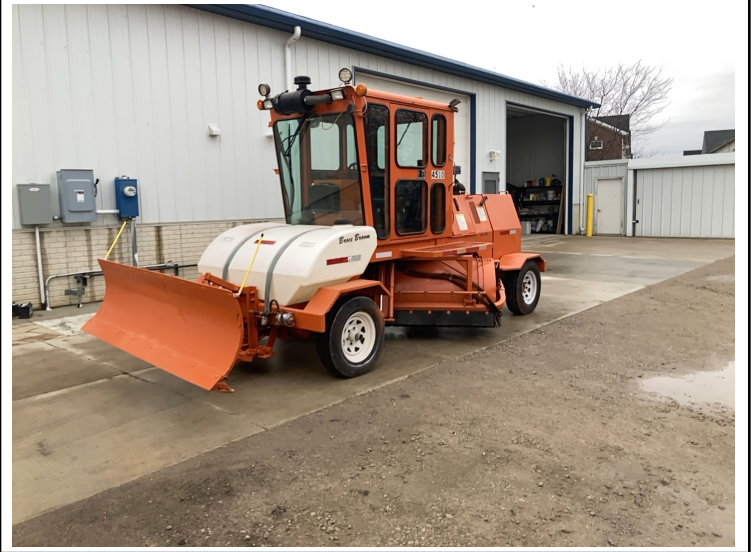
Equipment Photo

The unit runs and drives. The snow blade has a dent in the face of it. The fuel tank may have a dent in it. The control on the right side in the cab appears to be oily and could possibly have a leak under the cover. The front left wheel hub dust cap is missing the outside cover. There is a bolt missing from the A/C unit. The front tie rod appears to be bent. The front left tire has paint on the sidewall. The rear right tire has cuts on the sidewall. The front right tire has cuts on the sidewall, and the tire is low on air pressure. The backup alarm did not operate in the video.

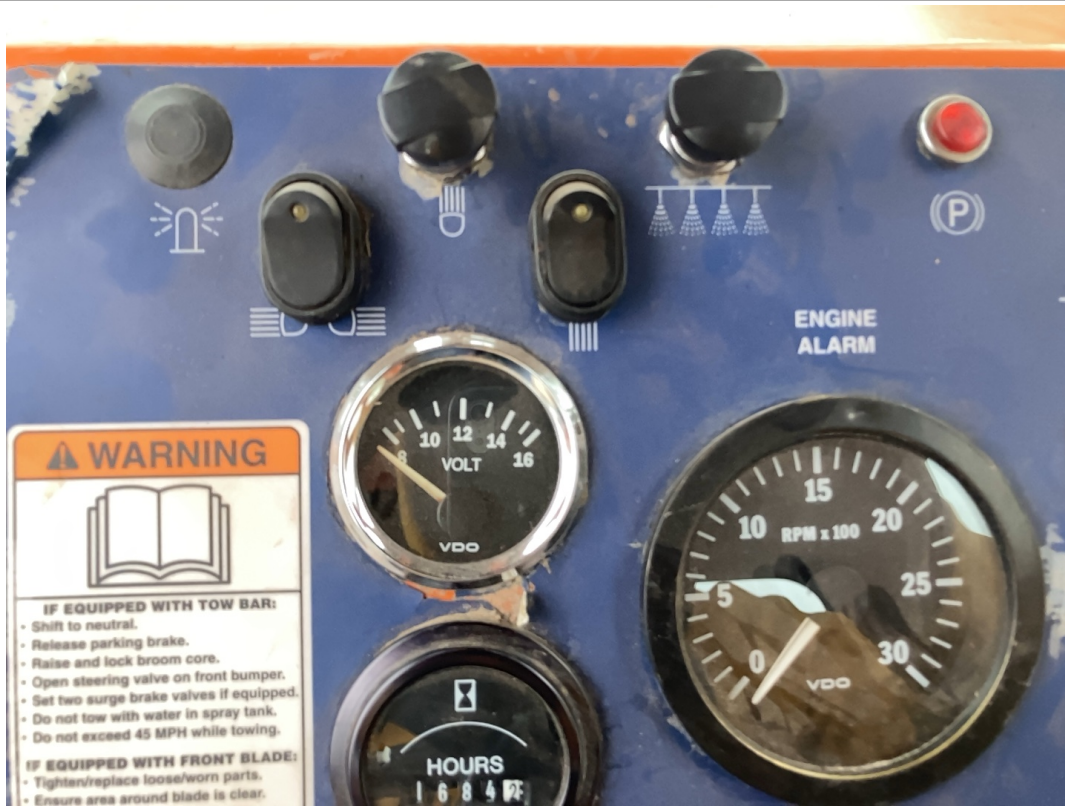
Switches and Controls / Engine Hours: 1,684 / 03-26-2024
