2019 KUBOTA KX-80 / 0

Specifications	
Year	2019
Make	Kubota
Model	KX-80
Date of Inspection	03/27/2024
Location of Inspection	20595 Eigg Road, Alexandria, Ontario, K0C1A0
Serial Number	JKUK0804C01H46929
Cylinders	No Damages Observed
Engine Hours	2,479
EMS Warning Lights	No Active Warnings
Travel Control	No Damages Observed
Operator's Seat	See Notes
Mirrors	No Damages Observed
Radio	No
A/C	Yes
Steering Wheel	N/A
Pedals	No Damages Observed
Floorboard	No Damages Observed
Power Mirrors	No
Heated Mirrors	No
Switches and Controls	See Notes
Steps	No Damages Observed
Handrails	No Damages Observed
Oil Dipstick	Good Level / Good Color
Engine Compartment	See Notes
Exhaust	See Notes
Axles	N/A
Deluxe Instrumentation	No Damages Observed
Backup Camera	N/A
ROPS	See Notes
Front Lights	No Damages Observed
Rear Lights	No Damages Observed
Left Track Condition	No Damages Observed
Left Track Brand	Q-Track
Left Track Size	450X81SNX78
Left Track Tread Depth Measurement	30/32"

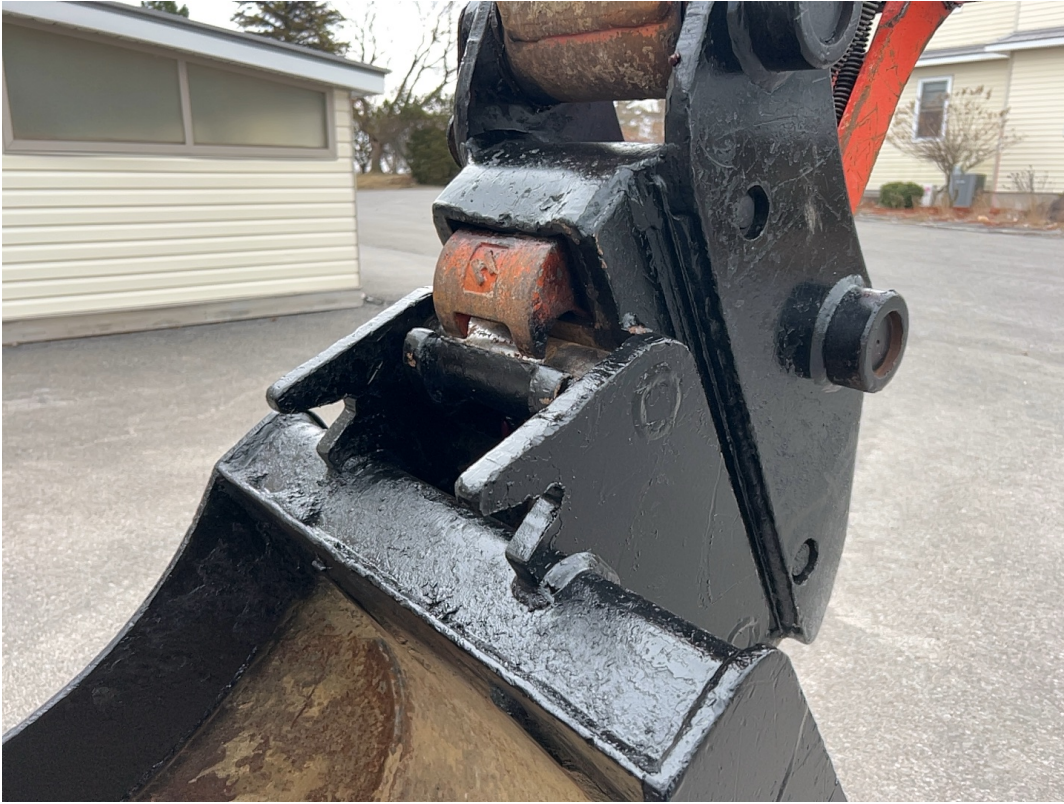
Attachments / 03-27-2024

The unit runs and drives. The window brake tool is missing in the cab. A piece of exterior molding is missing on the right side of the cab by the window. The rear of the bucket appears to have dents and a dent. The rear engine hood appears to have a small dent in it. The backfill blade has a couple of small dents on the top lip. The operator's seat bottom cushion appears to be dirty and stained. The control box in the cab on the right rear has been broken and taped back together. The cover around the exhaust in the engine compartment is rusty. The radiator fins appear to be a little bit dirty. The right track has a gouge on the inside face of the rubber, and the tread lugs have small cuts in them. The left track has a small gouge in the tread lug.
