2015 SNORKEL A46JE / 0

Specifications	
Year	2015
Make	Snorkel
Model	A46JE
Date of Inspection	04/09/2024
Location of Inspection	4710 Salina St, Pulaski, NY, 13142
Serial Number	A46JE-04-000112
Engine Hours	348
EMS Warning Lights	No Active Warnings
Travel Control	No Damages Observed
Operator's Seat	N/A
Mirrors	N/A
Radio	No
A/C	No
Steering Wheel	N/A
Pedals	No Damages Observed
Floorboard	No Damages Observed
Power Mirrors	No
Heated Mirrors	No
Switches and Controls	No Damages Observed
Steps	N/A
Handrails	No Damages Observed
Oil Dipstick	N/A
Hydraulic Compartment	See Notes
Exhaust	N/A
Axles	No Damages Observed
ROPS	N/A
Front Lights	N/A
Rear Lights	N/A
Front Left Tire Condition	See Notes
Front Left Tire Brand	OTR
Front Left Tire Size	IN240/55D17.5
Rear Left Tire Condition	No Damages Observed
Rear Left Tire Brand	OTR
Rear Left Tire Size	IN240/55D17.5
Front Right Tire Condition	See Notes
Front Right Tire Brand	Could Not Be Located
Front Right Tire Size	IN240/55D17.5

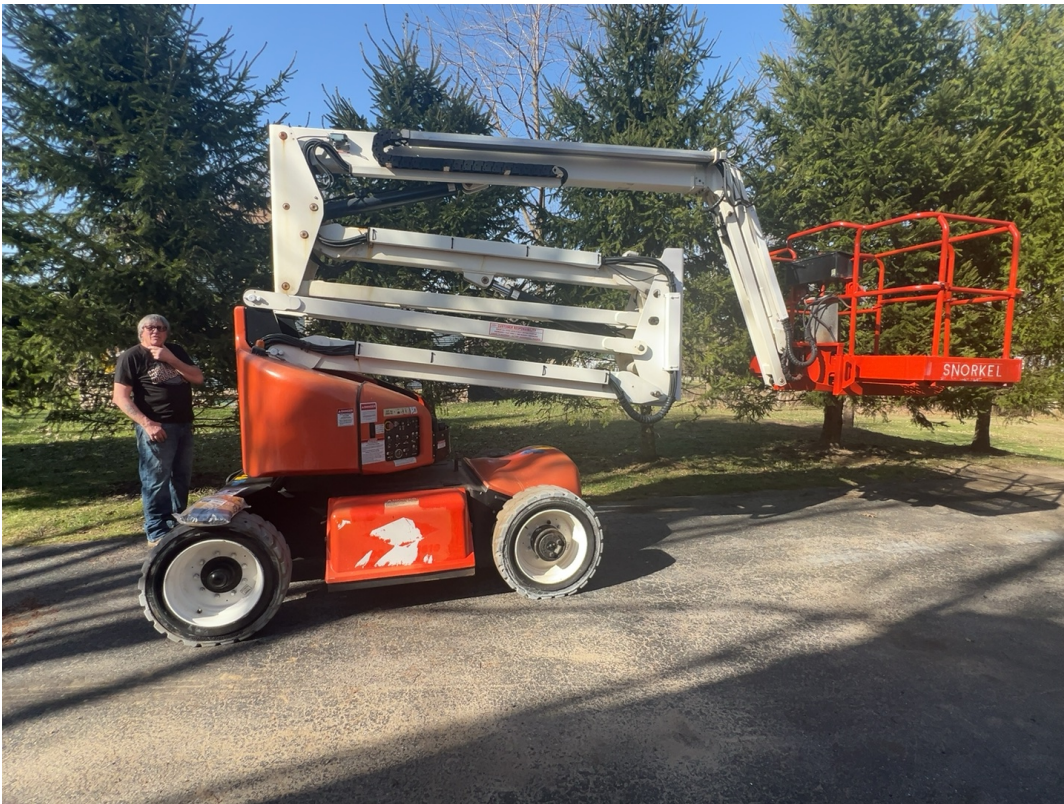
Left / 04-09-2024

The unit runs and drives. The left lower cover has paint worn off. The compartment where the hydraulic tank is located appears to be oily, and the hydraulic hose going to the tank seems to be leaking. The hydraulic compartment area is full of leaves and debris. The control station in the basket is missing retainer screws and the speed control knob. The decal has cracks on the control station. The front left tire has a gouge in the sidewall. The front right tire appears to have screws and cuts in the tire treads. The rear right tire's treads are gouged and some of the rubber is missing on the lugs. The operator appeared to have some trouble moving the unit with the controls in the basket or could have been operator error in the operational video. The travel and operation alarms could only be heard during a part of the operation.

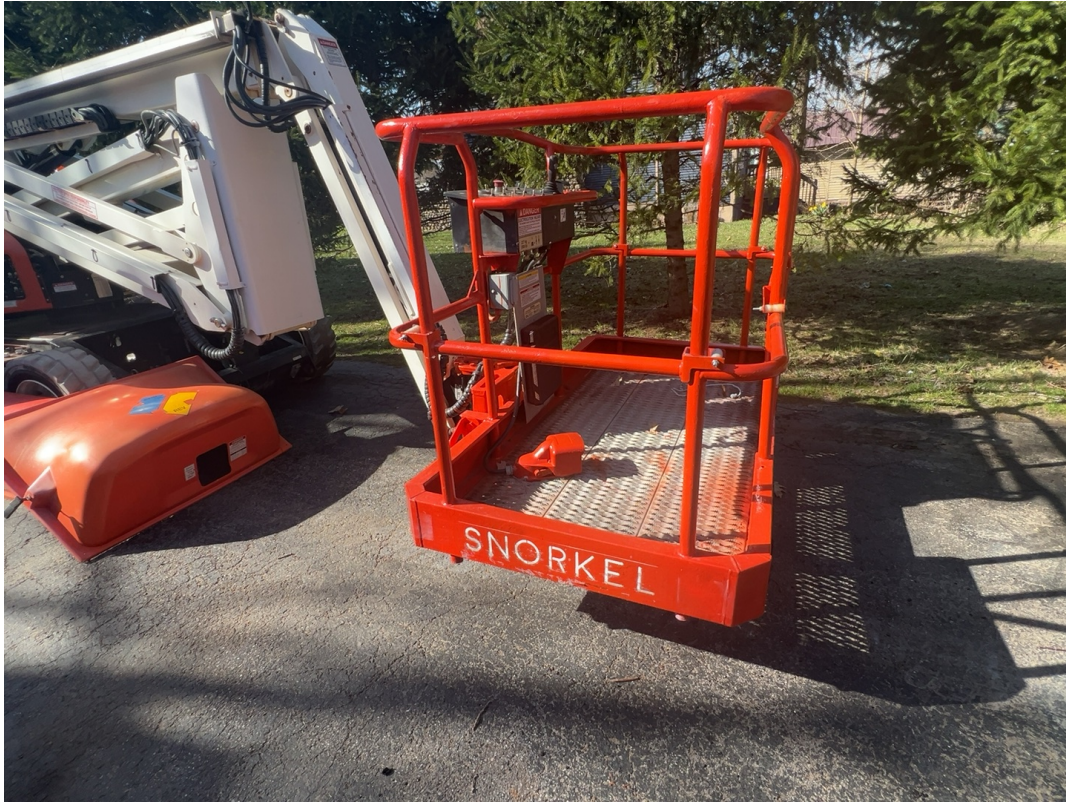
Attachments / 04-09-2024

Rear Right Tire Condition	See Notes
Rear Right Tire Brand	OTR
Rear Right Tire Size	IN240/55D17.5
Attachments - Basket	No Damages Observed
