Mei Ho House Revitalisation Project

**Mei Ho House
Required Treatment to Architectural Features**

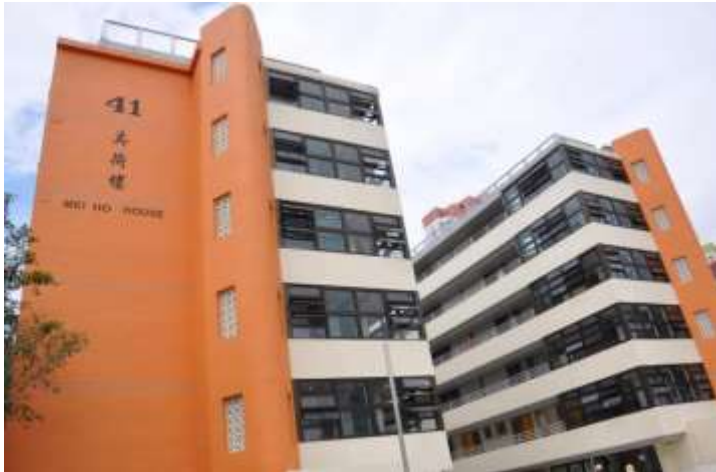
Architectural Feature	Required Treatment
a) External walls	Repaint with reversible matt emulsion paint. No restriction on the colour scheme but no permanent paint/ coating system should be used. Due to the poor structural condition of the central connecting block, there is no objection to rebuilding the central block following the same design, layout and architectural details of the existing block, in order to make it structural capable for some other new uses which demand higher loading capacities.

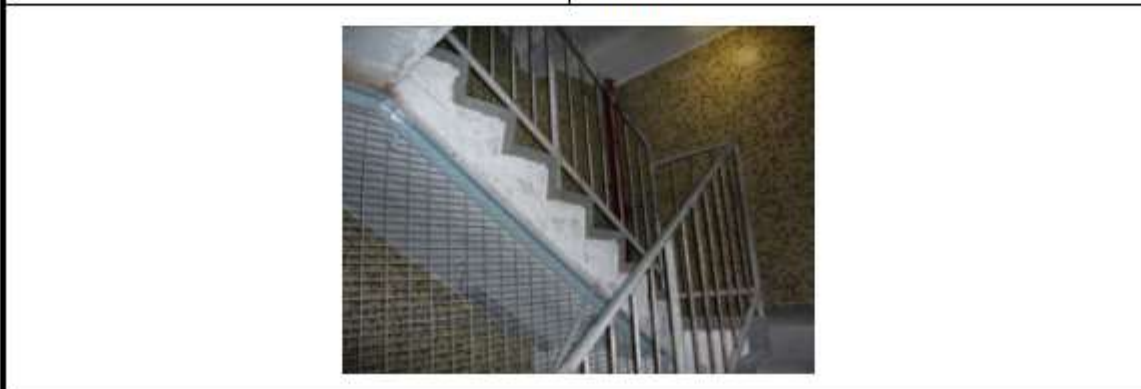
Architectural Feature	Required Treatment
<p>b) Staircase</p>	<p>Should be checked and upgraded in accordance with the current safety standards; railings are not historic and no conservation requirement for them. No objection to making openings at staircase walls if required under the Building Ordinance.</p>

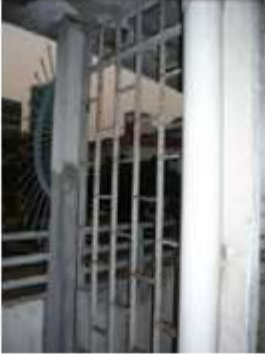
Architectural Feature	Required Treatment
c) Metal gates to concert rubbish chutes	Can be removed if necessary.

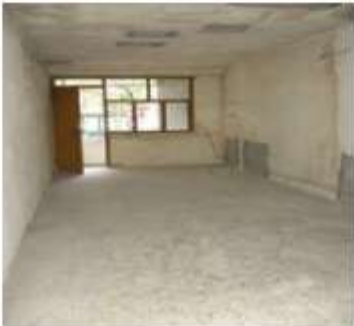
Architectural Feature	Required Treatment
e) Floors and internal walls	Demolition/ openings made to the non-loading bearing internal walls and floor slabs may be allowed subject to the advice of a Registered Structural Engineer.
