Panduit Corporation

CRC error and power delivery performance testing of cabling configurations with PoE extender to the requirements of IEEE 802.3 using 100BASE-T protocol up to a length of 2,000 ft

103805776CRT-001

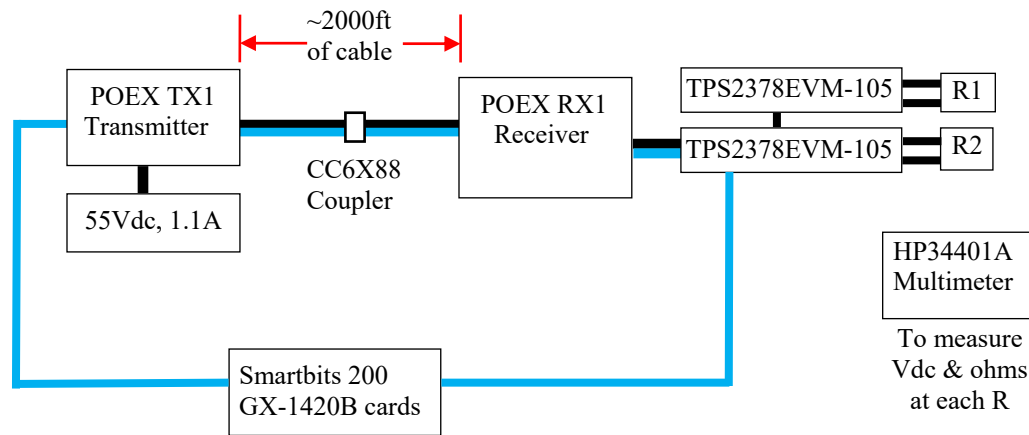
The following figures illustrate the test setups. The data path in blue and the power path is in black. The power and data are operating simultaneously during the test.

Figure 1: Test setup for the one-port receiver (dual signature PD).

A Smartbits 200 equipped with GX-1420B cards was used to generate 100BASE-T traffic (100Mbps). Then, power is added to the link under test using the PoE extender transmitter, part number POEX TX1. The data and power are carried over a length of approximately 2,000 ft of cable (2 reels of approximately 1,000 ft with a CC6X88 coupler in between). At the receiver end, test boards are used to separate the data and power. The multimeter is used to measure the received power and the Smartbits 200 to analyze for CRC errors. For each test, at least 2GB of data was transmitted in both directions with the Smartbits unit.

Table 2: Test results for the one-port receiver (dual signature PD).

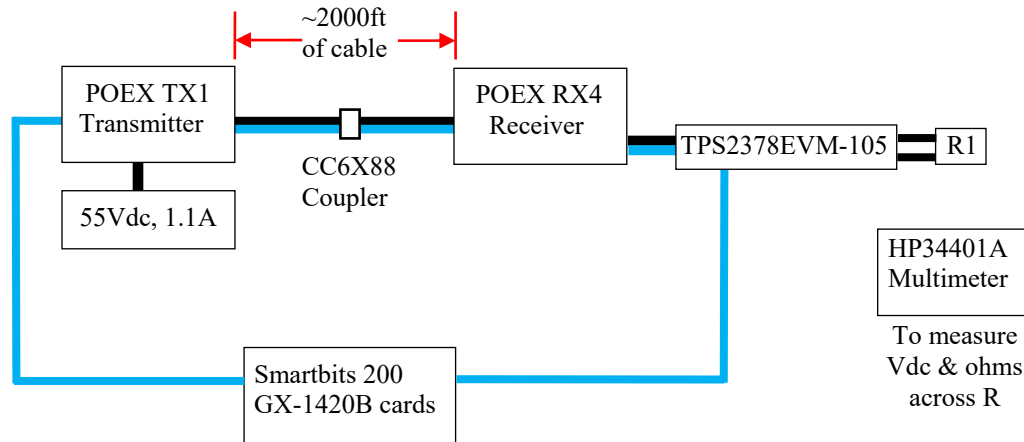
Figure 2: Test setup for the four-port receiver (single port tested).

Table 3: Test results for the four-port receiver (single port tested).
