4.1 Case study: when faulty design creates catastrophes – the case of the nuclear accident at Three Mile Island

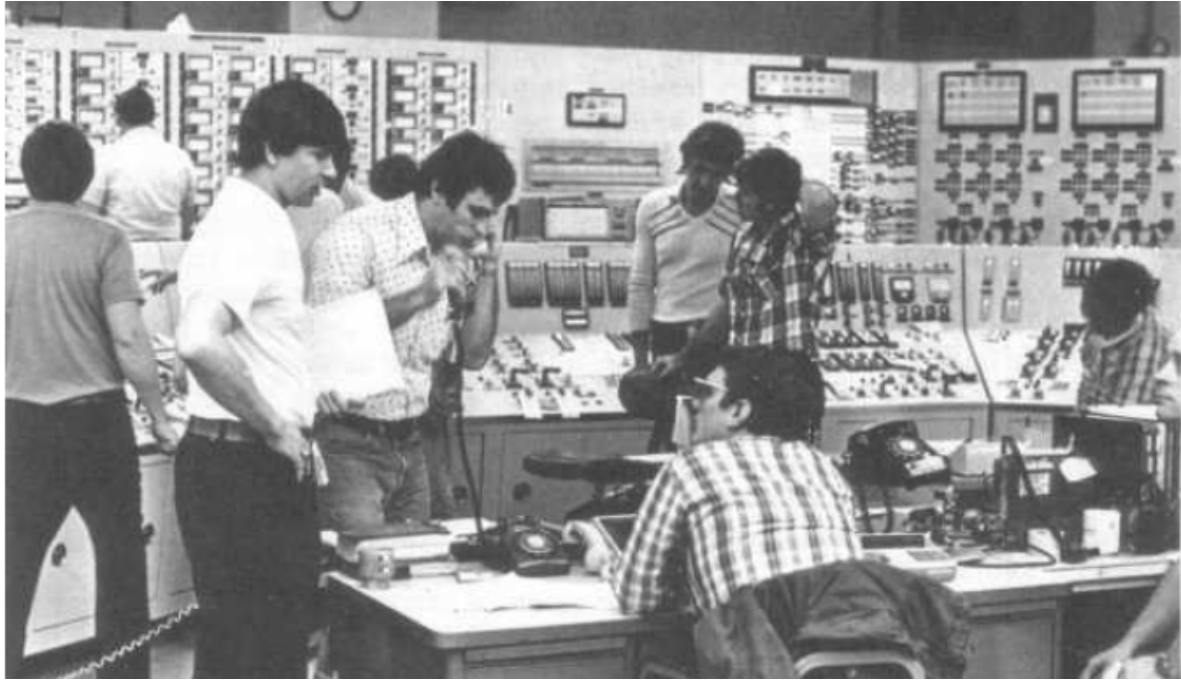
First of all, the control room was complex but unnecessarily so (fig. 4.1a). In the book titled *User Friendly*, Cliff Kuang (2020) likens the room layout to the bridge of a ship, with a massive console in the centre, behind which there was a wall of control panels stretching around for 90 feet, hosting 1100 dials, gauges, switches, and 600 warning lights. This vast number of indicators requires proper organization if it is to be understandable and to be quickly and safely consulted and operated in emergency conditions.

Figure 4.1a: Three Mile Island control room (Malone et al., 1980)

Unfortunately, the control panels of Three Mile Island control room disregarded these types of symmetries. Here are a few examples:

- The colour code for indicators was not symmetric. A symmetric colour code would associate an identical colour to a state of things and a complementary or very different colour to the opposite (e.g. red for alert, green for business as usual). At Three Mile Island, many different colours were used inconsistently. Blue would not always mean open, yellow did not generally indicate attention, red did not always signal an anomaly, etc.
- Control panels extended vertically from the floor to the ceiling. Vertical symmetry is against the horizontal symmetry of our bodies. While it is easy to inspect controls

that lie horizontally from left to right, it is much more cumbersome to kneel or bend to read something below or beyond our line of sight. At TMI, many gauges were below eyesight when standing behind the control panel, and many other controls required leaning over to inspect or actuate.

- However, while a horizontal display is easier to peruse, operators can get inaccurate readings if the visual arch extends too much due to the phenomenon of parallax. This optical distortion occurs when a gauge is located in the extreme periphery of our visual field. According to Malone et al. (1980), TMI had 115 vertical indicators above the eye level of the fifth percentile male. None had mirrored scales or limit switches.
- The layering created by the central console and the control panels behind it would generate obstructed views for operators sitting at the console if they needed to read indicators on the lower part of the panel or if another operator was standing between the console and the wall.
