2024-07-17 - back deck at 2436 gerrard

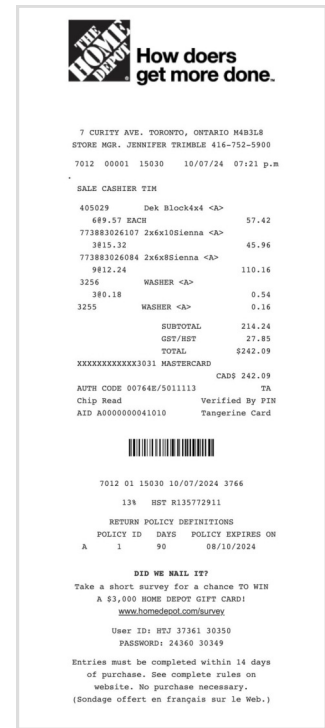
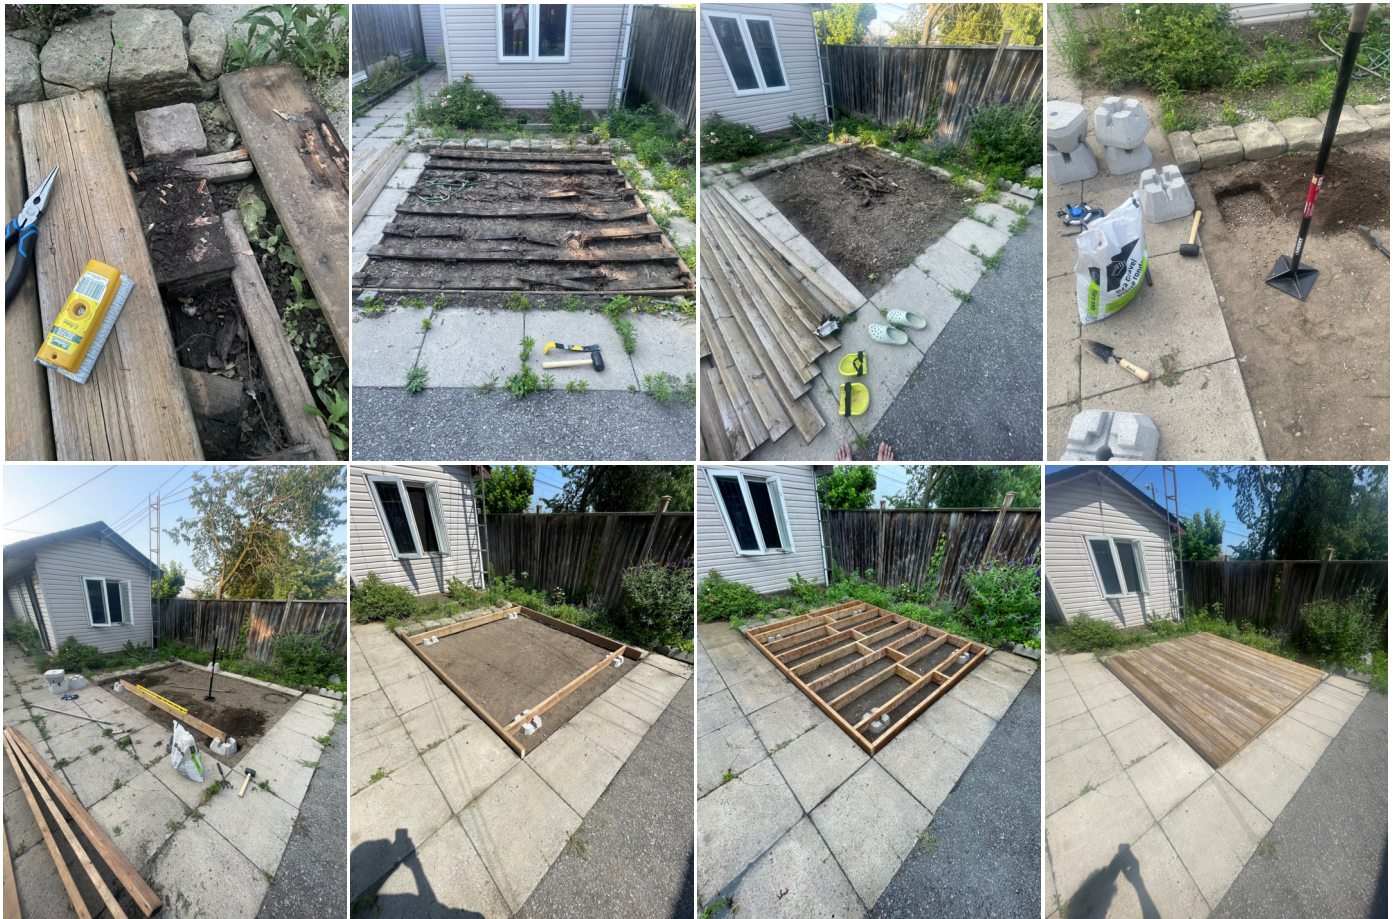
- power-washed existing deck boards
- started trying to remove nails for sanding, realized foundation of deck was completely rotted away
- removed all deck boards with pry-bar
- individually removed all old rusty nails from existing deck boards, so that they could be re-used
- cleared away rotted foundation, levelled build area
- dug holes and set and levelled new block foundation
- built floating frame with pressure-treated 2x6s
- screwed existing deck boards back on

- one option is to sand & stain the existing boards (sadly i don't have time!)
- another option is to let the deck boards reach the end of their life naturally. in a year-ish, replace just the deck boards. the new foundation shouldn't need any work for a while (10+ years, i hope!)
