Frost-Proof Wall Hydrant Installation, Use & Repair Guide

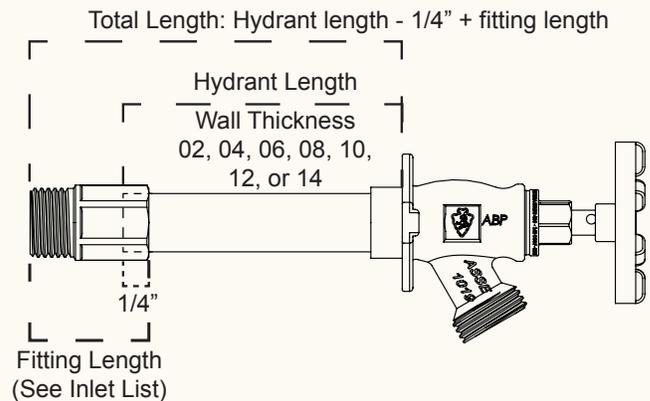
Rough-In Dimensions

How to Measure a Frost-Proof Stem:

- 1- Identify the model of frost-proof hydrant installed.
- 2- Measure overall (tip to tip) length of the stem assembly.

- 3- Subtract 4" & add to PK #:
 - i.e. 8" - 4" = 4": PK2004
 - 420 Series hydrant with 4" wall depth.

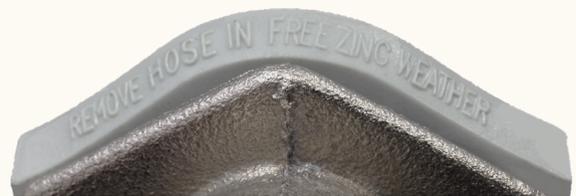
The only cause of a burst frost-proof hydrant is water expansion from freezing water inside an un-drained wall hydrant. Properly installed valves (with downward tilt) will always drain unless a hose or other device was left attached.

Grey gap spacer wedge can be used to ensure downward tilt.
"REMOVE HOSE IN FREEZING WEATHER".

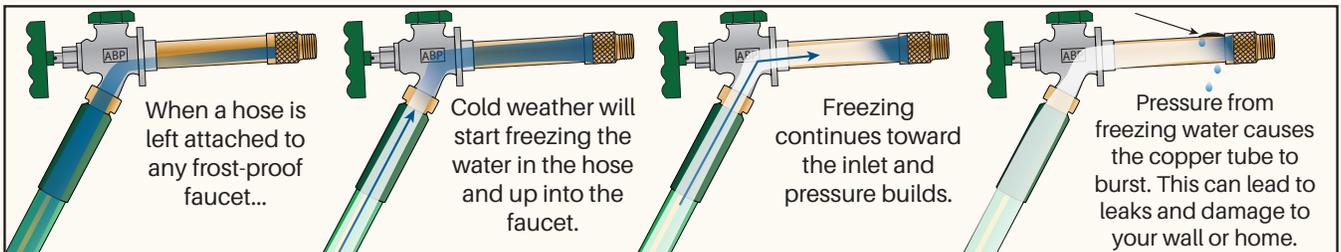
When a hose or other device is left attached to the faucet (such as an irrigation timer, "y" hose splitter, or add-on back-flow preventer), water will remain trapped inside the wall hydrant. If cold weather hits, water inside the hose will begin to freeze upward toward the back, or "seat", of the faucet, and the pressure inside the copper tubing will exceed capacity and burst. This will cause leaks within the wall and can cause considerable damage. Frost-proof wall hydrants are designed to prevent this damage as long as the user ensures the faucets are angled downward and all hoses/devices are removed during freezing weather.

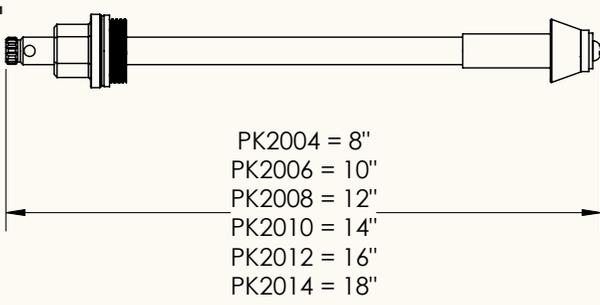
How to measure a frost-proof stem:

- 1- Measure overall (tip to tip) length of the stem assembly, with the check assembly pushed in.
- 2- Subtract 4".

*For 420 series hydrants installed prior to 1999, use PK20__SP stem assembly to replace old style stems that have a spring check assembly. Contact Arrowhead Brass for more details

If your faucet stem has a SPRING or does NOT measure to an even length, you need an "SP" Stem

- SP stems are 4-1/4" longer than the hydrant length (i.e. PK2004SP = 8-1/4").
- SP stems are designed for valves older than 1999. SP stems are non-returnable & not covered under warranty.

<p>Air-Vent Assembly</p> <p># PK1430 Includes green cap, housing, plunger, & O-ring (#'s 7-10)</p>	<p>Rubber-Coated Handle & Screw</p> <p># PK1295 Rubber-coated green oval handle (# 2) & stainless screw (# 1)</p>	<p>Spring-less Check Assembly</p> <p># PK2016 Replacement spring-less check assembly (# 6)</p>	<p>Gap-Spacer Wedge</p> <p># PK1450 Replacement gap spacer, used to tilt faucet downward</p>	<p>420 Series 4" Stem Assembly</p> <p># PK2004 4-inch hydrant stem assembly (# 3-6) (8" total length)</p>	<p>420 Series 6" Stem Assembly</p> <p># PK2006 6-inch hydrant stem assembly (# 3-6) (10" total length)</p>	<p>420 Series 8" Stem Assembly</p> <p># PK2008 8-inch hydrant stem assembly (# 3-6) (12" total length)</p>
<p>420 Series 10" Stem Assembly</p> <p># PK2010 10-inch hydrant stem assembly (# 3-6) (14" total length)</p>	<p>420 Series 12" Stem Assembly</p> <p># PK2012 12-inch hydrant stem assembly (# 3-6) (16" total length)</p>	<p>420 Series 14" Stem Assembly</p> <p># PK2014 14-inch hydrant stem assembly (# 3-6) (18" total length)</p>

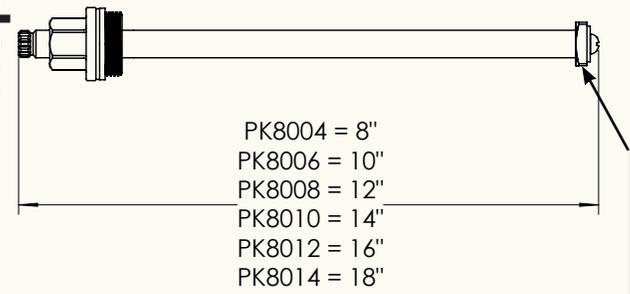
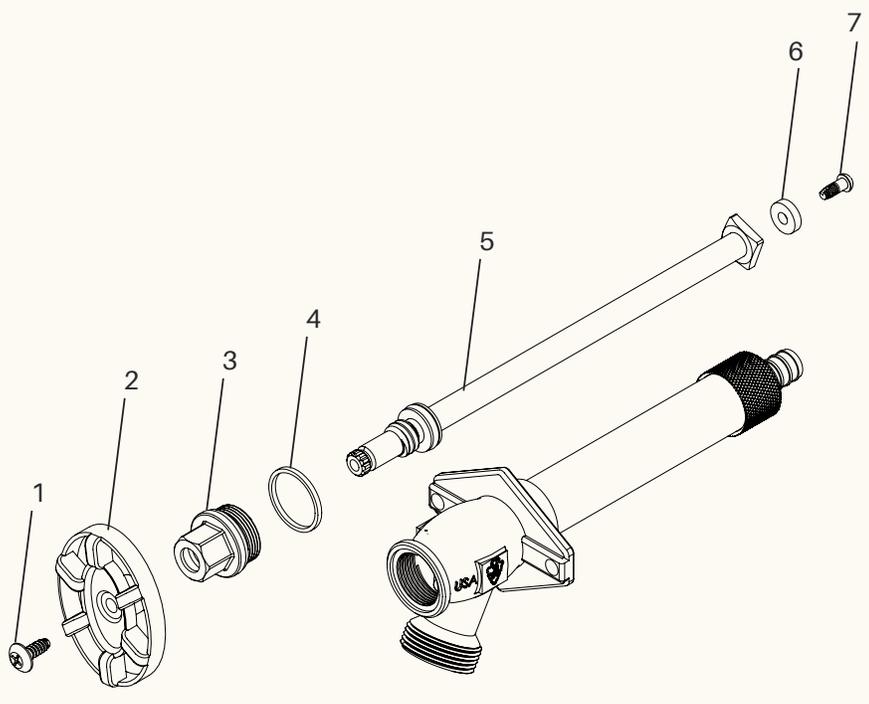
How to measure a frost-proof stem:

- 1- Measure overall (tip to tip) length of the stem assembly.
- 2- Subtract 4".

On faucets older than 1999: replacement stems may require a trim to the brass square washer retainer. Use a file or grinder to trim 1/16" off each corner to fit the stem into faucet. Contact Arrowhead Brass for more information.

If the original stem is not an even length from tip to tip (8", 10", 12", 14", 16" or 18"), and is 1/4" longer, you likely will need an "SP" stem: PK80__SP.

# PK1000 Seat washer (# 6) & screw (# 7), nylon washer (# 4) & handle screw (# 1)	Green Oval Handle & Screw

# PK8004 4-inch hydrant stem assembly (#'s 3-7) (8" total length)	450 Series 6" Stem Assembly

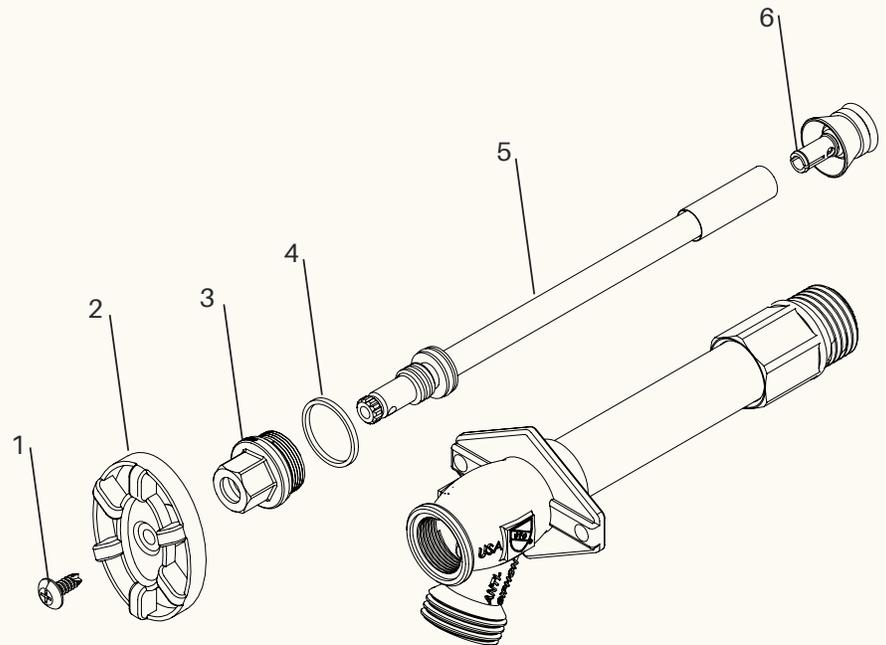
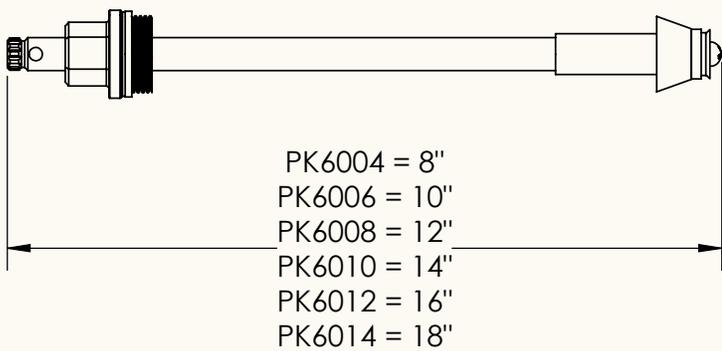
How to measure a frost-proof stem:

- 1- Measure overall (tip to tip) length of the stem assembly, with the check assembly pushed in.
- 2- Subtract 4".

# PK1295 Rubber-coated green oval handle (# 2) & stainless screw (# 1)	# PK6026 Replacement spring-less check assembly (# 6)	# PK1450 Replacement gap spacer, used to tilt faucet downward	# PK6004 4-inch hydrant stem assembly (# 3-6) (8" total length)	# PK6006 6-inch hydrant stem assembly (# 3-6) (10" total length)	# PK6008 8-inch hydrant stem assembly (# 3-6) (12" total length)	# PK6010 10-inch hydrant stem assembly (# 3-6) (14" total length)

# PK6012 12-inch hydrant stem assembly (# 3-6) (16" total length)	# PK6014 14-inch hydrant stem assembly (# 3-6) (18" total length)

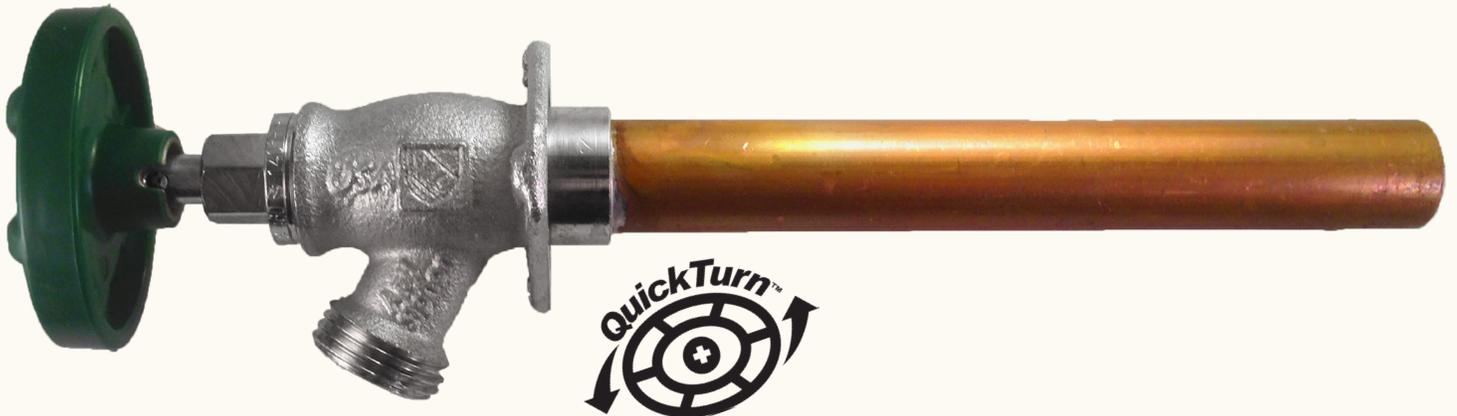
Discontinued 470 Series Freeze-Proof®

- Freeze-Proof® technology prevents damage from freezing water by reducing pressure build-up.
- O-ring shut off design that prevents damage & wear to hydrant seat.

- Maintains constant separation between household and irrigation water sources.
- Prevents back-flow by utilizing patented Arrow-Breaker® integrated anti-siphon technology.

- QuickTurn® easy on/off operation without letting go of the handle.
- ASSE 1019-A Certified.
- Max. 140°F - 125 PSI.
- 3 Year limited warranty; Made in the USA from domestic and foreign components.

- Shut-off water to the hydrant & open it all the way.
- Loosen the bonnet with a wrench and remove stem assembly.
- With the stem removed, briefly turn water supply back on to flush the hydrant, then shut-off again.
- Inspect the stem for cracks or damage to the O-rings or other parts. The recommended repair is to replace the Freeze-Proof® check assembly [PK7026] or replace the entire stem. Read instructions on next page to identify the stem part kit needed [i.e. PK7004 - PK7014].
- Reinstall stem with bonnet in the open position, close the hydrant and turn water back on to the valve.

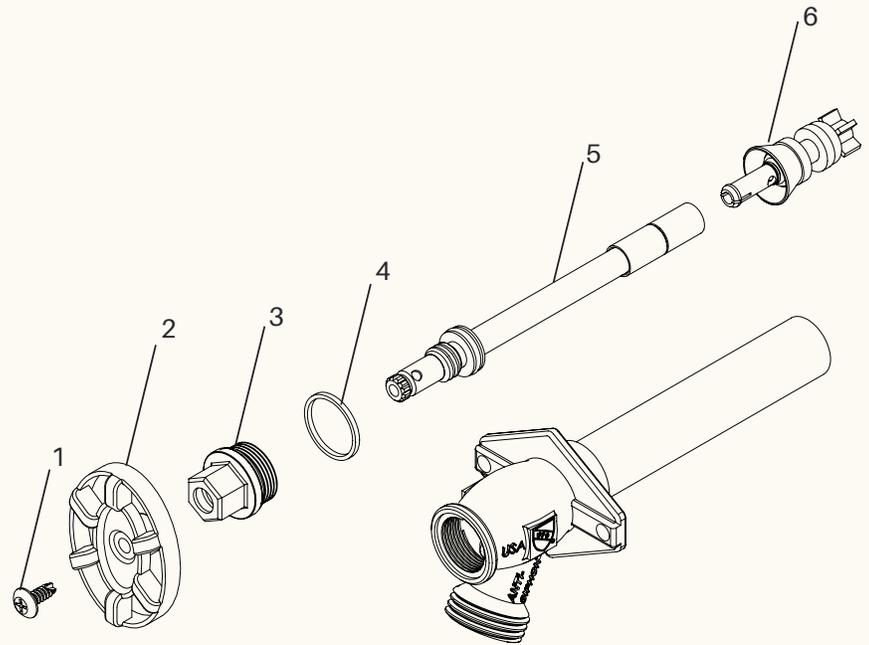
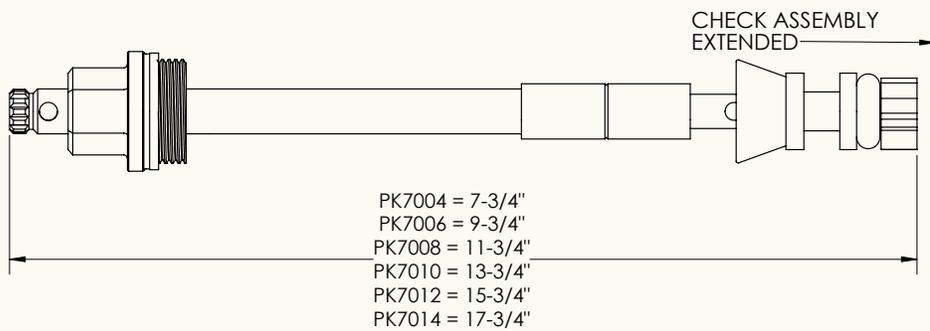
How to measure a frost-proof stem:

- 1- Measure overall (tip to tip) length of the stem assembly.
- 2- Subtract 3.75".

# PK1297 Rubber-coated green oval handle (# 2) & stainless screw (# 1)	Freeze-Proof® Check Assembly

# PK7026 Replacement Freeze-Proof® check assembly (# 6)	Gap-Spacer Wedge

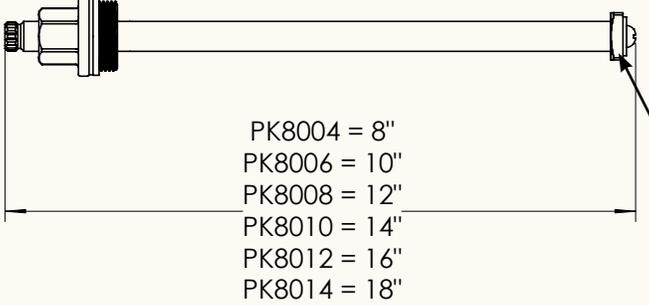
How to measure a frost-proof stem:

- 1- Measure overall (tip to tip) length of the stem assembly.
- 2- Subtract 4".

On faucets older than 1999: replacement stems may require a trim to the brass square washer retainer. Use a file or grinder to trim 1/16" off each corner to fit the stem into faucet. Contact Arrowhead Brass for more information.

If the original stem is not an even length from tip to tip (8", 10", 12", 14", 16" or 18"), and is 1/4" longer, you likely will need an "SP" stem: PK80__SP.

# PK1000 Seat washer (# 6) & screw (# 7), nylon washer (# 4) & handle screw (# 1)	# PK1295 Rubber-coated green oval handle (# 2) & stainless screw (# 1)	# PK1390 Self-draining vacuum breaker- fine threads (# 8)	# PK1450 Replacement gap spacer, used to tilt faucet downward	# PK8004 4-inch hydrant stem assembly (# 3-7) (8" total length)	# PK8006 6-inch hydrant stem assembly (# 3-7) (10" total length)	# PK8008 8-inch hydrant stem assembly (# 3-7) (12" total length)
480 Series 10" Stem Assembly 	480 Series 12" Stem Assembly 	480 Series 14" Stem Assembly

# PK8010 10-inch hydrant stem assembly (# 3-7) (14" total length)	# PK8012 12-inch hydrant stem assembly (# 3-7) (16" total length)	# PK8014 14-inch hydrant stem assembly (# 3-7) (18" total length)

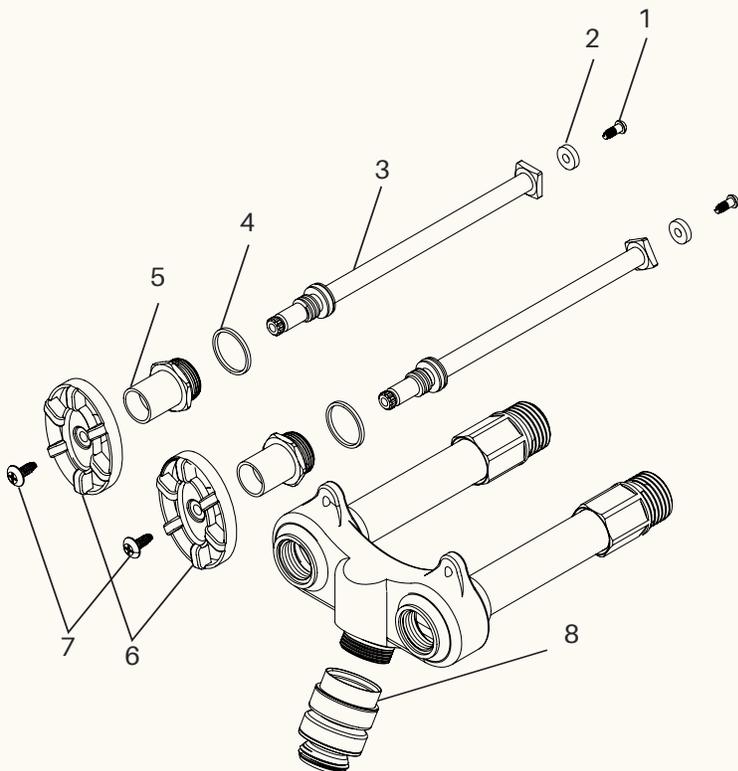
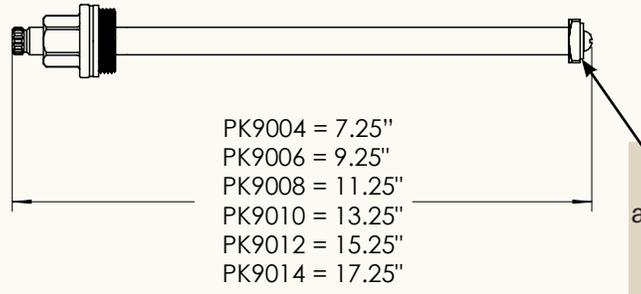
How to measure a frost-proof stem:

- 1- Measure overall (tip to tip) length of the stem assembly.
- 2- Subtract 3.25".

Some hot and cold hydrants may have a "springless check assembly" at the end [similar to the 420 hydrants on pages 6-7]. The PK90__ stems will work as a replacement.

On vertical hydrants, if your stem length does not match the dimensions stated left, contact Arrowhead Brass customer service for assistance.

Stem Rebuild Kit 	Red & Blue Handles & Screws 	Self-draining vacuum breaker 	490 Series 4" Stem Assembly 	490 Series 6" Stem Assembly 	490 Series 8" Stem Assembly 	490 Series 10" Stem Assembly
# PK1000 Seat washer (# 1) & screw (# 2), nylon washer (# 4) & handle screw (# 7)	# PK1299 Red & blue oval handles (# 6) & stainless screws (# 7)	# PK1390 Self-draining vacuum breaker- fine threads; PK- retail package (# 8)	# PK9004 4-inch hydrant stem assembly (#'s 1-5) (7-1/4" total length)	# PK9006 6-inch hydrant stem assembly (#'s 1-5) (9-1/4" total length)	# PK9008 8-inch hydrant stem assembly (#'s 1-5) (11-1/4" total length)	# PK9010 10-inch hydrant stem assembly (#'s 1-5) (13-1/4" total length)

490 Series 12" Stem Assembly 	490 Series 14" Stem Assembly
# PK9012 12-inch hydrant stem assembly (#'s 1-5) (15-1/4" total length)	# PK9014 14-inch hydrant stem assembly (#'s 1-5) (17-1/4" total length)

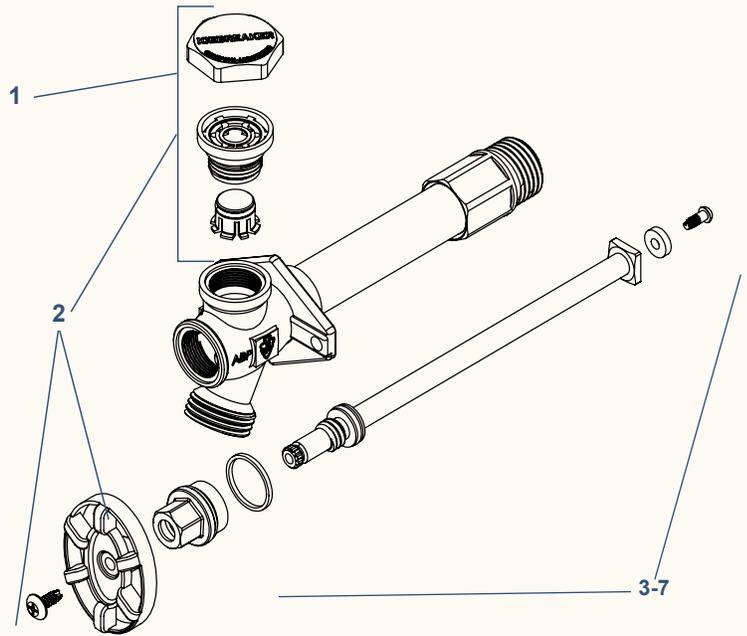
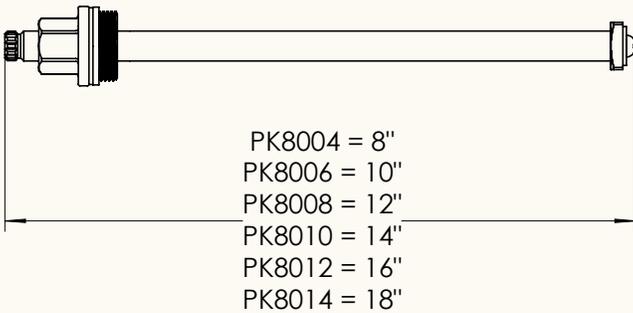
How to measure a frost-proof stem:

- 1- Measure overall (tip to tip) length of the stem assembly.
- 2- Subtract 4".

PK-ICE	UK-ICE	600 Series 4" Stem Assembly	600 Series 6" Stem Assembly	600 Series 8" Stem Assembly	600 Series 10" Stem Assembly	600 Series 12" Stem Assembly
# PK-ICE Replacement vent assembly	# UK-ICE Vent assembly with blue handle and screw	# PK8004 4-inch hydrant stem assembly (# 3-7) (8" total length)	# PK8006 6-inch hydrant stem assembly (# 3-7) (10" total length)	# PK8008 8-inch hydrant stem assembly (# 3-7) (12" total length)	# PK8010 10-inch hydrant stem assembly (# 3-7) (14" total length)	# PK8012 12-inch hydrant stem assembly (# 3-7) (16" total length)

600 Series 14" Stem Assembly	
# PK8014 14-inch hydrant stem assembly (# 3-7) (18" total length)
