# Test Report

Report No.: 779827-1

**Subject:** Model: Spine - covers the series

## Test of Model: Spine

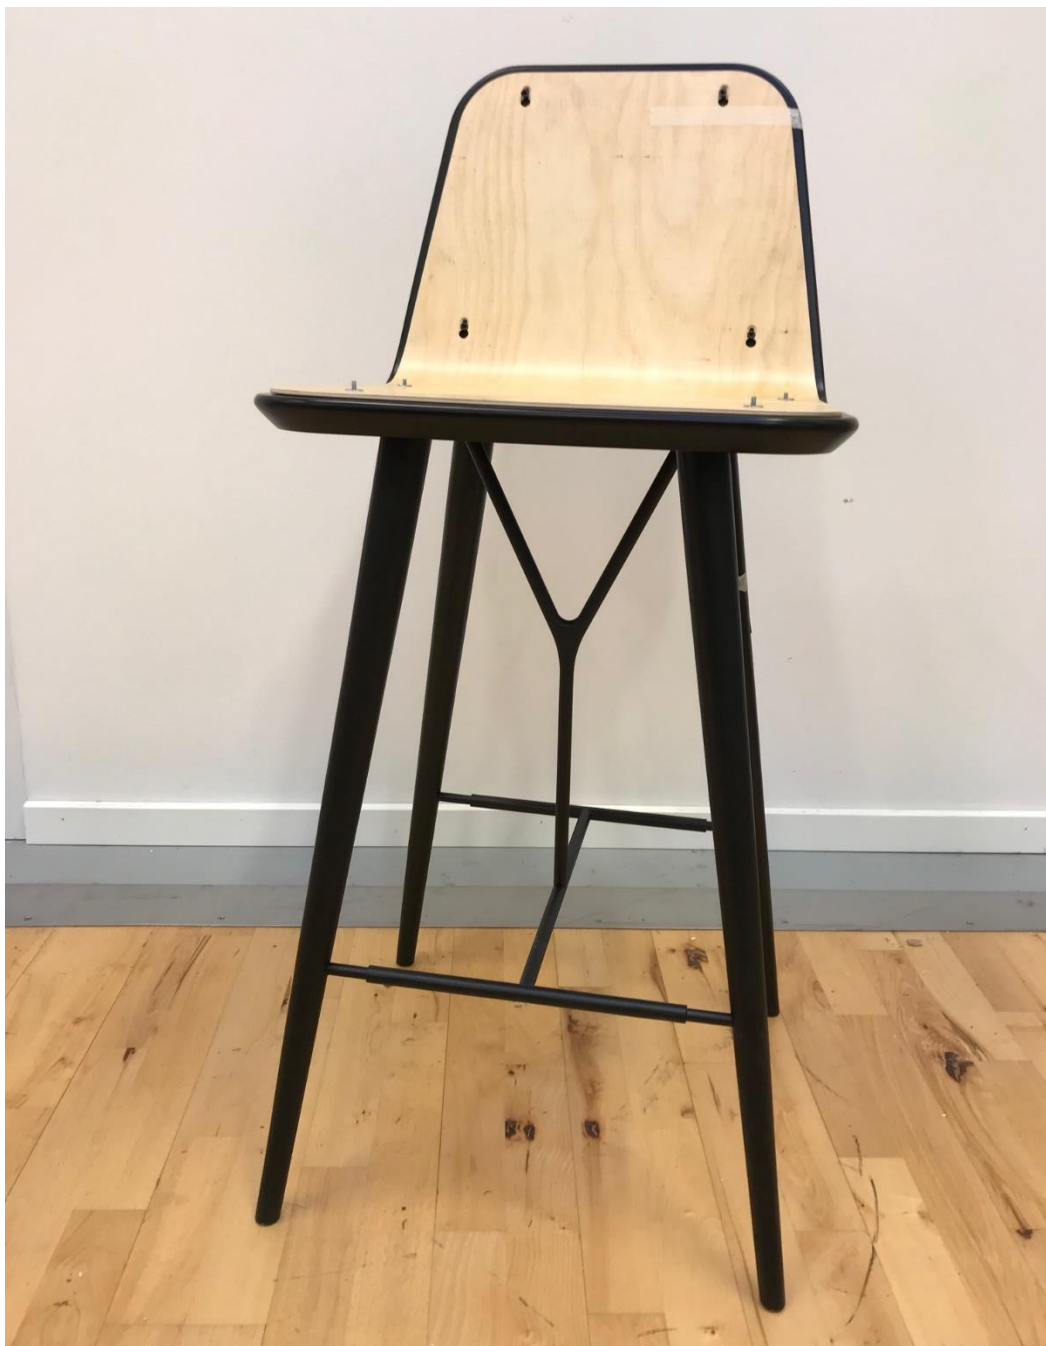
Photo

## Test of Model: Spine
