**No. 1568800.5**

SAMPLE DESCRIPTION:  
632000 Regal Oak & Regal Wide GH Engineered  
14.2mm timber flooring planks assembly fixed to a clear  
Perspex base using:  
- 1 Part Polyurethane wood adhesive solvent free  
- Clicseal in joins

**RESILIENT FLOOR COVERINGS (BASED ON ISO 4760:2022(E) - LAMINATE FLOORING – TOPICAL MOISTURE RESISTANCE – ASSEMBLED JOINT (MODIFIED))**

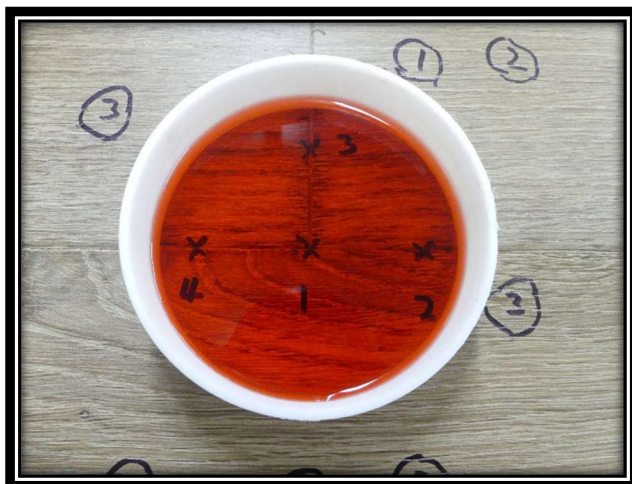
24 Hrs with Water

100 mls of dye solution was applied onto the sample surface. It was poured into a cylinder 100mm diameter placed in the centre of the sample at the "T joint." Sealant was used at the plank/cylinder interface to avoid leakage.

The underside of the sample was inspected through the clear Perspex to enable detection of any dye penetration through the sample.

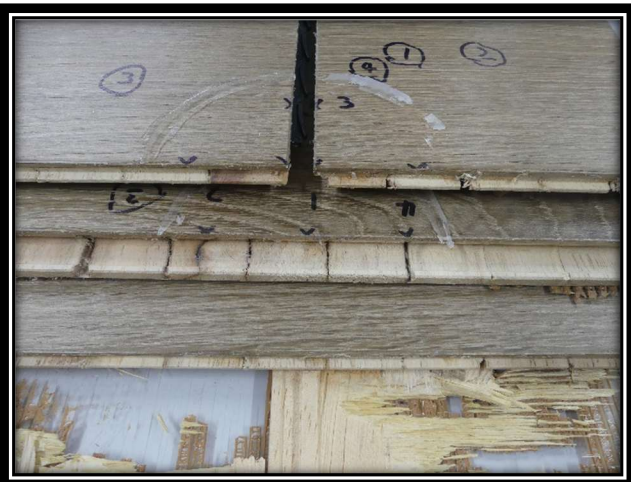
Recovered Swell (Disassembled)

Disassembly Observations:	Specimen 1	Specimen 2	Specimen 3
Migration of water along the upper surface:	No	No	No
Migration of water to the underside:	No	No	No
