FLIR MR160

Imaging Moisture Meter

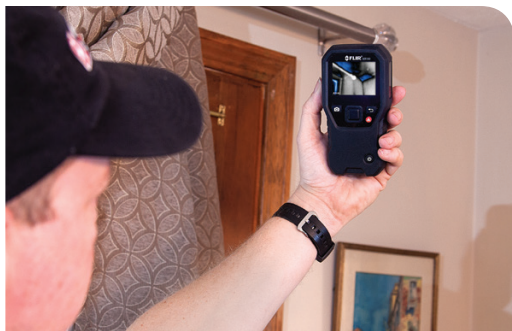
Scanning ceiling & wall joint for moisture issues

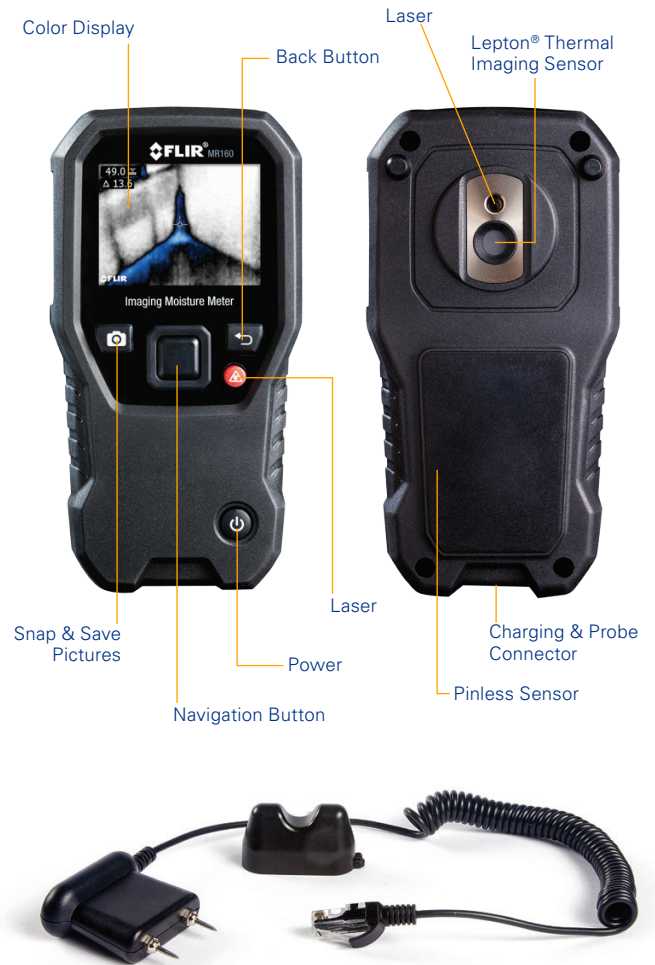
MR02 Pin Probe included
