## Electrical measurements on adjustable speed drives Ten measurements that tell you a lot

### **Application Note**

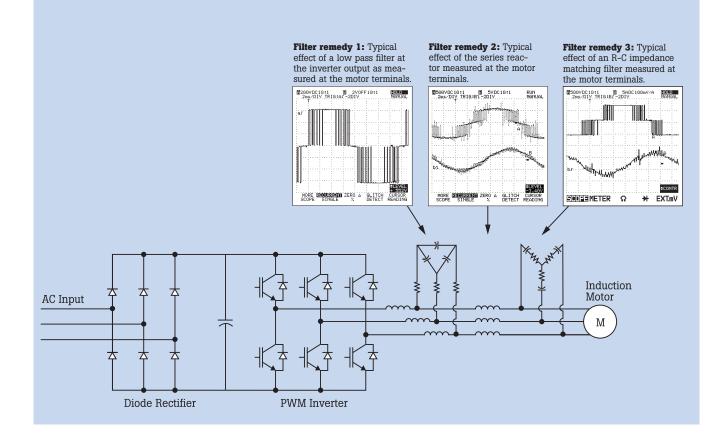
Inverter Output Filter Remedy 1	Series Reactor Remedy 2	Motor Terminal Filter Remedy 3
Series connected to the PWM output terminals.	Series connected to the PWM output terminals.	Parallel connected at the motor terminals.
Designed to slow rise time (dv/dt) below a critical value.	Acts as a current limiter and also slows rise time.	Designed to match the characteristic cable impedance.
Dependent on cable length.	Dependent on size of system.	Not cable length dependent.
Losses dependent on motor kVĀ.	Losses dependent on motor kVA.	Losses are more or less fixed.
Size/cost dependent on motor kVA.	Size/cost dependent on motor kVA.	Size/cost more or less fixed.

If the cabling in your PWM application cannot be shortened then use one of these three solutions to fix the problem.

- 1. An external "add-on" low pass filter can be installed between the PWM output terminals and the cable to the motor to slow the rise time.
- Install an R-C impedance matching filter at the motor terminals to minimize the overvoltages, or ringing effect.
- 3. In some applications, such as submersible pumps or drilling machines, it isn't possible to access the motor terminals and other methods of minimizing overvoltages are required. One method is to apply series reactors between the PWM output terminals and the cable to the motor. While this is a fairly simple solution, the reactors may be fairly large, bulky and expensive for large horsepower applications.

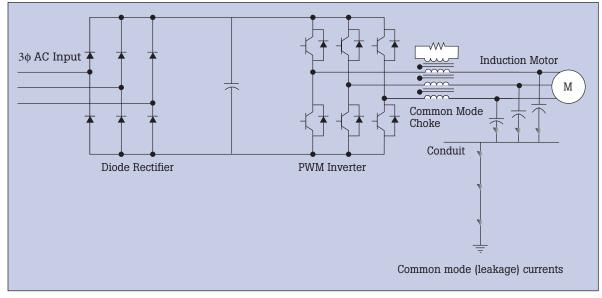
Figure 5A. Common mode choke with dampening resistor to reduce leakage currents.

A common mode choke can be used to reduce leakage currents (see Figure 5A). Also, special EMI suppression cables can be used between the drive output and the motor terminals. The copper conductors of the cable are covered with ferrite granules, which absorb the RF energy and convert it to heat. Isolation transformers on the ac inputs will also reduce common mode noise.
