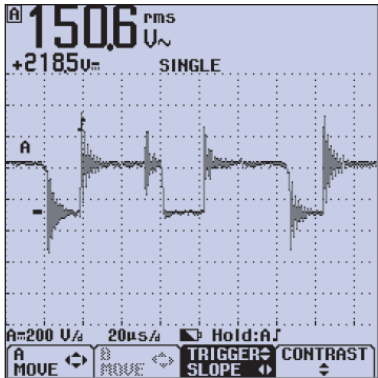
Figure 3A. Reflected voltages (ringing).

The trend with PWM drives has been to make the rise time of the pulses as fast as possible to reduce switching losses and increase the efficiency of the drive. However, fast rise times coupled with long cable lengths produce an impedance mismatch between the cable and the motor causing reflected waves, or “ringing” as shown in Figure 3A.

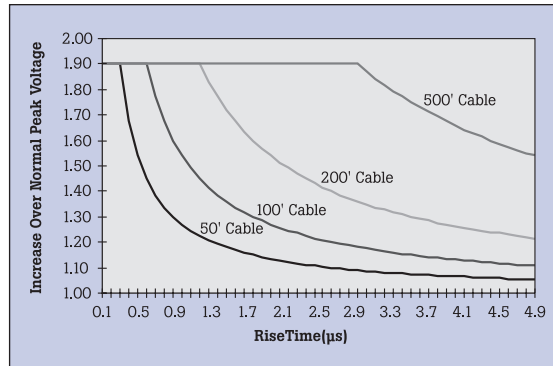
The relationship between cable length, rise time and the resultant increase in peak voltage is illustrated in Figure 3B. The peak voltage at the motor terminals will increase above the dc bus voltage of the ASD as cable length increases and the rise time of the ASD output pulse gets faster.

Figure 3B. Impact of rise time and cable length on magnitude of reflected voltages.

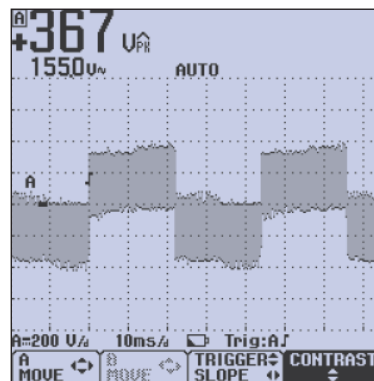
Figure 3C shows the ASD L-L voltage measurement at the motor terminals with six feet of cable, while Figure 3D shows the ASD L-L voltage with 100 feet of cable. Notice the difference in peak voltage measurements—about 210 volts. Also notice that there is only 5 V rms difference between the two waveforms (small digits on the display). This means your voltmeter will not find this problem.

Figure 3C. Normal PWM waveform.

Very few scopes will trigger as nicely and easily as the Fluke 123 ScopeMeter® Test Tool did for the measurements in Figures 3C and 3D.

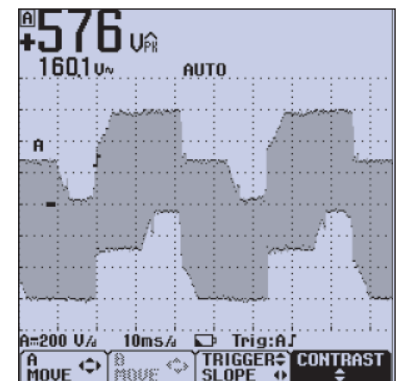
Figure 3D. PWM waveform with reflected voltages.

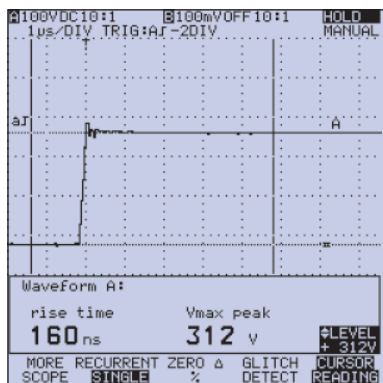
Figure 3E. Leading edge of normal PWM pulse.

The signals in figures 3E and 3F were captured by triggering on a single pulse using single shot mode with cursors enabled to make the peak voltage measurement along with rise time. While this measurement requires more button pressing and scope “know how,” the automated rise time measurement may be worth the trouble. Manually resetting the single shot trigger periodically will give you a sampling of various peak voltages for the different pulses. Also, slowly raising the trigger voltage will give you an idea of the maximum peak when the scope stops triggering.

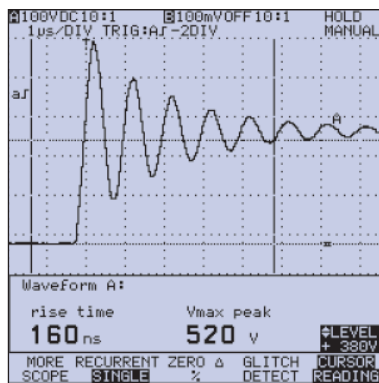
Figure 3F. Leading edge of PWM pulse with reflected voltage (ringing).

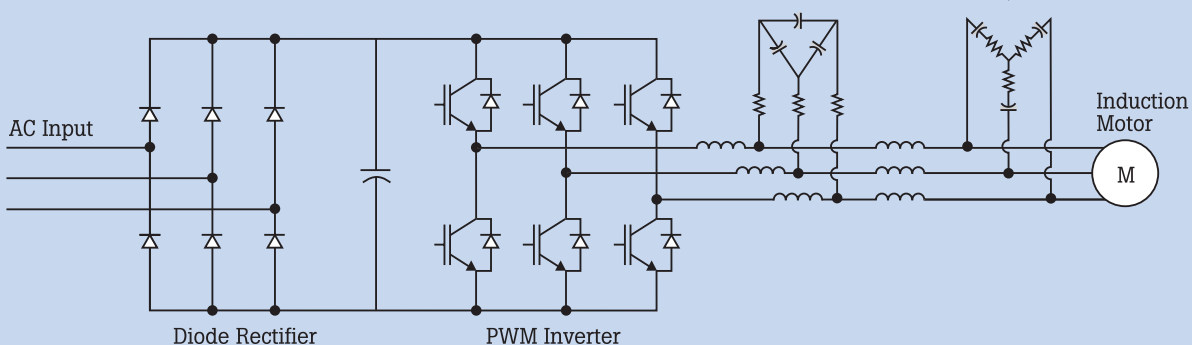
Filter remedy 1: Typical effect of a low pass filter at the inverter output as measured at the motor terminals.

Filter remedy 2: Typical effect of the series reactor measured at the motor terminals.

Filter remedy 3: Typical effect of an R-C impedance matching filter measured at the motor terminals.

Inverter Output Filter Remedy 1	Series Reactor Remedy 2	Motor Terminal Filter Remedy 3
Series connected to the PWM output terminals.	Series connected to the PWM output terminals.	Parallel connected at the motor terminals.
Designed to slow rise time (dv/dt) below a critical value.	Acts as a current limiter and also slows rise time.	Designed to match the characteristic cable impedance.
Dependent on cable length.	Dependent on size of system.	Not cable length dependent.
Losses dependent on motor kVA.	Losses dependent on motor kVA.	Losses are more or less fixed.
Size/cost dependent on motor kVA.	Size/cost dependent on motor kVA.	Size/cost more or less fixed.

1. An external “add-on” low pass filter can be installed between the PWM output terminals and the cable to the motor to slow the rise time.
2. Install an R-C impedance matching filter at the motor terminals to minimize the overvoltages, or ringing effect.
3. In some applications, such as submersible pumps or drilling machines, it isn’t possible to access the motor terminals and other methods of minimizing overvoltages are required. One method is to apply series reactors between the PWM output terminals and the cable to the motor. While this is a fairly simple solution, the reactors may be fairly large, bulky and expensive for large horsepower applications.

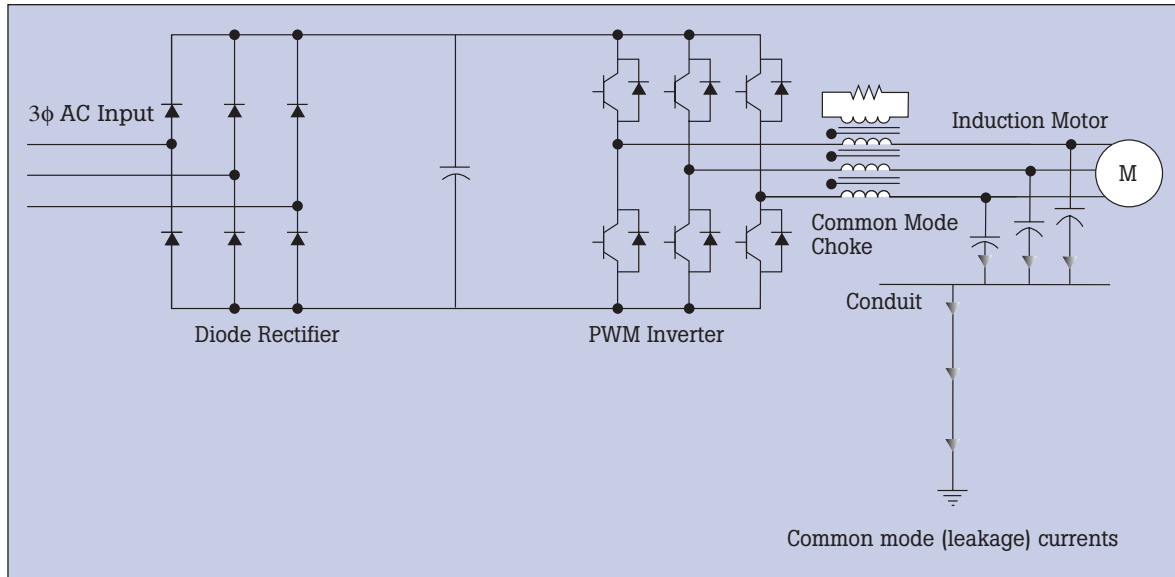
A common mode choke can be used to reduce leakage currents (see Figure 5A). Also, special EMI suppression cables can be used between the drive output and the motor terminals. The copper

Figure 5A. Common mode choke with dampening resistor to reduce leakage currents.

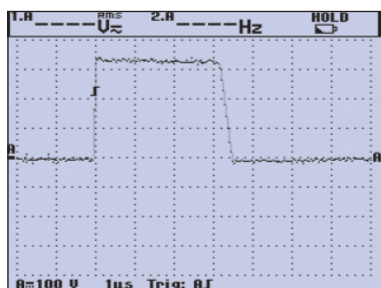
1. Check positive conducting IGBTs by connecting the scope common lead to the dc+ bus and measuring each of the three phases at the inverter’s motor output terminals. Check for nice, clean-edged square waves without any visible noise inside the pulses, and that all three phases have the same appearance.
2. Check negative conducting IGBTs by connecting the common lead to the dc- bus and performing the same measurements as in step one above on each of the three phases at the inverter’s motor output terminals.

Figure 6A. Square waves.

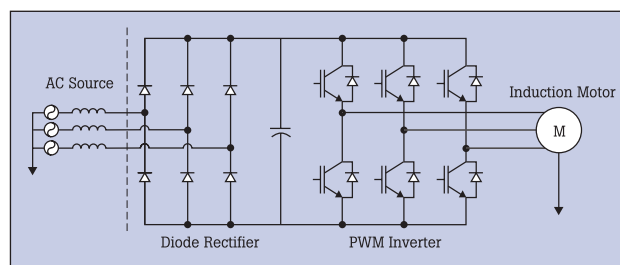
Figure 6B. Check all three phases at the inverter’s motor output terminals.

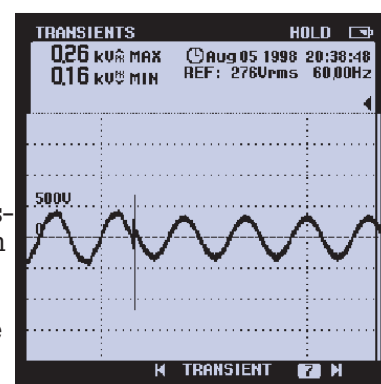
Figure 9A. Overvoltage transient capture.

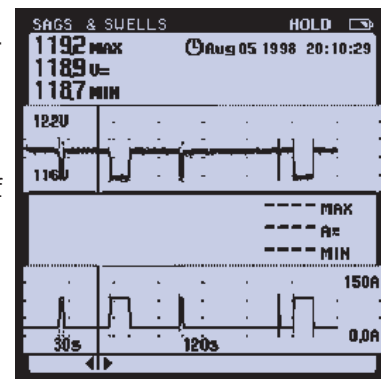
Figure 10A. Voltage sag.
