A Motor Car Match Safe

By Neil Shapiro

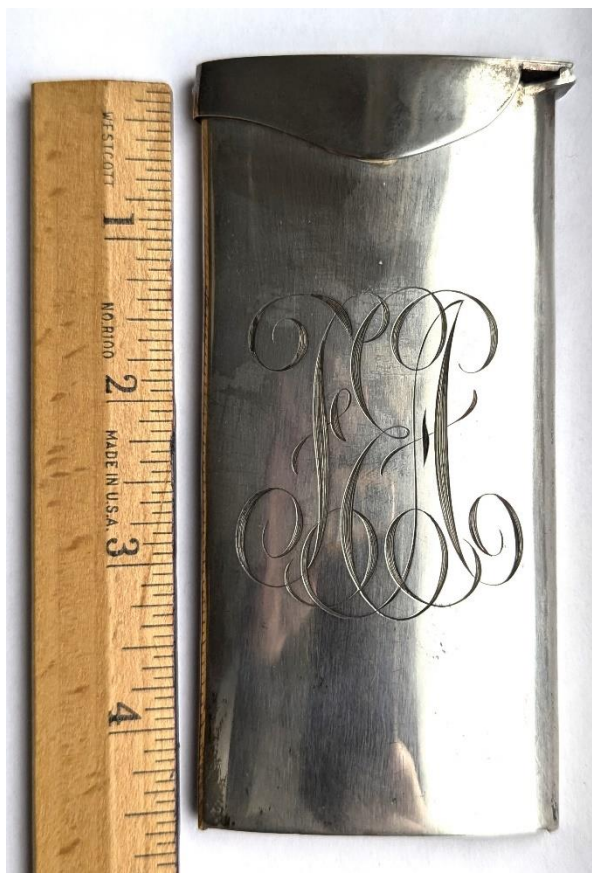
Front

One example of a match safe that held unignited massive matches was made by the Commonwealth Silver Co. of California (1905-1920). It measures 4 1/2” long x 2” high x 1/4” thick. It is curved at the back side and has a thumb lift lid, no spring, and a friction fit lid. The striker has a recessed area to apply a piece of roughened paper to a hard inner core.

For most match safe collectors, the plain silver case with only an elaborately engraved set of initials on the front would not be of great interest, but it is wonderful to have a relic of an early automotive accessory.

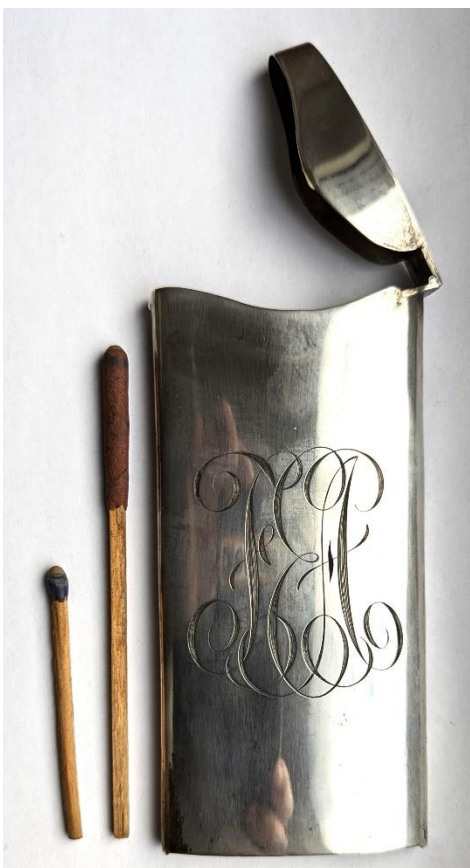
Large match & regular size match

The container that held the matches that ignited the headlights of these motor cars was large as were the matches it contained. Denis Alsford, a match historian, has written that these massive matches would flame for twenty seconds and keep alight in the strongest wind. In the UK they were called “flamers” and “wind vestas.”
