**HYUNDAI i40 VF WAGON 10/11 – ON  
HYUNDAI i40 VF SEDAN 06/12 – ON**

**UNT318**

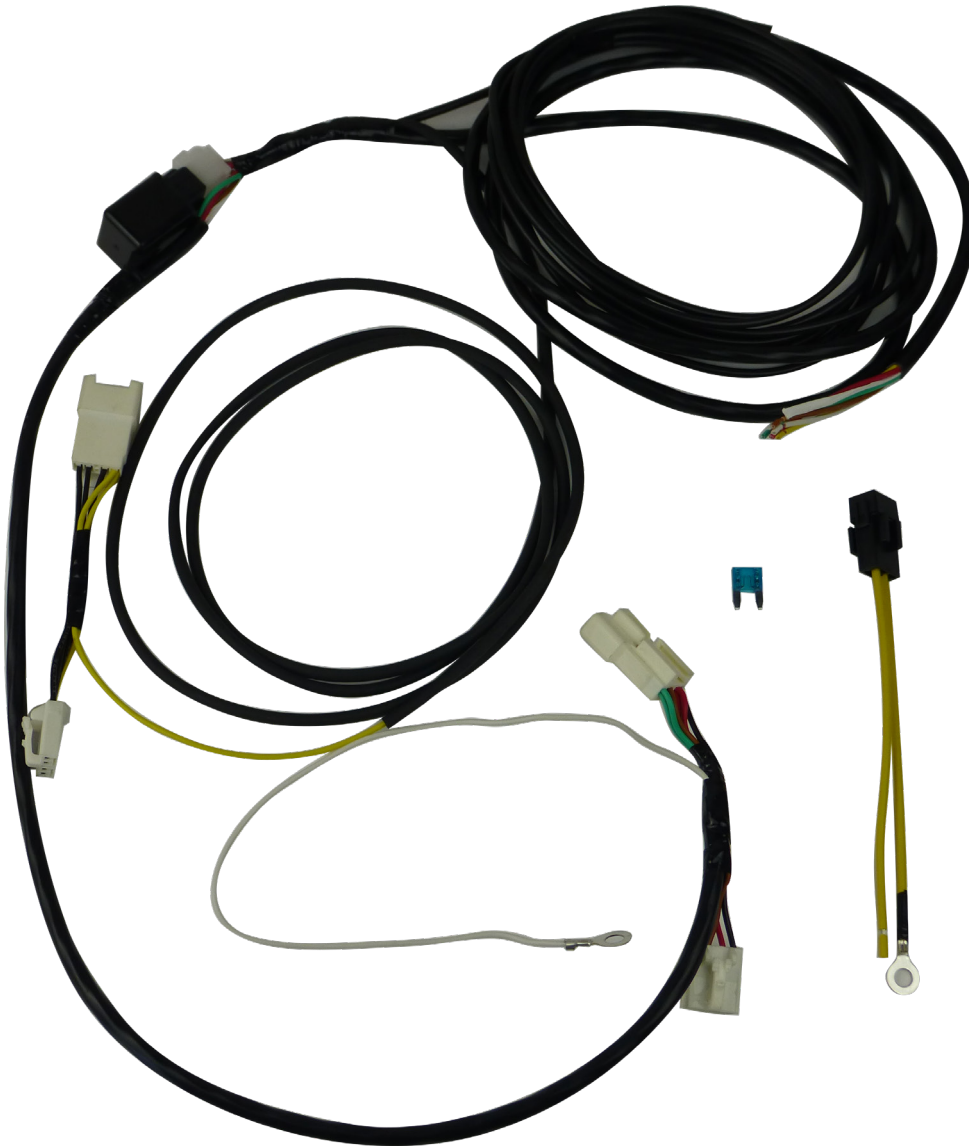
4. On the Towbar Wiring Harness locate the R/H/S cable and take to the Drivers side tail lights.
5. At the rear of the tail light remove the 4 way connector and connect to the 4 way connector on the Towbar Wiring Harness R/H/S cable.

6. Take the remaining 4 way connector and replace in the R/H/S tail light.
7. Secure the relay to prevent it from rattling around in the side trim area.

9. At the rear of the Passenger side tail light remove the 4 way connector and connect to the 4 way connector on the Towbar Wiring Harness cable.
10. Take the remaining 4 way connector and replace in the L/H/S tail light.
