RFE-HP-19UP

Reprogramming Kit™ Fits: 68RFE 2019-on

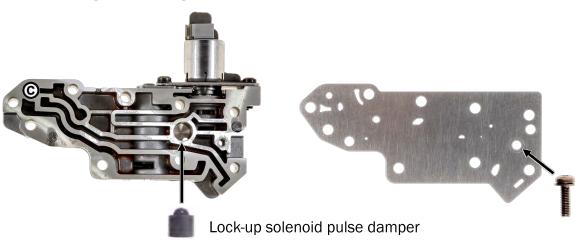
- Replace damper rubber insert with the **new** one provided
- **(n → (||**
- Install the assembled damper in the lock-up valve body
- Install one plastic 1/4"checkball ©
- Install separator plate
- Bolt it together using the short bolt

Tip! If you replace the lock-up solenoid, the manufacturer recommends entering the "PI Curve" of the new solenoid into the computer using a capable scanner. Scan the 2D barcode on the solenoid with your smart phone to read the code that needs to be entered.

Lock-up Solenoid

2D Barcode

Separator plate bolt torque to 50 lb-in
