## Item #13869131 - 2017 Genie GTH-636 Telehandler

- Features: Open Operator Station, 6000 lb Max Lift Capacity, 2017 US EPA Label, CARB Compliant, 47.5 in Forks
- Meter Reading: 1,667 Hours
- Serial # : GTH06E-11473
- Inspection Completed: 8/23/25

# Inspection Report

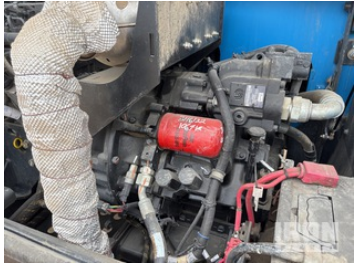
| Item | Assessment | Photo |
|---|---|---|
| Transmission | ★★☆☆☆ | |

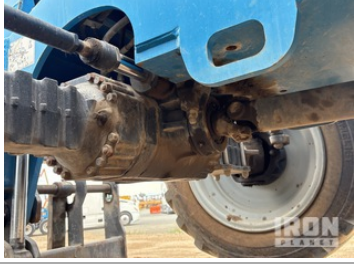
| Item | Assessment | Photo |
|---|---|---|
| Front Drive Axle | ★★★★☆<br>Seep around drain plug | |

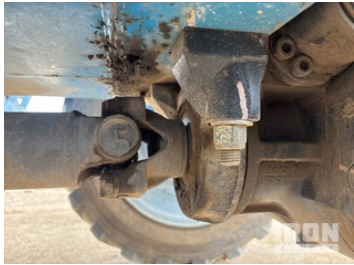
| Rear Axle Oscillating Pin | <div> <div> <div>★</div> <div>★</div> <div>★</div> <div>★</div> <div>☆</div> </div> </div> | |

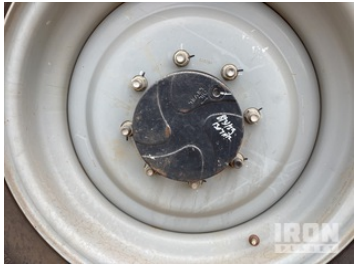
| Final Drives | <div> <div> <div>★</div> <div>★</div> <div>★</div> <div>★</div> <div>☆</div> </div> </div> | |

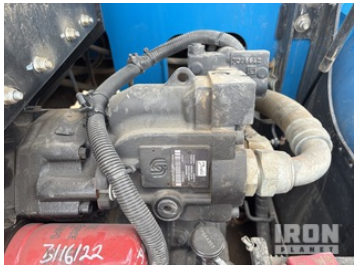
| Hydraulics | | |
|---|---|---|
| Pumps (Hydraulics) | ★★★☆☆ | |

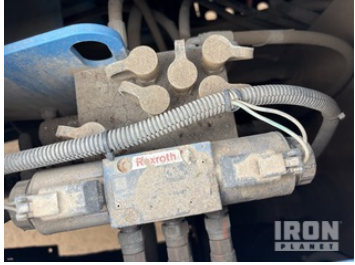
| Hydraulics | | |
|---|---|---|
| Valves | ★★★☆☆ | |

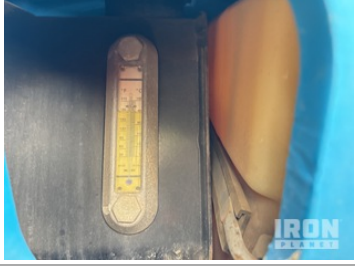
| Hydraulics | | |
|---|---|---|
| Hydraulic Tank | ★★★☆☆ | |

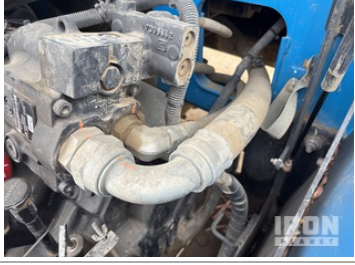
| Hydraulics | | |
|---|---|---|
| Hoses (Hydraulics) | ★★★☆☆ | |

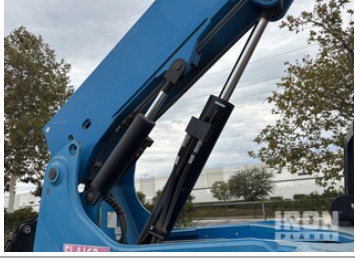
| Hydraulics | | |
|---|---|---|
| Boom Lift Cylinder(s) | ★★★☆☆ | |

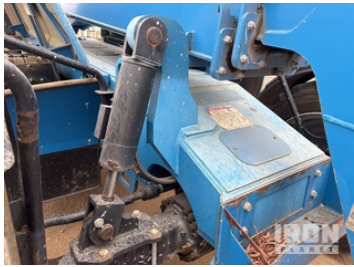
| Carriage Tilt Cylinder | ★★★★☆ | |

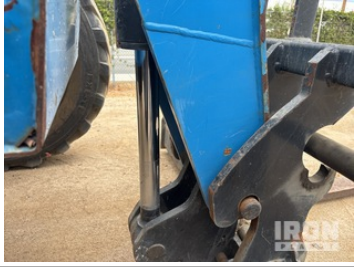
| Fork Positioning Cylinder (on fork carriage) | ★★★★☆ | |

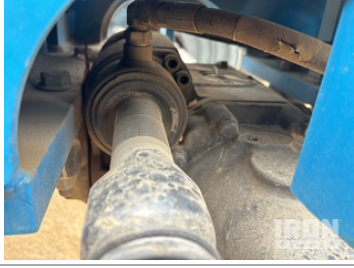
| Steering Cylinders | ★★★★☆ | |

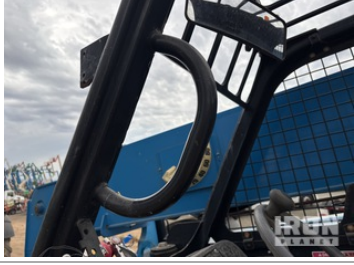
| Hand Rails | No visible damage or missing components | |

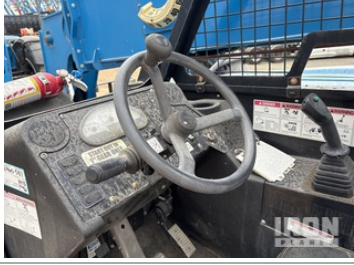
| Control Station | | |
|---|---|---|
| Steering Control | ★★★★☆ | |

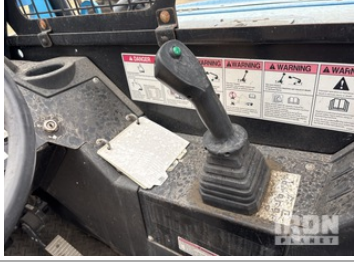
| Control Station | | |
|---|---|---|
| Hydraulic Controls | ★★★★☆ | |

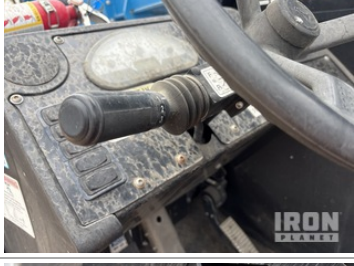
| Control Station | | |
|---|---|---|
| Drivetrain Controls | ★★★★☆ | |

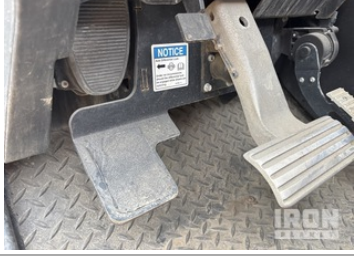
| Control Station | | |
|---|---|---|
| Transmission Disconnect Control | ★★★★☆ | |

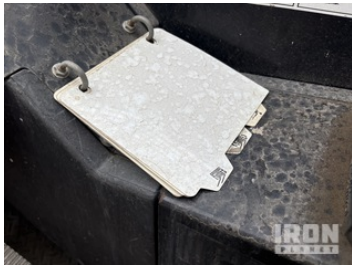
| Load Charts | Chart book in cab | |

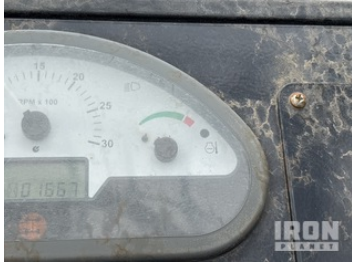
| Engine Oil Pressure | The gauge registers in the operating range. | |

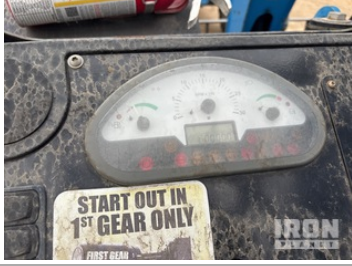
| Warning Lights | Operational | |

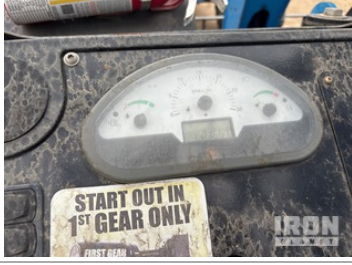
| Gauges | Operational | |

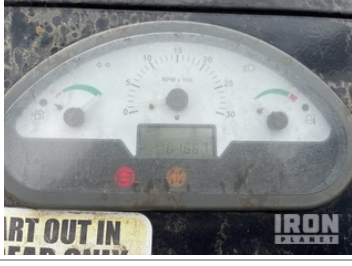
| Hour Meter / Odometer | 1667 hrs | |

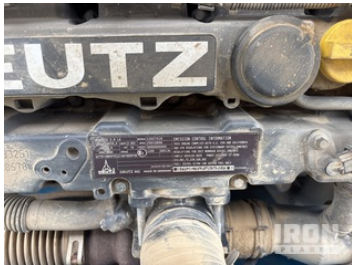
| Engine | | |
|---|---|---|
| Engine | 2017 US EPA Label, CARB Compliant | |

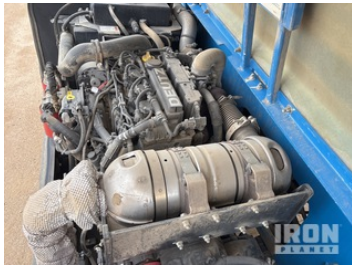
| Engine | | |
|---|---|---|
| Exhaust System | No visible damage or missing components | |

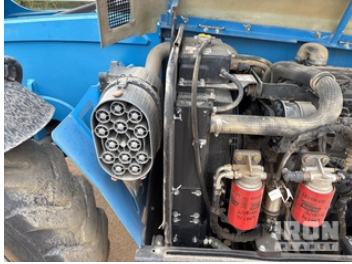
| Engine | | |
|---|---|---|
| Radiator | ★★★★☆ | |

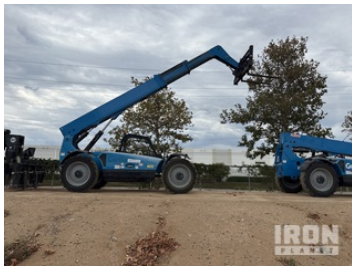
| Item | Assessment | Photo |
|---|---|---|
| Boom Condition | ★★★★☆ | |

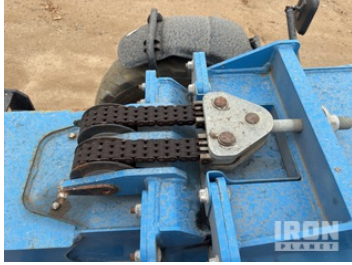
| Item | Assessment | Photo |
|---|---|---|
| Chain / Tensioners | ★★★★☆ | |

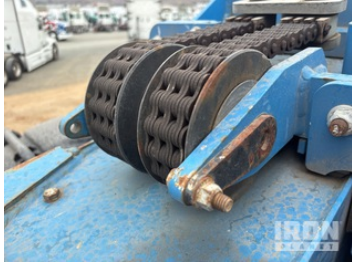
| Item | Assessment | Photo |
|---|---|---|
| Rollers and Guides | ★★★★☆ | |

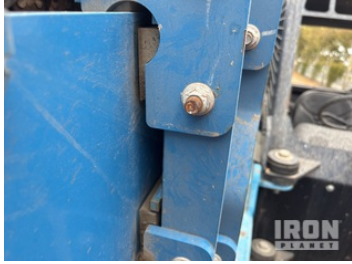
| Item | Assessment | Photo |
|---|---|---|
| Boom Wear Guides | ★★★★☆ | |

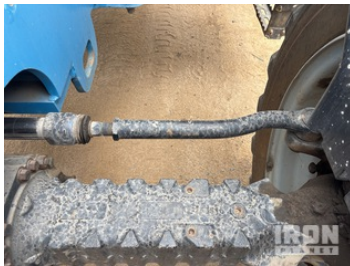
| Item | Assessment | Photo |
|---|---|---|
| Steering Linkage | ★★★★☆ | |

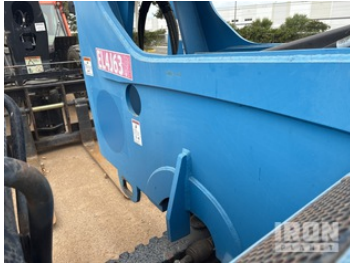
| Item | Assessment | Photo |
|---|---|---|
| Frame Condition | ★★★★☆ | |

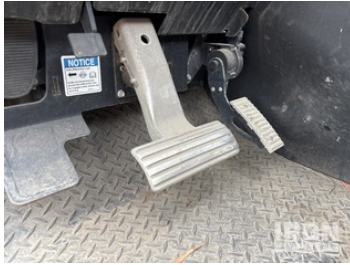
| Item | Assessment | Photo |
|---|---|---|
| Master Cylinder | ★★★★☆ | |

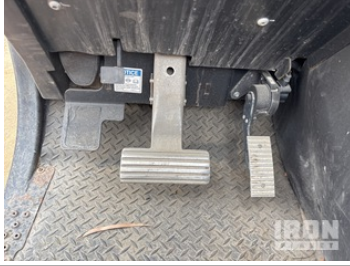
| Item | Assessment | Photo |
|---|---|---|
| Brake Control | ★★★★☆ | |

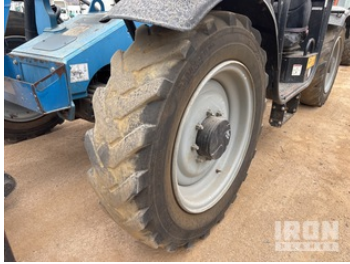
| Item | Assessment | Photo |
|---|---|---|
| Left Front Tire | Size: 330 Brand: EXTREMELIFT Model: EXL-T1 Tread Depth: 6/32 | |

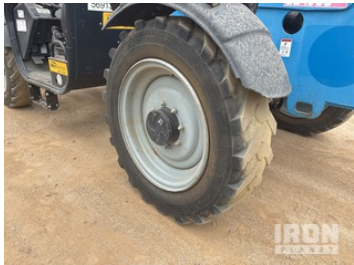
| Left Rear Tire | Tread Depth: 4/32 | |

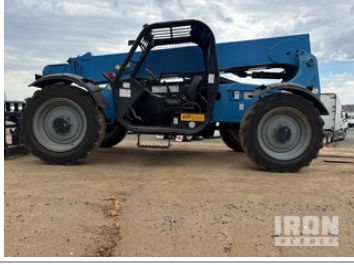
| Wheel Condition | No visible damage or missing components | |

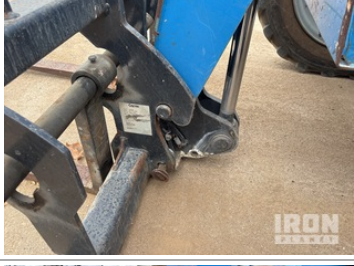
| Loader Quick Coupler | ★★★★☆ | |

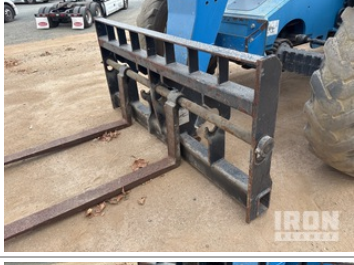
| Load Back Rest | ★★★★☆ | |

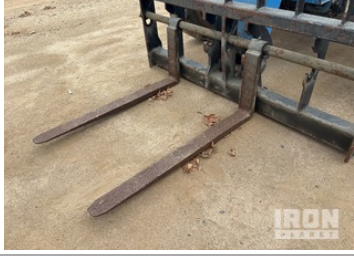
| Forks | ★★★★☆ | |
