## Item #13890693 - 2016 Skyjack SJ40T 4WD Diesel Telescopic Boom Lift

# Inspection Report

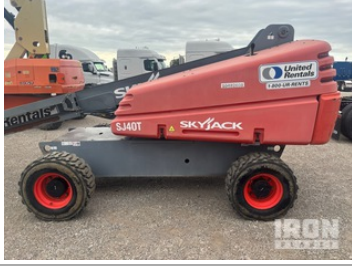
| Paint | No visible damage | |

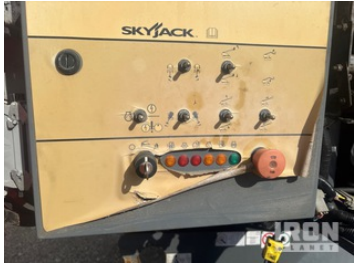
| Control Station Ground | | |
|---|---|---|
| Function Controls | ★★★★☆ | |

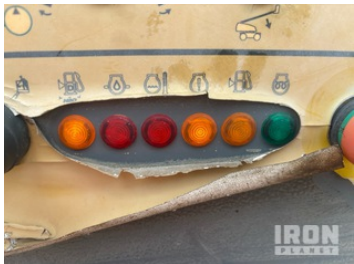
| Control Station Ground | | |
|---|---|---|
| Warning Lights | Operational | |

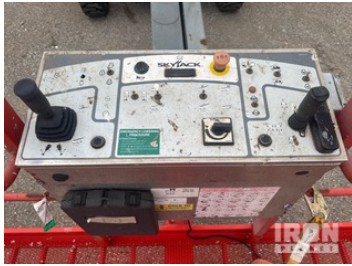
| Item | Assessment | Photo |
|---|---|---|
| Control Console | No visible damage or missing components | |

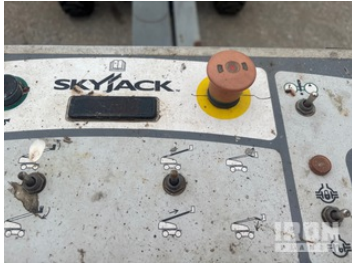
| Item | Assessment | Photo |
|---|---|---|
| Emergency Shut Off Switch | Operational | |

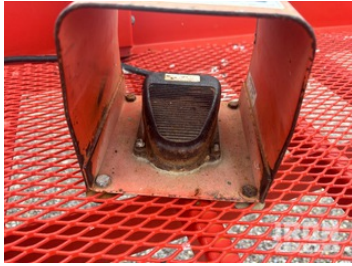
| Item | Assessment | Photo |
|---|---|---|
| Safety Control Hand/Foot Switch | ★★★★☆<br>Operational | |

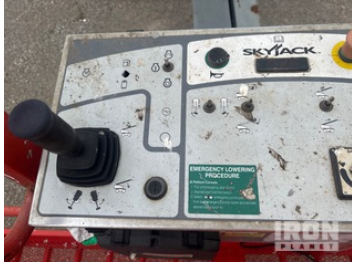
| Item | Assessment | Photo |
|---|---|---|
| Function Controls | ★★★★☆ | |

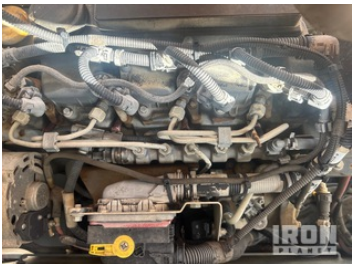
| Engine | | |
|---|---|---|
| Fuel System | Operational | |

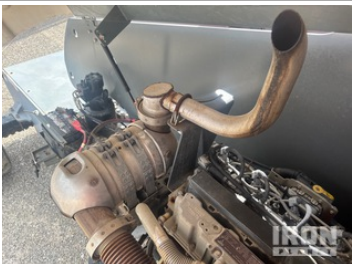
| Engine | | |
|---|---|---|
| Exhaust System | No visible damage or missing components | |

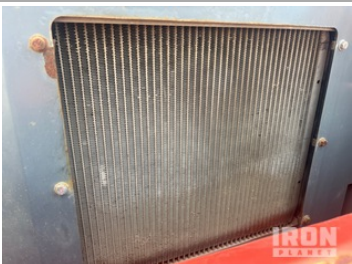
| Engine | | |
|---|---|---|
| Radiator | ★★★★☆ | |

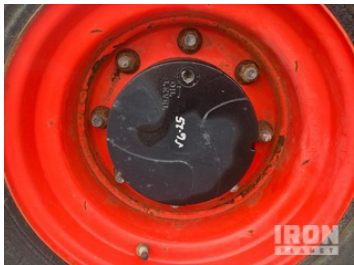
| Item | Assessment | Photo |
|---|---|---|
| Left Front Final Drive | ★★★★☆ | |

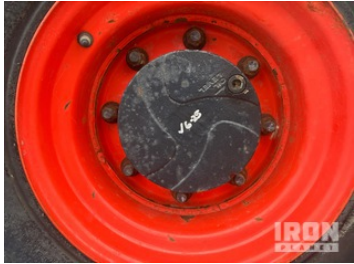
| Item | Assessment | Photo |
|---|---|---|
| Left Rear Final Drive | ★★★★☆ | |

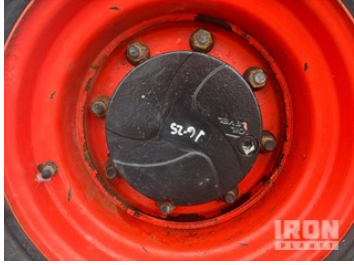
| Item | Assessment | Photo |
|---|---|---|
| Right Rear Final Drive | ★★★★☆ | |

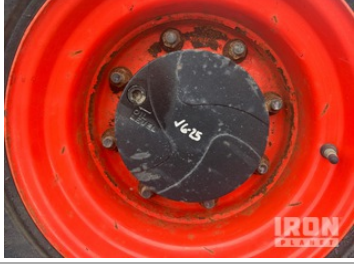
| Item | Assessment | Photo |
|---|---|---|
| Right Front Final Drive | ★★★★☆ | |

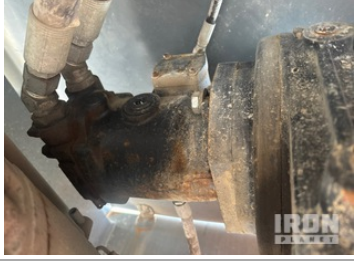
| Item | Assessment | Photo |
|---|---|---|
| Front Center Drive Motor | ★★★★☆ | |

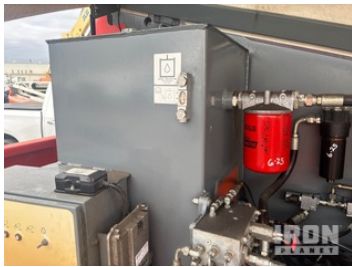
| Hydraulics | | |
|---|---|---|
| Hydraulic Tank | ★★★☆ | |

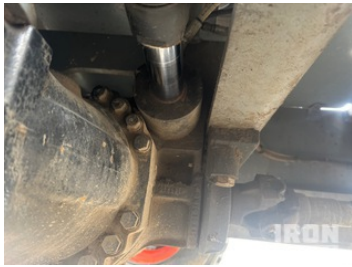
| Hydraulics | | |
|---|---|---|
| Steering Cylinders | ★★★☆ | |

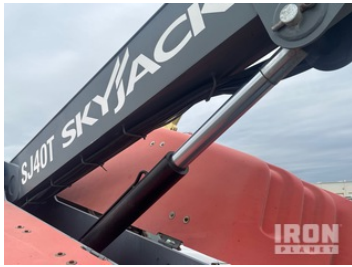
| Hydraulics | | |
|---|---|---|
| Boom Lift Cylinder | ★★★☆ | |

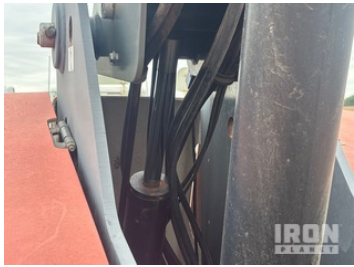
| Secondary Boom Cylinder | ★★★★☆ | |

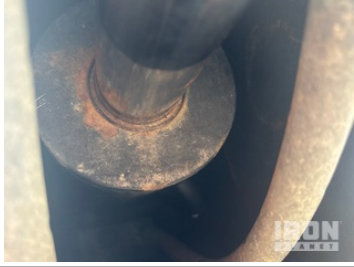
| Basket Tilt Cylinder | ★★★★☆ | |

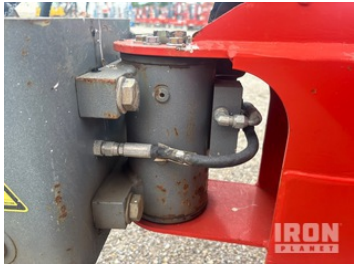
| Basket Rotator Motor | ★★★★☆ | |

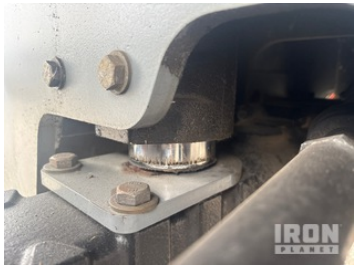
| Frame Leveling Cylinders | ★★★★☆ | |

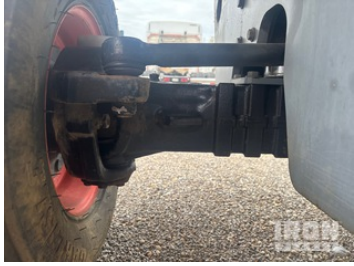
| Steering Linkage | ★★★★☆ | |

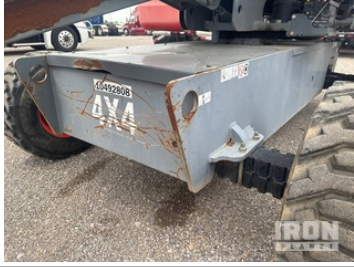
| Frame Condition | ★★★★☆ | |

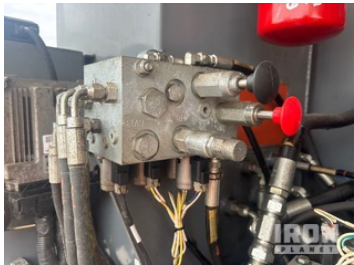
| Brake System | ★★★★☆<br>The brake system functioned, stopping and holding the machine. | |

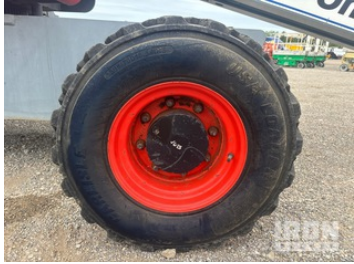
| Wheel Condition | No visible damage or missing components | |

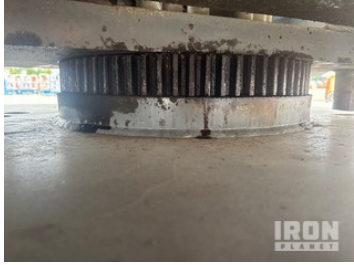
| Turntable Bearing | ★★★★☆ | |

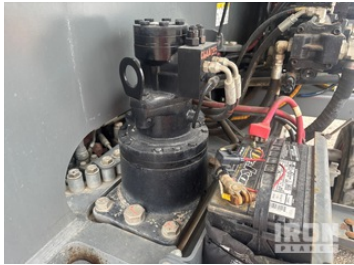
| Swing Motor | ★★★★☆ | |

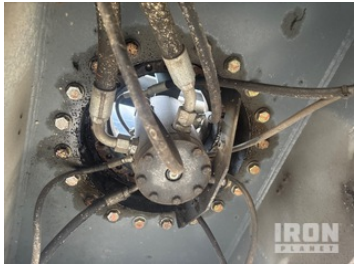
| Hydraulic Center Swivel | ★★★★☆ | |

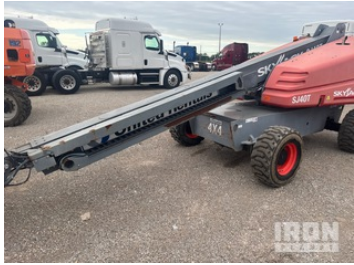
| Boom Condition | ★★★★☆ | |

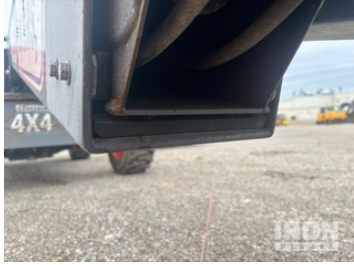
| Boom Wear Guides | ★★★★☆ | |
