## Item #14251171 - 2005 JLG 600S 4WD Diesel Telescopic Boom Lift

# Inspection Report

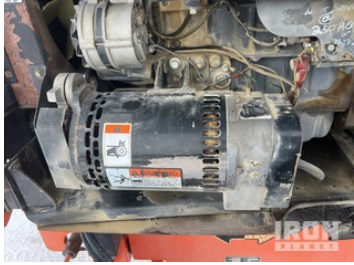
| Engine | | |
|---|---|---|
| Onboard Generator | Not operationally checked | |

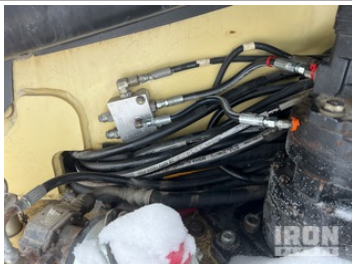
| Hydraulics | | |
|---|---|---|
| Hoses (Hydraulic) | ★★★★☆ | |

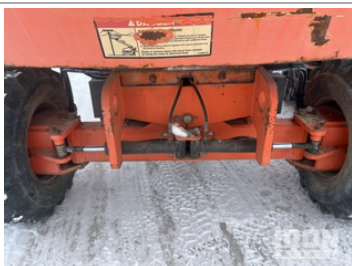
| Hydraulics | | |
|---|---|---|
| Steering Cylinders | ★★★★☆ | |

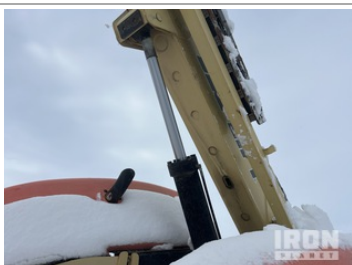
| Hydraulics | | |
|---|---|---|
| Boom Lift Cylinder | ★★★★☆ | |

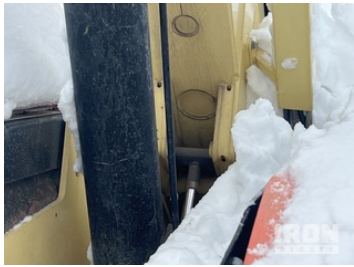
| Secondary Boom Cylinder | ☆☆☆☆ | |

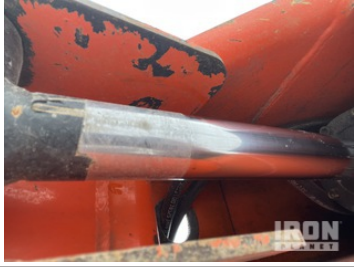
| Basket Tilt Cylinder | ☆☆☆☆ | |

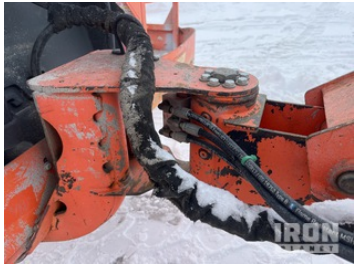
| Basket Rotator Motor | ☆☆☆☆ | |

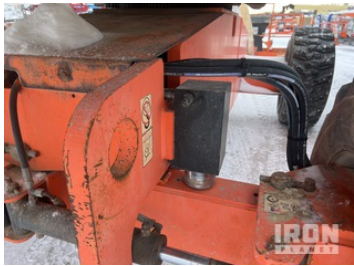
| Frame Leveling Cylinders | ☆☆☆☆ | |

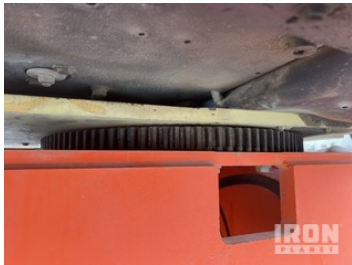
| Turntable Bearing | ★★★★☆ | |

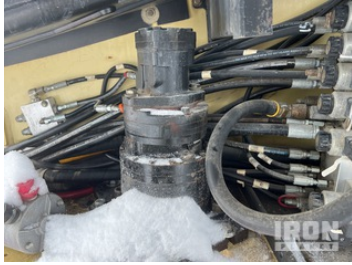
| Swing Motor | ★★★★☆ | |

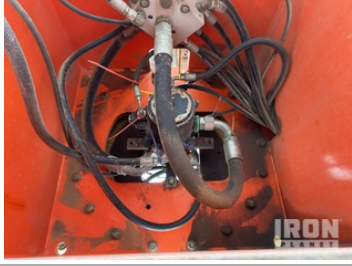
| Hydraulic Center Swivel | ★★★★☆ | |

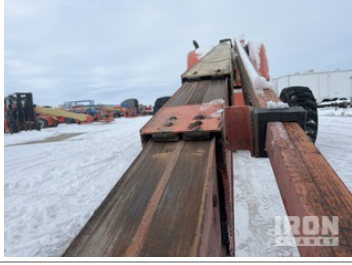
| Boom Condition | ★★★★☆ | |

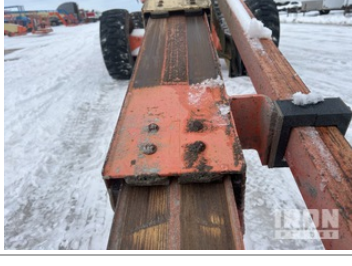
| Boom Wear Guides | ★★★★☆ | |
