## Item #14349303 - 2016 JLG 1055 Telehandler

# Inspection Report

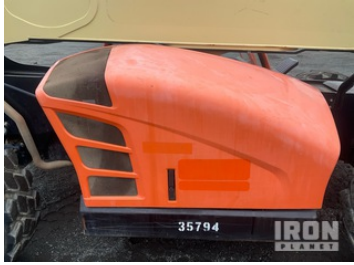
| Paint | No visible damage | |

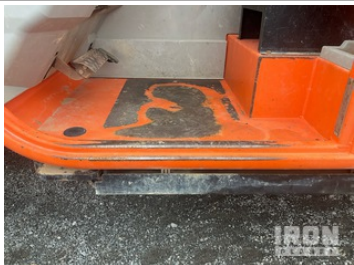
| Steps | No visible damage or missing components | |

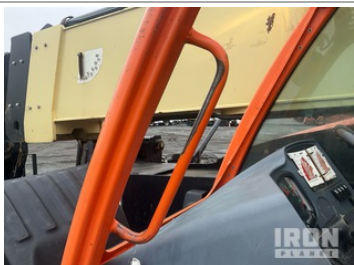
| Hand Rails | No visible damage or missing components | |

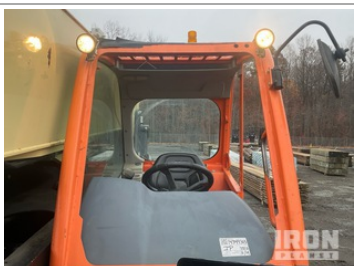
| Exterior Lights | All lights operational | |

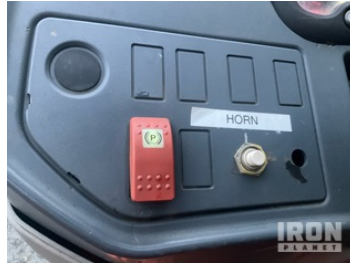
| Safety | | |
|---|---|---|
| Safety Lock Out/Stop | Operational | |

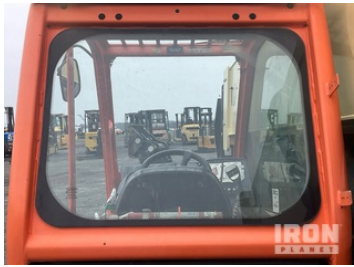
| Glass | No visible damage or missing components | |

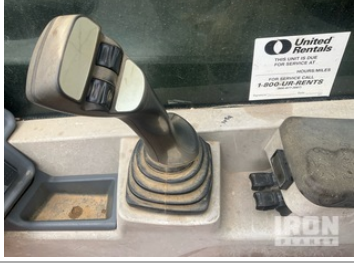
| Hydraulic Controls | ★★★★☆ | |

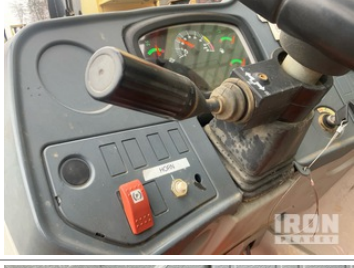
| Drivetrain Controls | ★★★★☆ | |

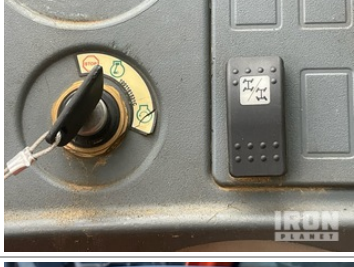
| Transmission Disconnect Control | ★★★★☆ | |

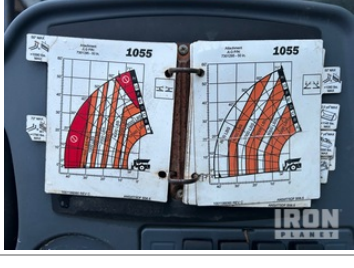
| Load Charts | Chart book in cab | |

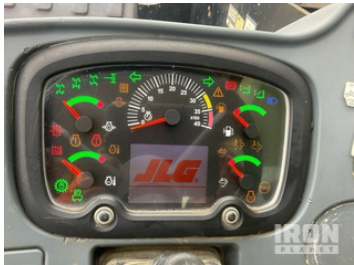
| Engine Oil Pressure | The fault indicator shuts off after the engine oil pressure rises. | |

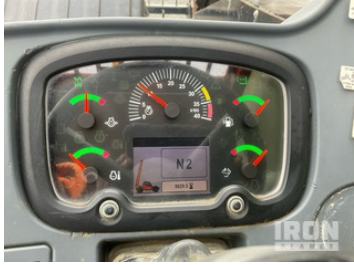
| Warning Lights | Operational | |

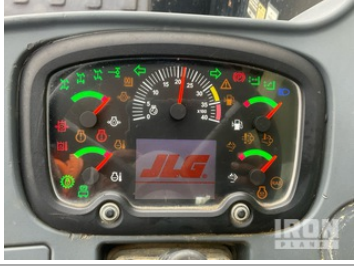
| Gauges | Operational | |

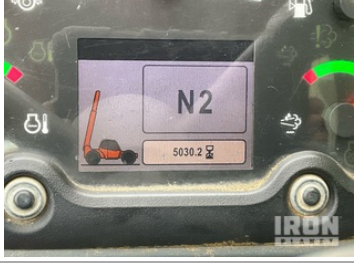
| Hour Meter / Odometer | 5030 hrs | |

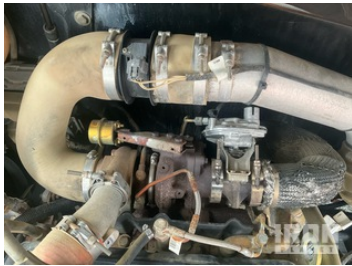
| Exhaust System | No visible damage or missing components | |

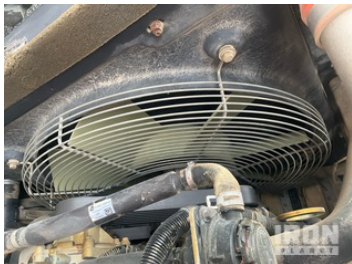
| Radiator | ★★★★☆ | |

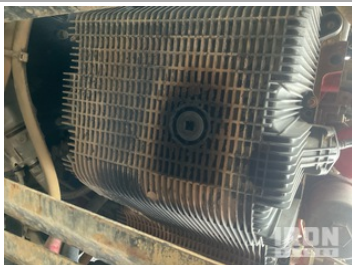
| Oil Leaks | No dripping leaks | |

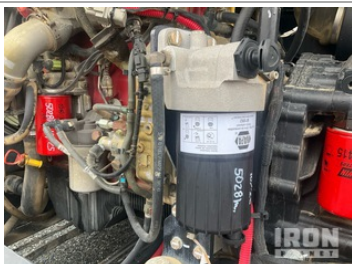
| Fuel Leaks | No dripping leaks | |

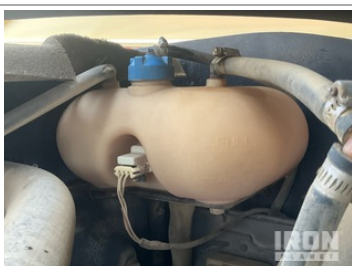
| Cooling System Leaks | No dripping leaks | |

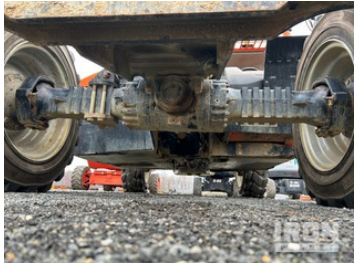
| Item | Assessment | Photo |
|---|---|---|
| Front Drive Axle | ★★☆☆ | |

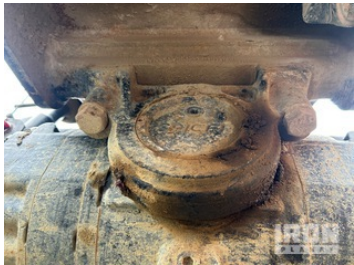
| Item | Assessment | Photo |
|---|---|---|
| Front Axle Oscillating Pin | ★★☆☆ | |

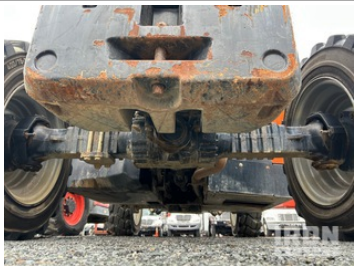
| Item | Assessment | Photo |
|---|---|---|
| Rear Drive Axle | ★★☆☆ | |

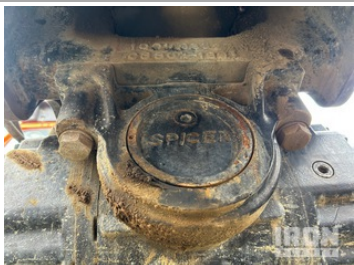
| Item | Assessment | Photo |
|---|---|---|
| Rear Axle Oscillating Pin | ★★☆☆ | |

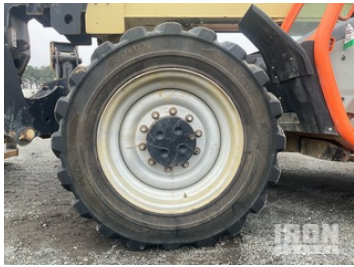
| Final Drives | ★★★★☆ | |

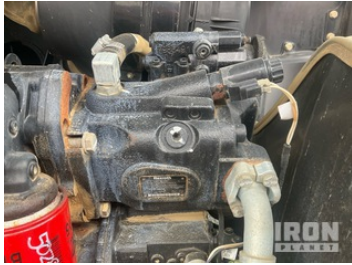
| Hydraulics | | |
|---|---|---|
| Pumps (Hydraulics) | ★★★★☆ | |

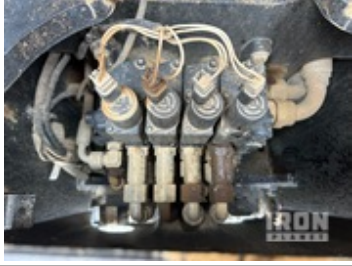
| Hydraulics | | |
|---|---|---|
| Valves | ★★★★☆ | |

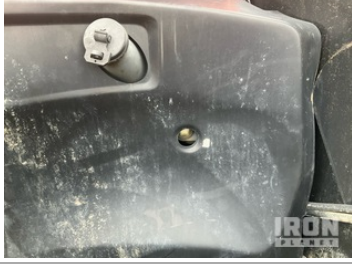
| Hydraulics | | |
|---|---|---|
| Hydraulic Tank | ★★★★☆ | |

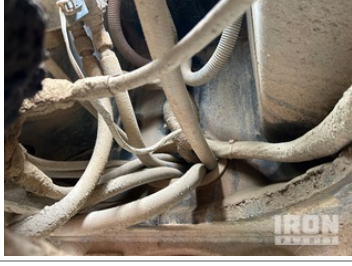
| Hydraulics | | |
|---|---|---|
| Hoses (Hydraulics) | ★★★★☆ | |

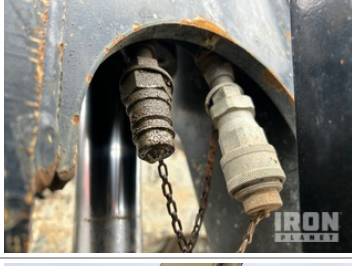
| Hydraulics | | |
|---|---|---|
| Auxiliary Hydraulic Plumbing | Not operationally checked, Has oil accumulation oil dripping | |

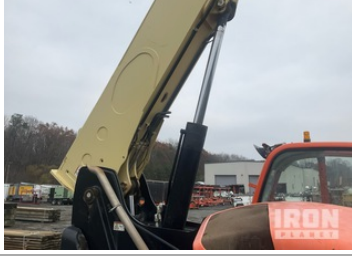
| Hydraulics | | |
|---|---|---|
| Boom Lift Cylinder(s) | ★★★★☆ | |

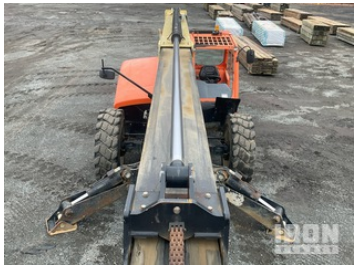
| Telescopic Boom Cylinders | ★★★★☆ | |

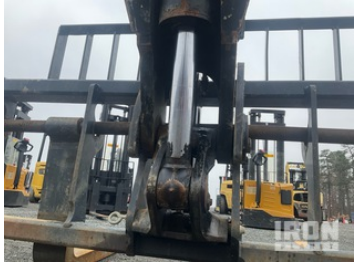
| Carriage Tilt Cylinder | ★★★★☆ | |

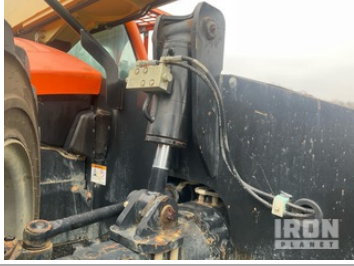
| Frame Leveling Cylinders | ★★★★☆ | |

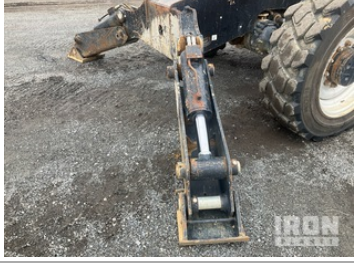
| Outrigger Cylinders | ★★★★☆ | |

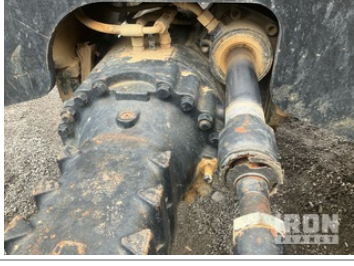
| Steering Cylinders | ★★★★☆ | |

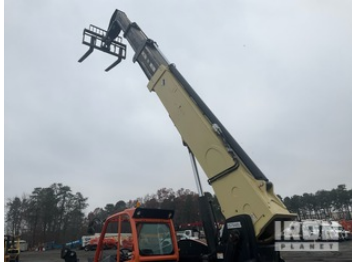
| Boom Condition | ★★★★☆ | |

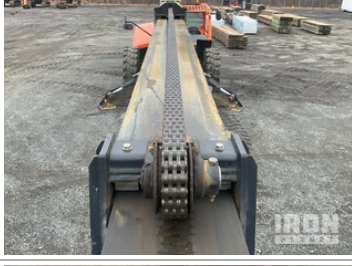
| Chain / Tensioners | ★★★★☆ | |

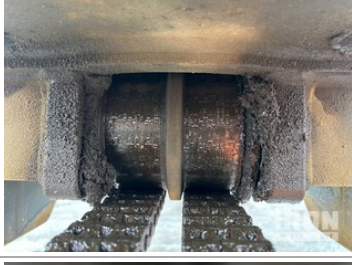
| Rollers and Guides | ★★★★☆ | |

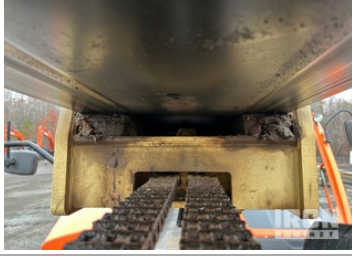
| Boom Wear Guides | ★★★★☆ | |

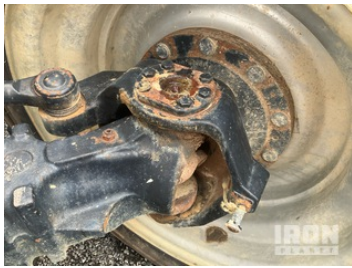
| Item | Assessment | Photo |
|---|---|---|
| Steering Linkage | ★★★★☆ | |

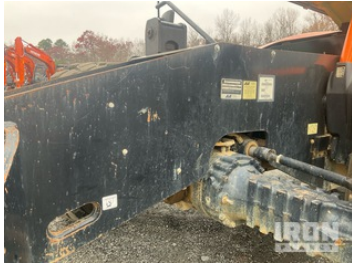
| Item | Assessment | Photo |
|---|---|---|
| Frame Condition | ★★★★☆ | |

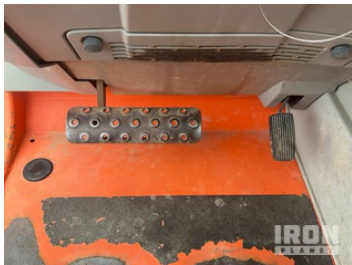
| Item | Assessment | Photo |
|---|---|---|
| Brake Control | ★★★★☆ | |

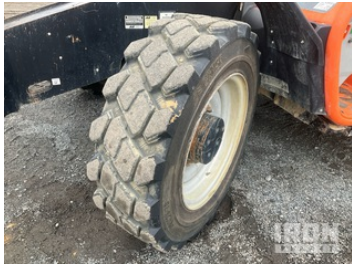
| Item | Assessment | Photo |
|---|---|---|
| Left Front Tire | Size: 400/75-28 Brand: Camso Model: TLH753 Tread Depth: 31/32 | |

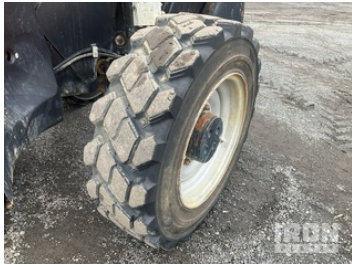
| Item | Assessment | Photo |
|---|---|---|
| Left Rear Tire | Size: 400/75-28 Brand: Camso Model: TLH753 Tread Depth: 30/32 | |

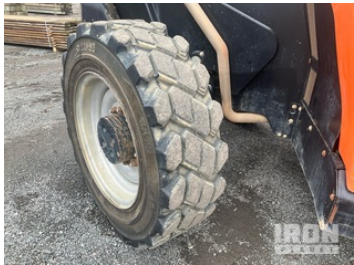
| Right Rear Tire | Size: 400/75-28 Brand: Camso Model: TLH753 Tread Depth: 30/32 | |

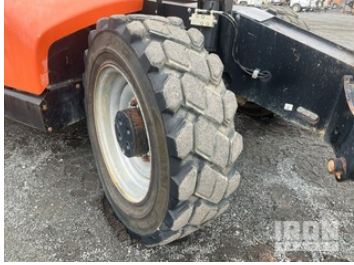
| Right Front Tire | Size: 400/75-28 Brand: Camso Model: TLH753 Tread Depth: 31/32 | |

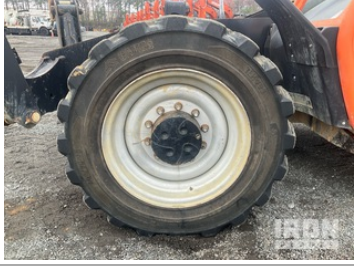
| Wheel Condition | No visible damage or missing components | |

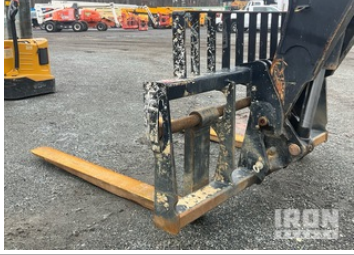
| Loader Quick Coupler | <p>★★★★☆</p> <p>Not operationally checked</p> | |

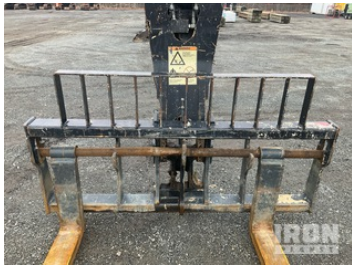
| Load Back Rest | ☆☆☆☆<br>Unknown material sticks | |

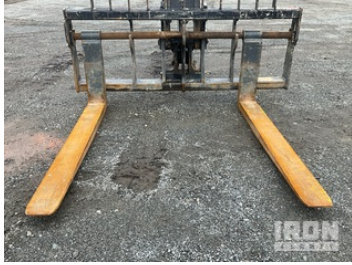
| Forks | ☆☆☆☆ | |
