## Item #13810958 - 2016 JLG 600AJ 4WD Diesel Articulating Boom Lift

# Inspection Report

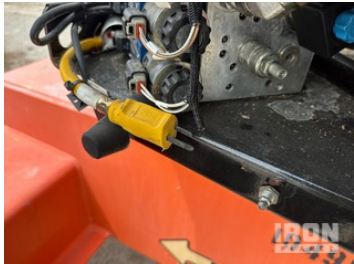
| Electrical Operating System | | |
|---|---|---|
| Battery Charger | Included | |

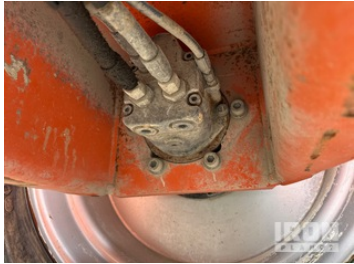
| Item | Assessment | Photo |
|---|---|---|
| Left Front Drive Motor | ★★★★☆ | |

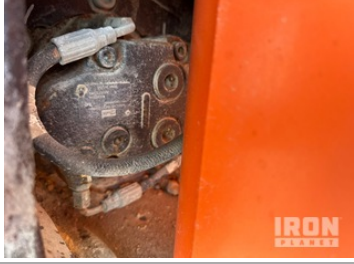
| Item | Assessment | Photo |
|---|---|---|
| Left Rear Drive Motor | ★★★★☆ | |

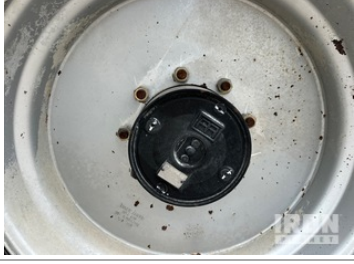
| Item | Assessment | Photo |
|---|---|---|
| Right Rear Final Drive | ★★★★☆ | |

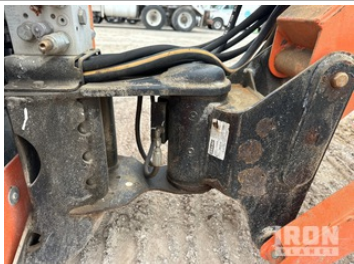
| Basket Rotator Motor | ★★★★☆ | |
