## Item #14097041 - 2016 JLG 800 AJ 4WD Diesel Articulating Boom Lift

# Inspection Report

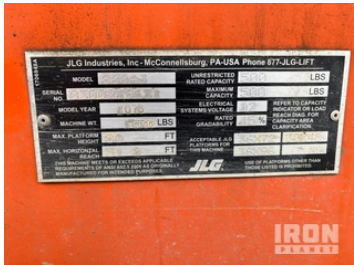
| Serial Number / VIN | 0300219631 | |

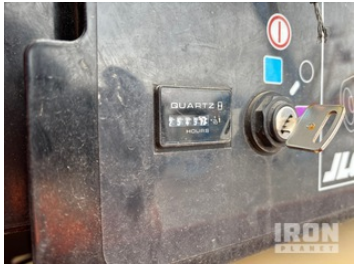
| Hour Meter / Odometer | 2549 hrs | |

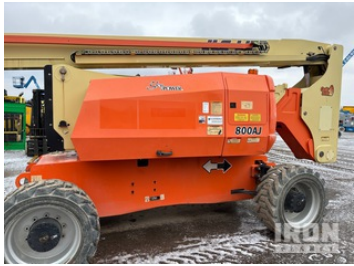
| Paint | No visible damage | |

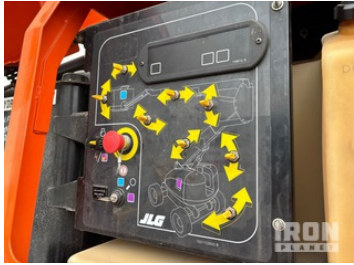
| Control Station Ground | | |
|---|---|---|
| Function Controls | ★★★★☆ | |

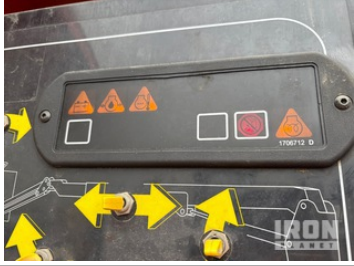
| Control Station Ground | | |
|---|---|---|
| Oil Pressure | The fault indicator shuts off after the engine oil pressure rises. | |

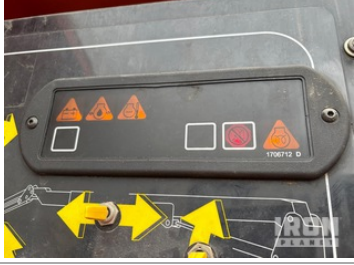
| Control Station Ground | | |
|---|---|---|
| Warning Lights | Operational | |

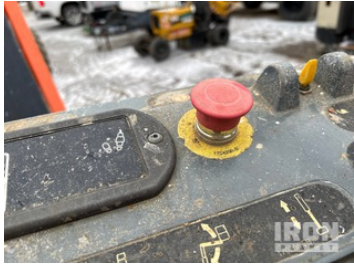
| Item | Assessment | Photo |
|---|---|---|
| Emergency Shut Off Switch | Operational | |

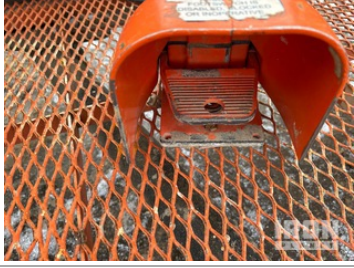
| Item | Assessment | Photo |
|---|---|---|
| Safety Control Hand/Foot Switch | ★★★★☆<br>Operational | |

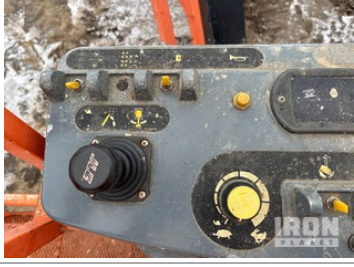
| Item | Assessment | Photo |
|---|---|---|
| Function Controls | ★★★★☆ | |

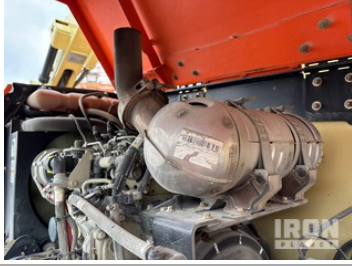
| Engine | | |
|---|---|---|
| Exhaust System | No visible damage or missing components | |

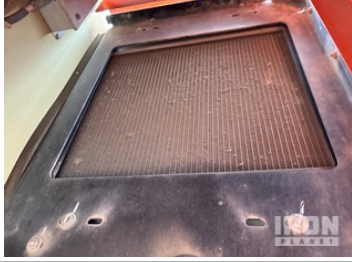
| Engine | | |
|---|---|---|
| Radiator | ★★★★☆ | |

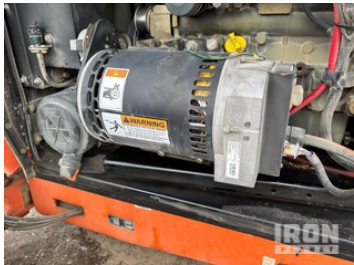
| Onboard Generator | Not operationally checked | |

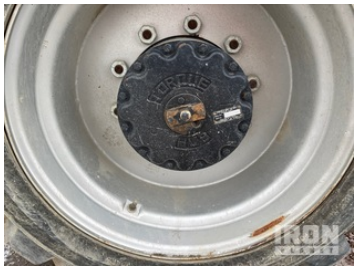
| Item | Assessment | Photo |
|---|---|---|
| Left Front Final Drive | ★★★★☆ | A close-up photograph of the left front final drive assembly, showing a black metal housing with a central bolt and a silver metal flange. |

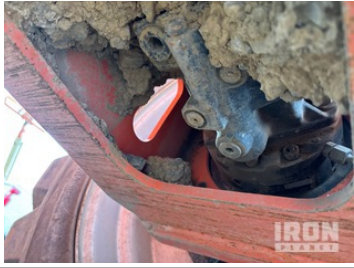
| Item | Assessment | Photo |
|---|---|---|
| Left Front Drive Motor | ★★★★☆ | A close-up photograph of the left front drive motor, showing a blue metal housing and a red hydraulic hose. |

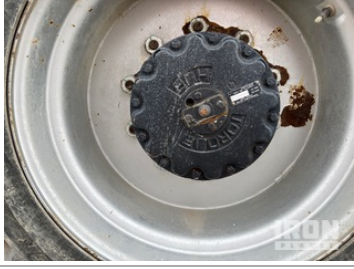
| Item | Assessment | Photo |
|---|---|---|
| Left Rear Final Drive | ★★★★☆ | A close-up photograph of the left rear final drive assembly, showing a black metal housing with a central bolt and a silver metal flange. |

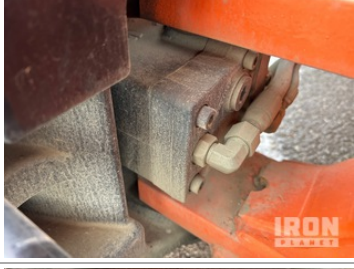
| Item | Assessment | Photo |
|---|---|---|
| Left Rear Drive Motor | ★★★★☆ | A close-up photograph of the left rear drive motor, showing a blue metal housing and a red hydraulic hose. |

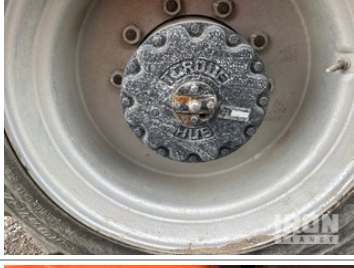
| Item | Assessment | Photo |
|---|---|---|
| Right Rear Final Drive | ★★★★☆ | A close-up photograph of the right rear final drive assembly, showing a black metal housing with a central bolt and a silver metal flange. |

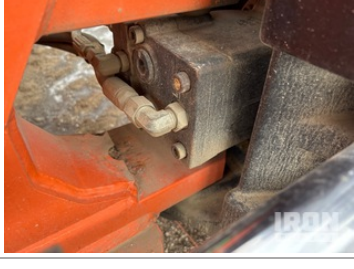
| Item | Assessment | Photo |
|---|---|---|
| Right Rear Drive Motor | ★★★★☆ | A close-up photograph of the right rear drive motor, showing a blue metal housing and a red hydraulic hose. |

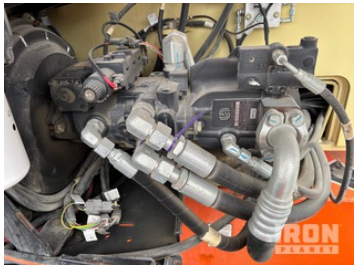
| Hydraulics | | |
|---|---|---|
| Pumps (Hydraulics) | ★★★★☆ | |

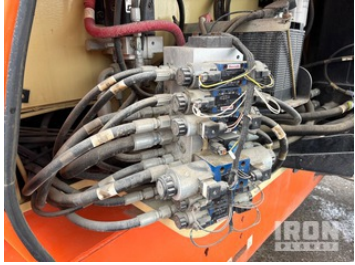
| Hydraulics | | |
|---|---|---|
| Valves | ★★★★☆ | |

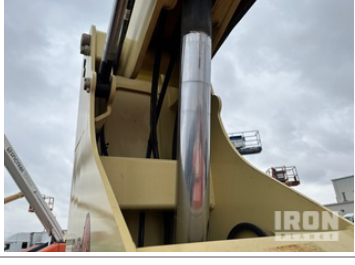
| Hydraulics | | |
|---|---|---|
| Boom Lift Cylinder | ★★★★☆ | |

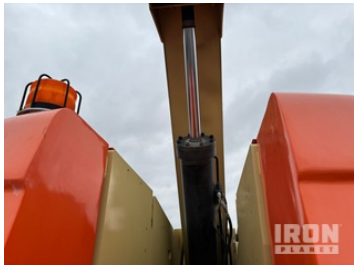
| Secondary Boom Cylinder | ★★★★☆ | |

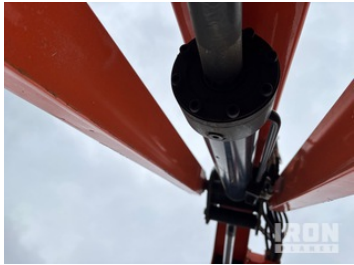
| Jib Cylinder | ★★★★☆ | |

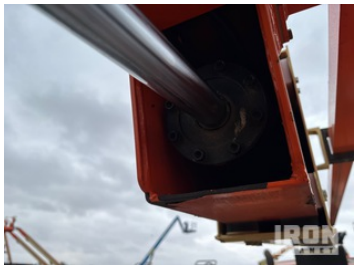
| Basket Tilt Cylinder | ★★★★☆ | |

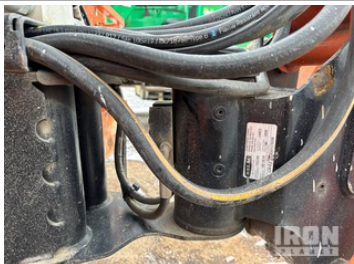
| Basket Rotator Motor | ★★★★☆ | |

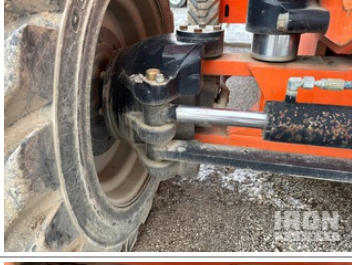
| Steering Linkage | ★★★★☆ | |

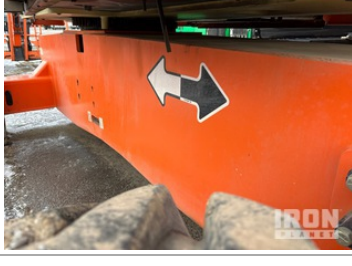
| Frame Condition | ★★★★☆ | |

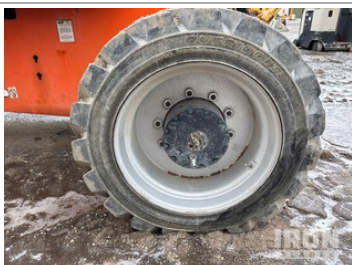
| Wheel Condition | No visible damage or missing components | |

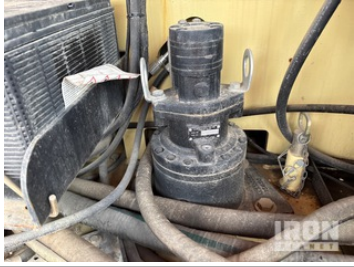
| Swing Motor | ★★★★☆ | |

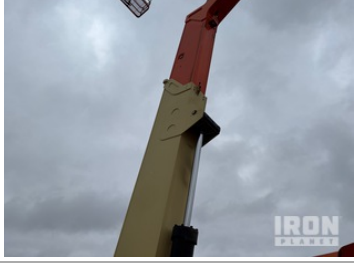
| Boom Condition | ★★★★☆ | |

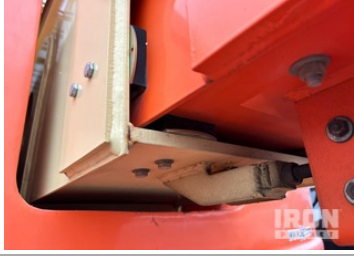
| Boom Wear Guides | ★★★★☆ | |
