## Item #13869113 - 2018 Genie S40 4WD Diesel Telescopic Boom Lift

# Inspection Report

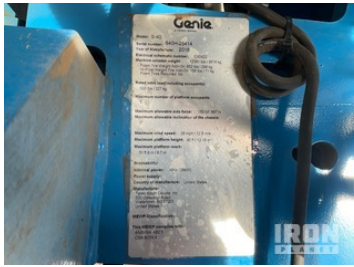
| Serial Number / VIN | S40H-25414 | |

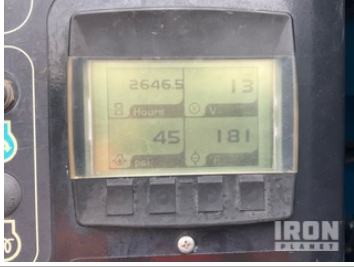
| Hour Meter / Odometer | 2646 mi | |

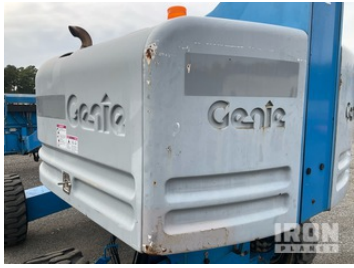
| Paint | No visible damage | |

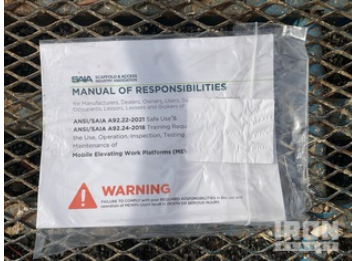
| <b>Safety</b> | | |
|---|---|---|
| ANSI Guidelines | Yes | |

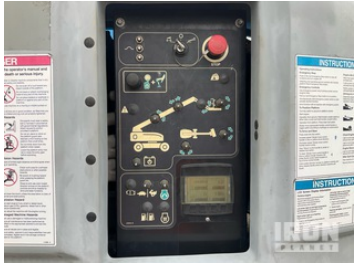
| Control Station Ground | | |
|---|---|---|
| Function Controls | ★★★★☆ | |

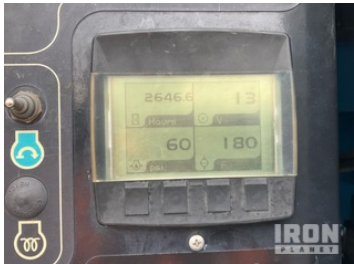
| Control Station Ground | | |
|---|---|---|
| Oil Pressure | The gauge registers in the operating range. | |

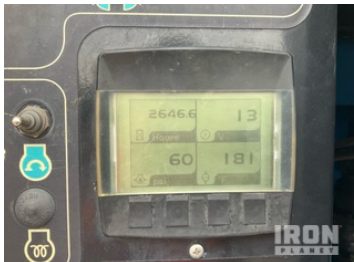
| Control Station Ground | | |
|---|---|---|
| Warning Lights | Operational | |

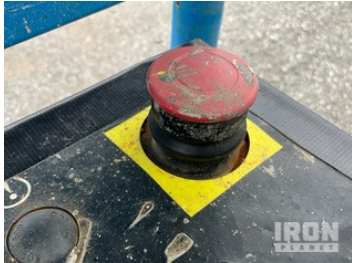
| Item | Assessment | Photo |
|---|---|---|
| Emergency Shut Off Switch | Operational | |

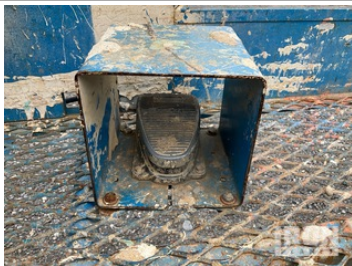
| Item | Assessment | Photo |
|---|---|---|
| Safety Control Hand/Foot Switch | ★★★★☆<br>Operational | |

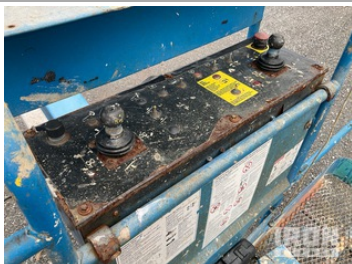
| Item | Assessment | Photo |
|---|---|---|
| Function Controls | ★★★★☆ | |

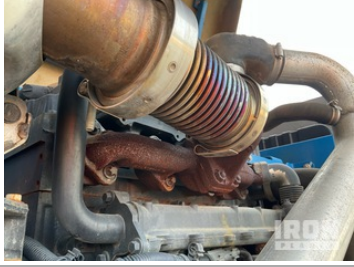
| Exhaust System | No visible damage or missing components | |

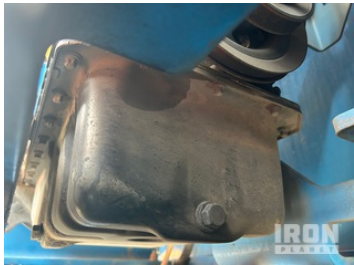
| Oil Leaks | No dripping leaks | |

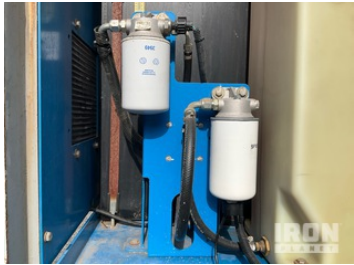
| Fuel Leaks | No dripping leaks | |

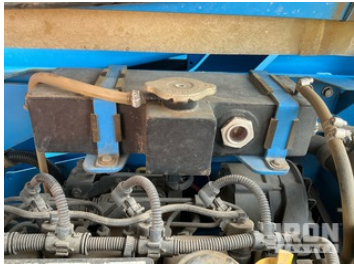
| Cooling System Leaks | No dripping leaks | |

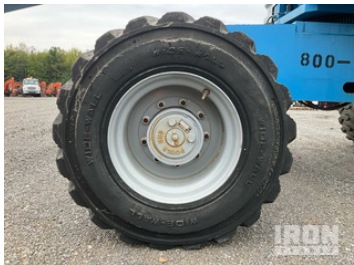
| Item | Assessment | Photo |
|---|---|---|
| Left Front Final Drive | ★★★★☆ | |

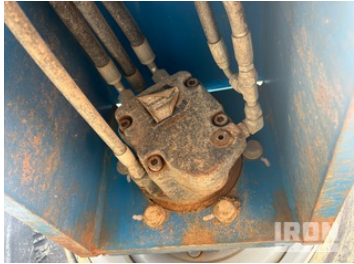
| Item | Assessment | Photo |
|---|---|---|
| Left Front Drive Motor | ★★★★☆ | |

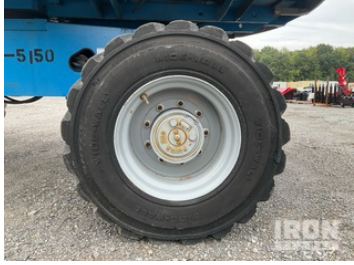
| Item | Assessment | Photo |
|---|---|---|
| Left Rear Final Drive | ★★★★☆ | |

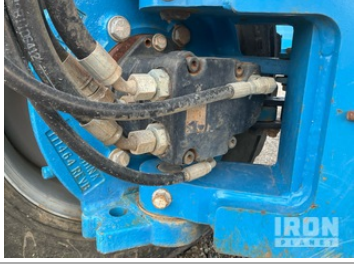
| Item | Assessment | Photo |
|---|---|---|
| Left Rear Drive Motor | ★★★★☆ | |

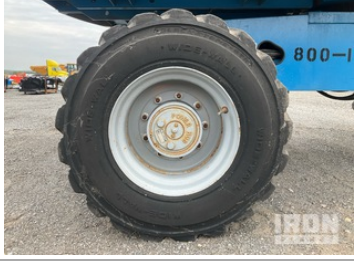
| Item | Assessment | Photo |
|---|---|---|
| Right Rear Final Drive | ★★★★☆ | |

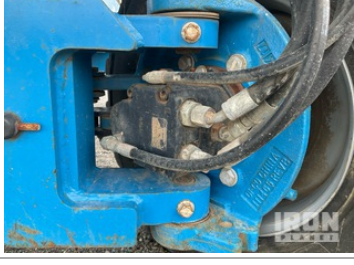
| Item | Assessment | Photo |
|---|---|---|
| Right Rear Drive Motor | ★★★★☆ | |

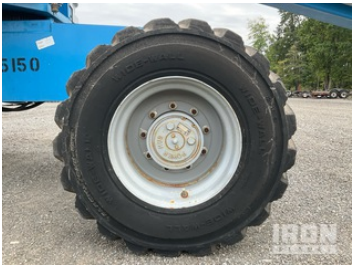
| Right Front Final Drive | ☆☆☆☆ | |

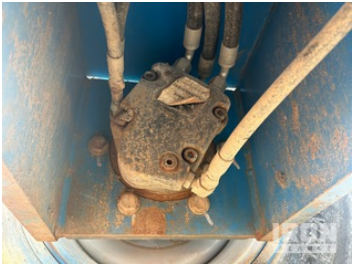
| Right Front Drive Motor | ☆☆☆☆ | |

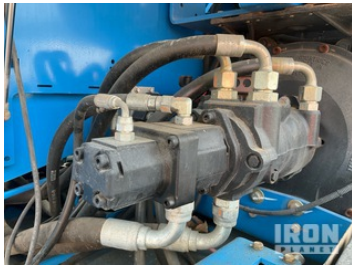
| Hydraulics | | |
|---|---|---|
| Pumps (Hydraulics) | ★★★★☆ | |

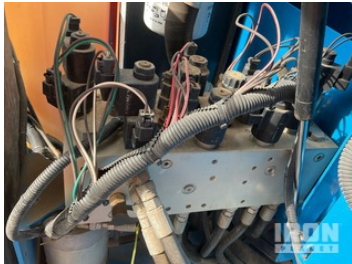
| Hydraulics | | |
|---|---|---|
| Valves | ★★★★☆ | |

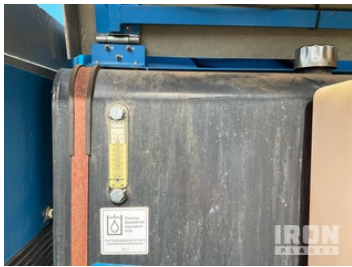
| Hydraulics | | |
|---|---|---|
| Hydraulic Tank | ★★★★☆ | |

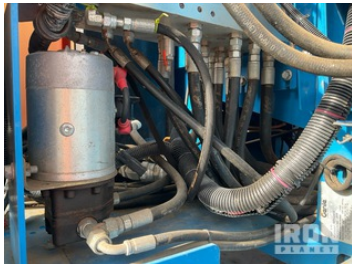
| Hydraulics | | |
|---|---|---|
| Hoses (Hydraulic) | ★★★★☆ | |

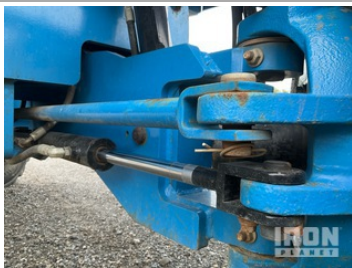
| Hydraulics | | |
|---|---|---|
| Steering Cylinders | ★★★★☆ | |

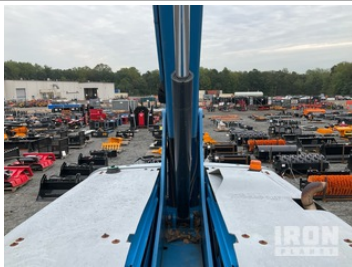
| Hydraulics | | |
|---|---|---|
| Boom Lift Cylinder | ★★★★☆ | |

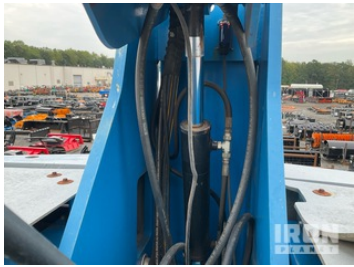
| Secondary Boom Cylinder | ★★★★☆ | |

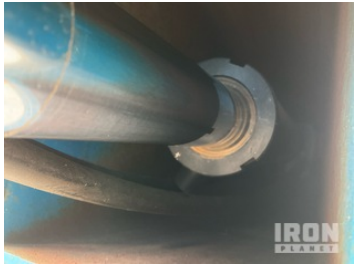
| Basket Tilt Cylinder | ★★★★☆ | |

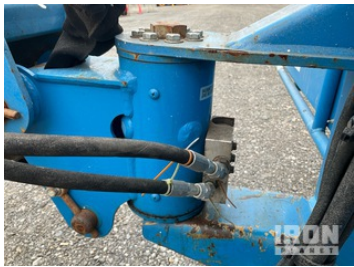
| Basket Rotator Motor | ★★★★☆ | |

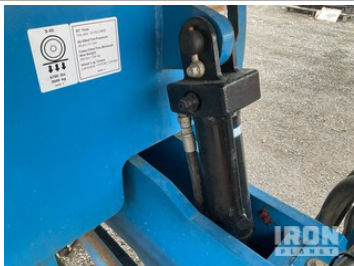
| Frame Leveling Cylinders | ★★★★☆ | |

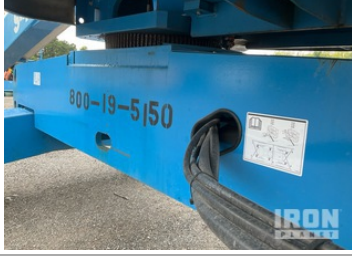
| Chassis | | |
|---|---|---|
| Frame Condition | ★★★★☆ | |

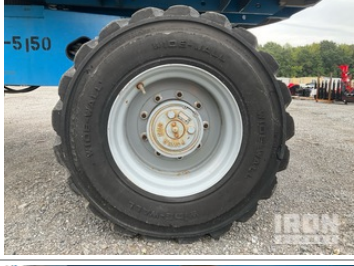
| Wheel Condition | No visible damage or missing components | |

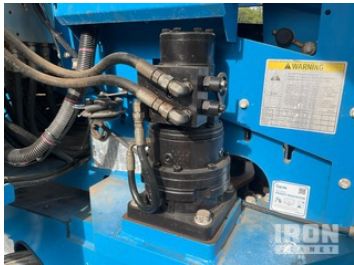
| Swing Motor | ★★★★☆ | |

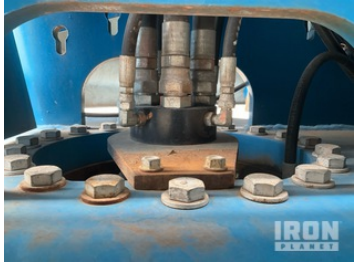
| Hydraulic Center Swivel | ★★★★☆ | |

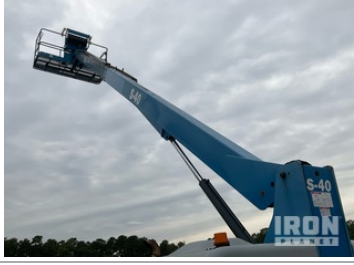
| Boom Condition | ★★★★☆ | |

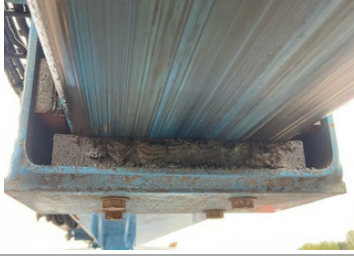
| Boom Wear Guides | ★★★★☆ | |
