## Item #13869120 - 2017 Genie GTH-1056 Telehandler

# Inspection Report

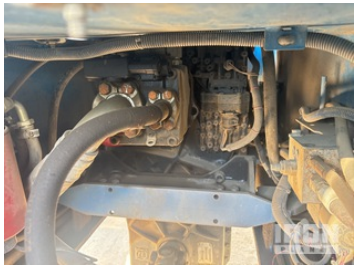
| Item | Assessment | Photo |
|---|---|---|
| Pumps (Hydraulics) | ★★★★ | |

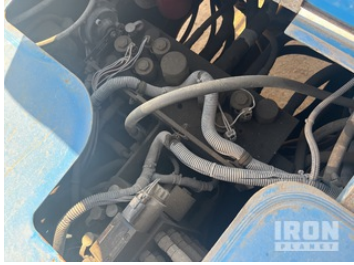
| Item | Assessment | Photo |
|---|---|---|
| Valves | ★★★★<br>Seep | |

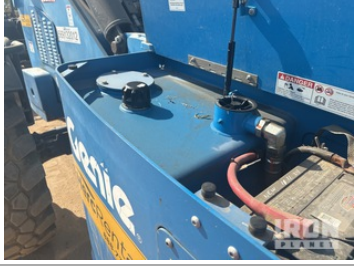
| Item | Assessment | Photo |
|---|---|---|
| Hydraulic Tank | ★★★★ | |

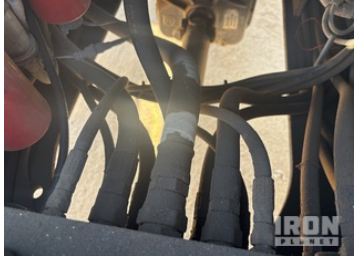
| Item | Assessment | Photo |
|---|---|---|
| Hoses (Hydraulics) | Seep | |

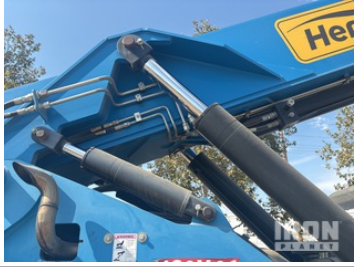
| Boom Lift Cylinder(s) | ★★★★☆ | |

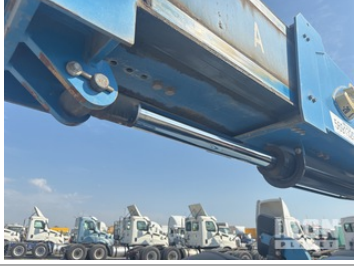
| Telescopic Boom Cylinders | ★★★★☆ | |

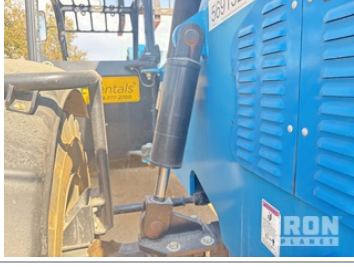
| Carriage Tilt Cylinder | ★★★★☆ | |

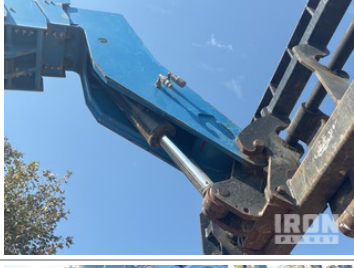
| Fork Positioning Cylinder (on fork carriage) | ★★★★☆ | |

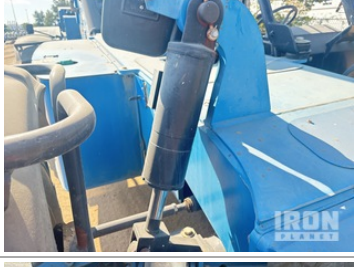
| Frame Leveling Cylinders | ★★★★☆ | |

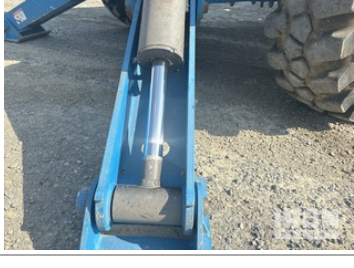
| Outrigger Cylinders | ★★★★☆ | |

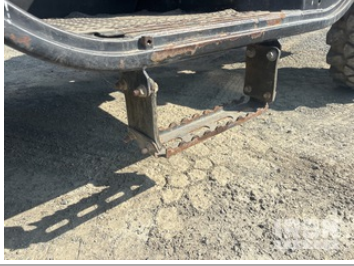
| Steps | No visible damage or missing components | |

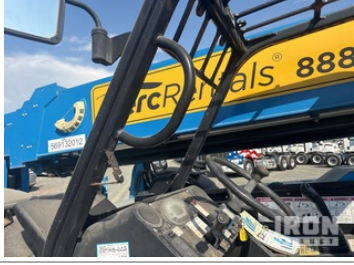
| Hand Rails | No visible damage or missing components | |

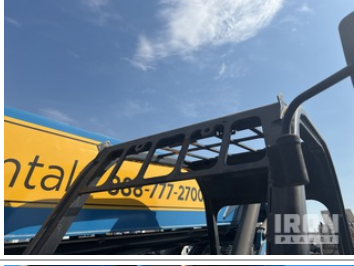
| Exterior Lights | No lights equips | |

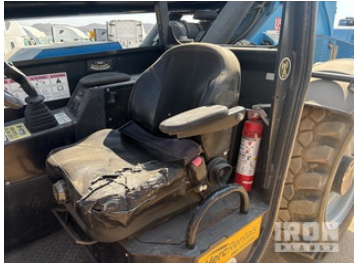
| Control Station | | |
|---|---|---|
| Seat/Armrests | Operator seat cover torn | |

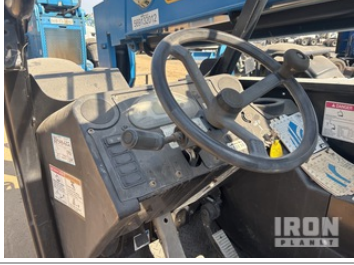
| Control Station | | |
|---|---|---|
| Steering Control | ★★★★☆<br>Heavy steering wheel play | |

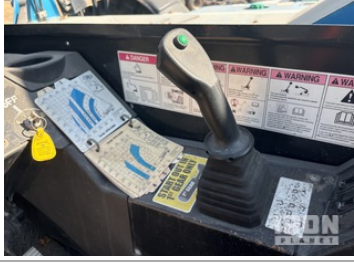
| Control Station | | |
|---|---|---|
| Hydraulic Controls | ★★★★☆ | |

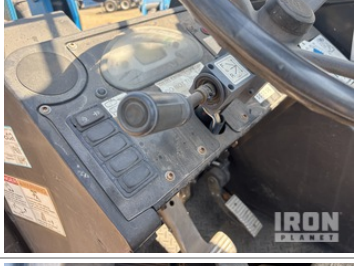
| Control Station | | |
|---|---|---|
| Drivetrain Controls | ★★★★☆ | |

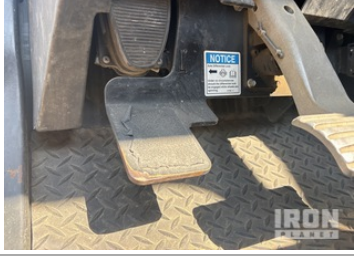
| Control Station | | |
|---|---|---|
| Transmission Disconnect Control | ★★★★☆ | |

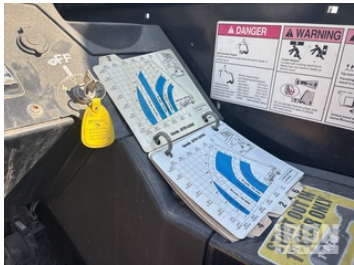
| Load Charts | Chart book in cab | |

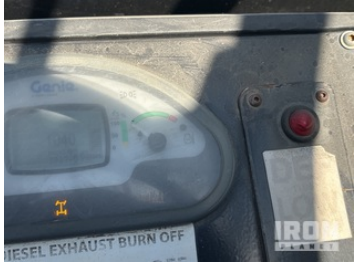
| Engine Oil Pressure | The gauge registers in the operating range. | |

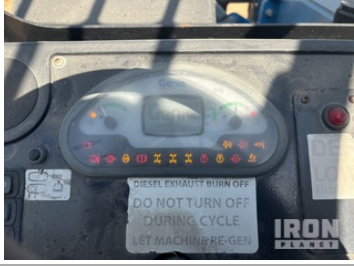
| Warning Lights | Operational | |

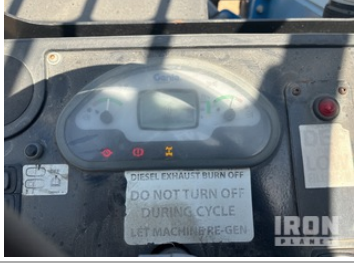
| Gauges | Operational | |

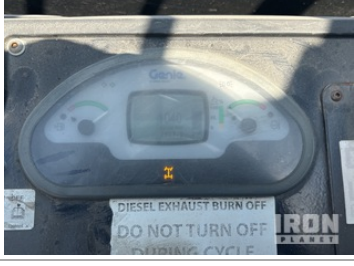
| Hour Meter / Odometer | 2917 hrs | |

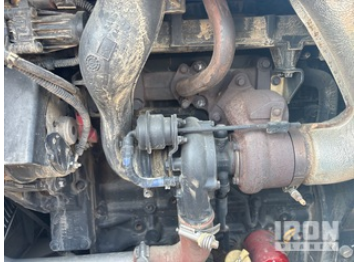
| Engine | | |
|---|---|---|
| Exhaust System | No visible damage or missing components | |

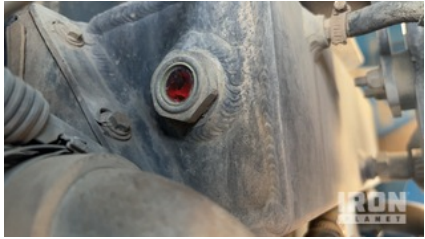
| Engine | | |
|---|---|---|
| Radiator | ★★★★☆ | |

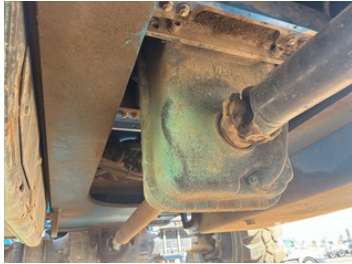
| Item | Assessment | Photo |
|---|---|---|
| Transfer Case / Drop Box | ★★☆☆<br>Operational | |

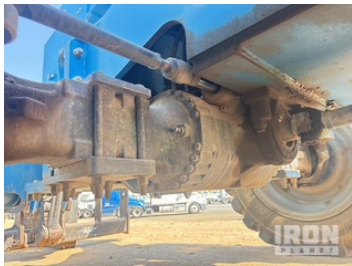
| Item | Assessment | Photo |
|---|---|---|
| Front Drive Axle | ★★☆☆ | |

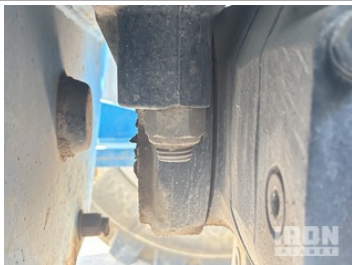
| Item | Assessment | Photo |
|---|---|---|
| Front Axle Oscillating Pin | ★★☆☆ | |

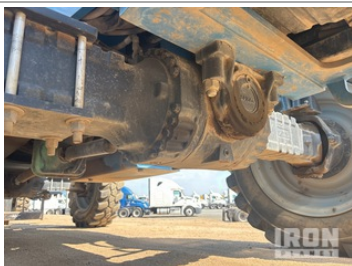
| Item | Assessment | Photo |
|---|---|---|
| Rear Drive Axle | ★★☆☆ | |

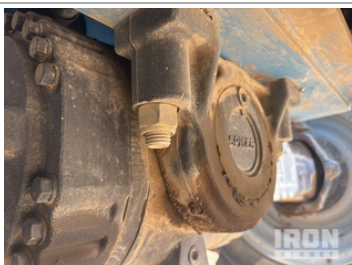
| Item | Assessment | Photo |
|---|---|---|
| Rear Axle Oscillating Pin | ★★☆☆ | |

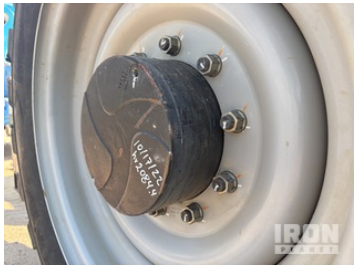
| Final Drives | ★★★★☆ | |

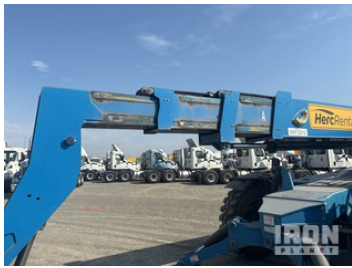
| Item | Assessment | Photo |
|---|---|---|
| Boom Condition | ★★★★☆ | |

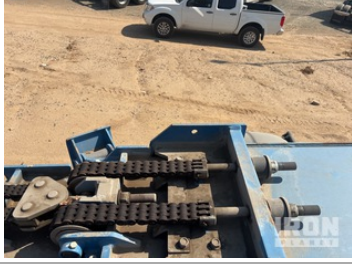
| Item | Assessment | Photo |
|---|---|---|
| Chain / Tensioners | ★★★★☆ | |

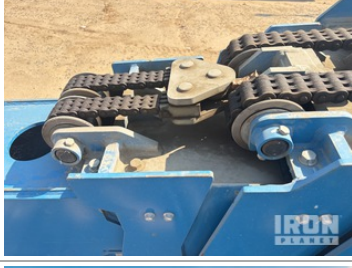
| Item | Assessment | Photo |
|---|---|---|
| Rollers and Guides | ★★★★☆ | |

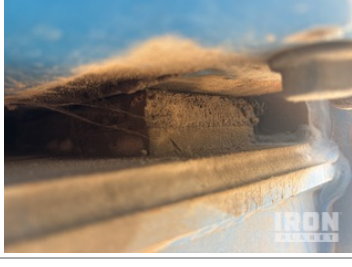
| Item | Assessment | Photo |
|---|---|---|
| Boom Wear Guides | ★★★★☆ | |

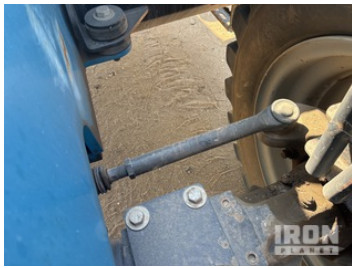
| Item | Assessment | Photo |
|---|---|---|
| Steering Linkage | ★★★★☆ | |

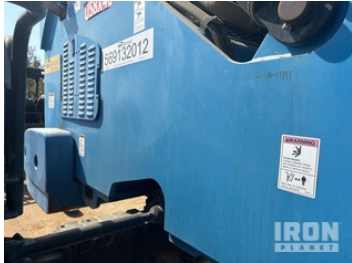
| Item | Assessment | Photo |
|---|---|---|
| Frame Condition | ★★★★☆ | |

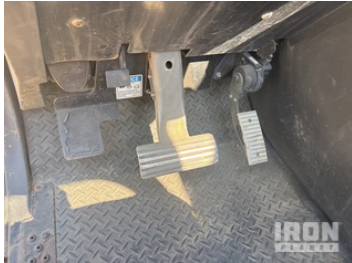
| Item | Assessment | Photo |
|---|---|---|
| Master Cylinder | ★★★★☆ | |

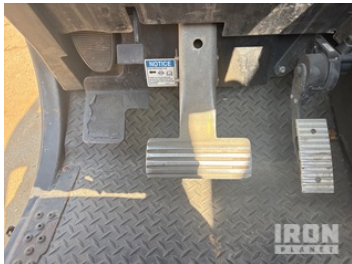
| Item | Assessment | Photo |
|---|---|---|
| Brake Control | ★★★★☆ | |

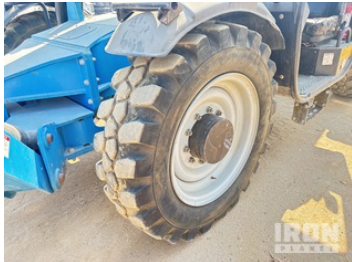
| Item | Assessment | Photo |
|---|---|---|
| Left Front Tire | Size: 14.00-28(360/85-28) Brand: Genie Model: ENDURO A/T Tread Depth: 22/32 | |

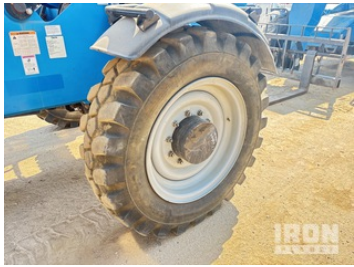
| Left Rear Tire | Tread Depth: 20/32 | |

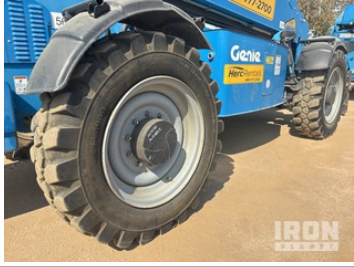
| Right Rear Tire | Tread Depth: 21/32 | |

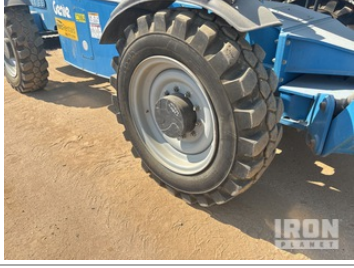
| Right Front Tire | Tread Depth: 20/32 | |

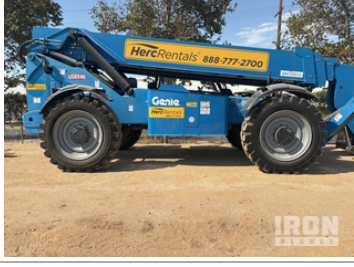
| Wheel Condition | No visible damage or missing components | |

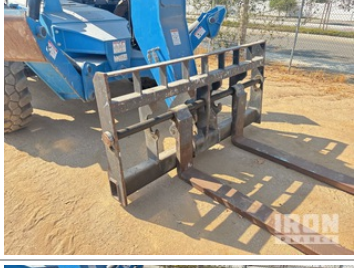
| Load Back Rest | ★★★★☆ | |

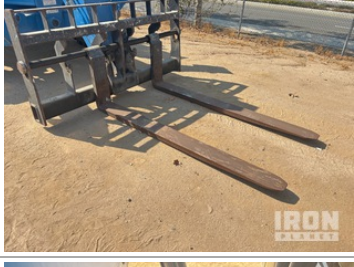
| Forks | ★★★★☆ | |
