## Item #14094971 - 2018 JCB 509.42 Telehandler

# Inspection Report

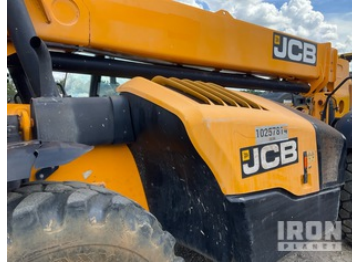
| Paint | No visible damage | |

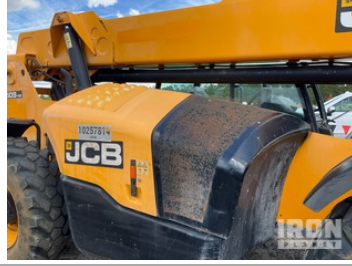
| Body Panels | No visible damage or missing components | |

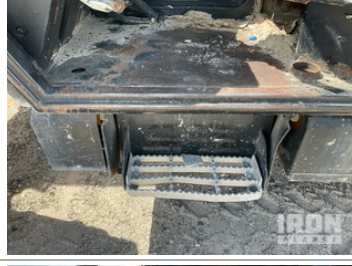
| Steps | No visible damage or missing components | |

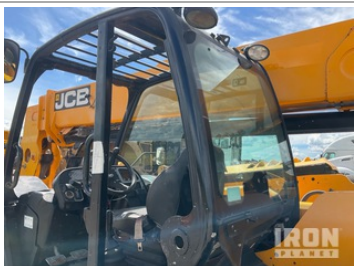
| Control Station | | |
|---|---|---|
| Glass | No visible damage or missing components | |

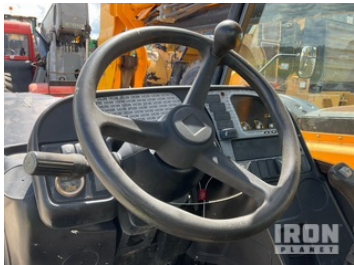
| Steering Control | ★★★★☆ | |

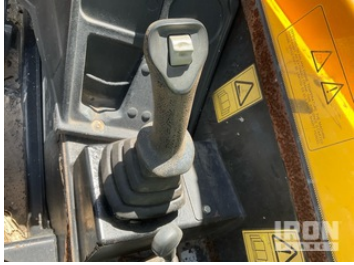
| Hydraulic Controls | ★★★★☆ | |

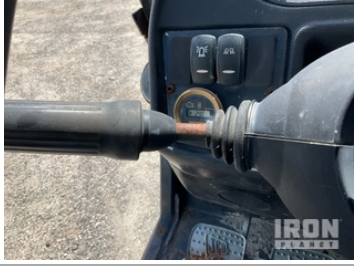
| Drivetrain Controls | ★★★★☆ | |

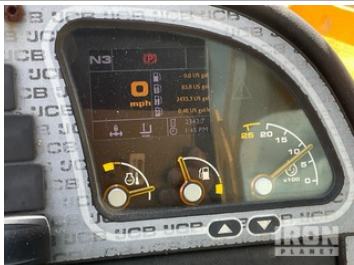
| Gauges | Operational | |

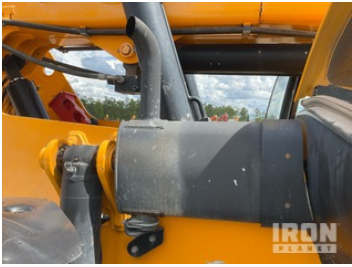
| Engine | | |
|---|---|---|
| Exhaust System | No visible damage or missing components | |

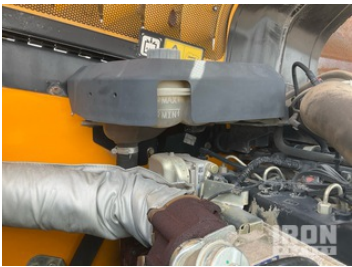
| Engine | | |
|---|---|---|
| Radiator | ★★★★☆ | |

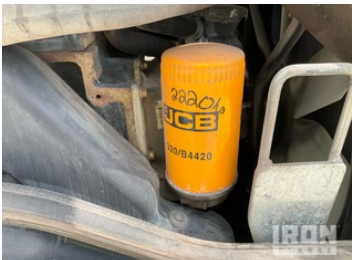
| Engine | | |
|---|---|---|
| Oil Leaks | No dripping leaks | |

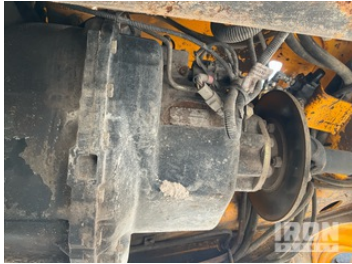
| Item | Assessment | Photo |
|---|---|---|
| Transfer Case / Drop Box | ★★☆☆<br>Operational | |

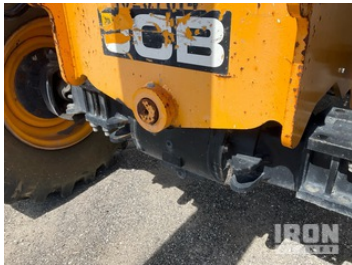
| Item | Assessment | Photo |
|---|---|---|
| Front Axle Oscillating Pin | ★★☆☆ | |

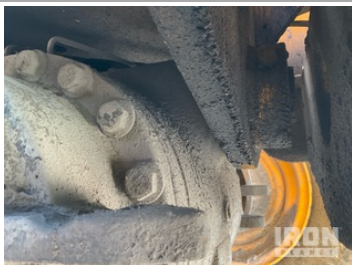
| Item | Assessment | Photo |
|---|---|---|
| Rear Axle Oscillating Pin | ★★☆☆ | |

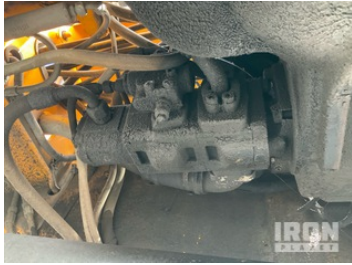
| Hydraulics | | |
|---|---|---|
| Pumps (Hydraulics) | ★★★★☆ | |

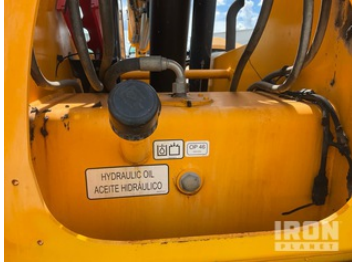
| Hydraulics | | |
|---|---|---|
| Hydraulic Tank | ★★★★☆ | |

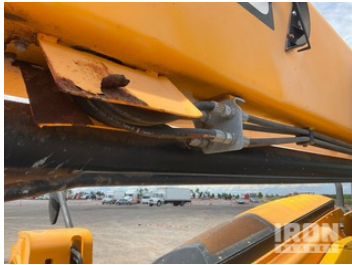
| Hydraulics | | |
|---|---|---|
| Hoses (Hydraulics) | ★★★★☆ | |

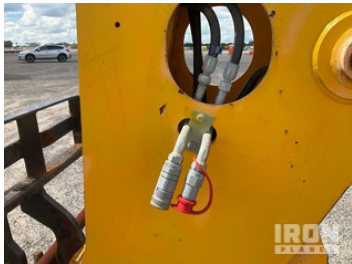
| Hydraulics | | |
|---|---|---|
| Auxiliary Hydraulic Plumbing | Capped off, Not operationally checked, Front | |

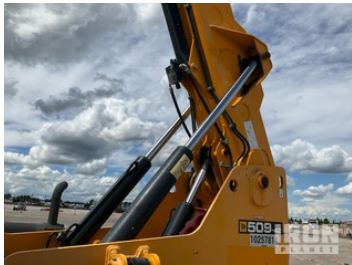
| Hydraulics | | |
|---|---|---|
| Boom Lift Cylinder(s) | ★★★★☆ | |

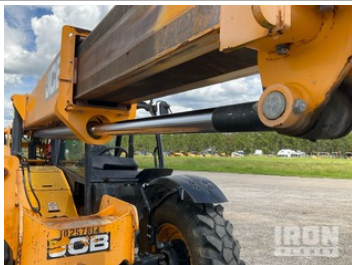
| Hydraulics | | |
|---|---|---|
| Telescopic Boom Cylinders | ★★★★☆ | |

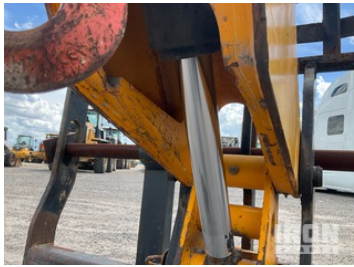
| Carriage Tilt Cylinder | ★★★★☆ | |

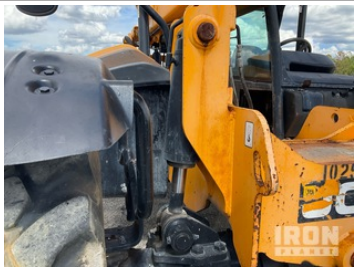
| Frame Leveling Cylinders | ★★★★☆ | |

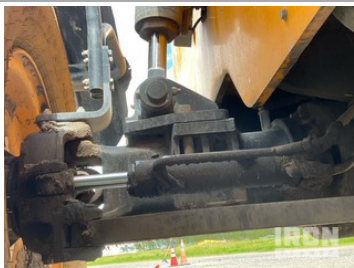
| Steering Cylinders | ★★★★☆ | |

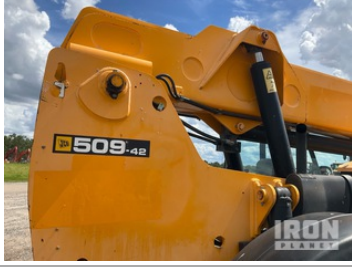
| Item | Assessment | Photo |
|---|---|---|
| Boom Condition | ★★★★☆ | |

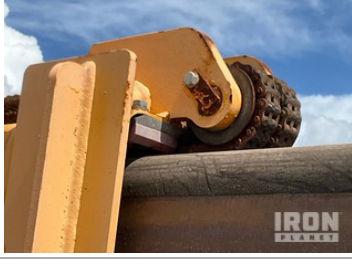
| Item | Assessment | Photo |
|---|---|---|
| Chain / Tensioners | ★★★★☆ | |

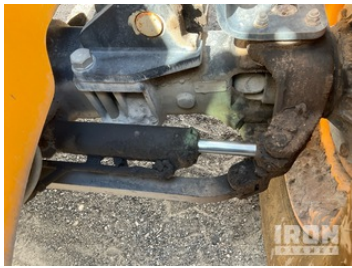
| Item | Assessment | Photo |
|---|---|---|
| Steering Linkage | ★★★★☆ | |

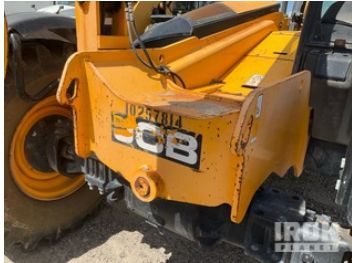
| Item | Assessment | Photo |
|---|---|---|
| Frame Condition | ★★★★☆ | |

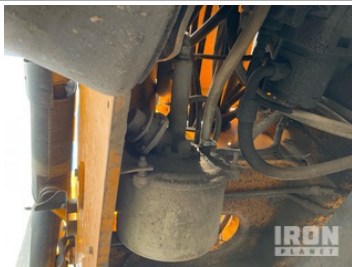
| Item | Assessment | Photo |
|---|---|---|
| Master Cylinder | ★★★★☆ | |

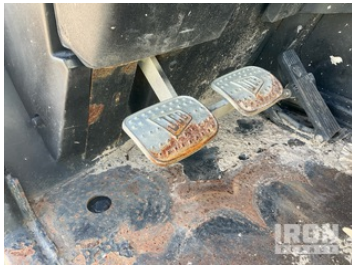
| Item | Assessment | Photo |
|---|---|---|
| Brake Control | ★★★★☆ | |

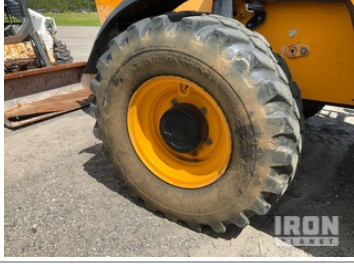
| Wheel Condition | No visible damage or missing components | |

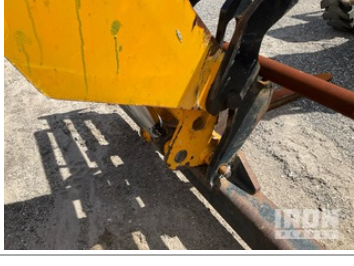
| Loader Quick Coupler | ★★★★☆<br>Not operationally checked | |

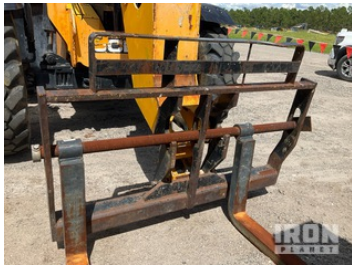
| Load Back Rest | ☆☆☆☆ | |

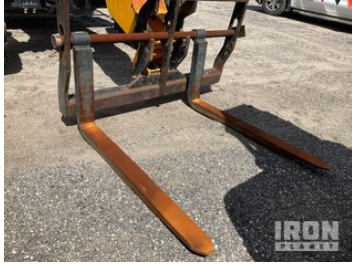
| Forks | ☆☆☆☆ | |
