## Item #14097125 - 2018 Skyjack SJIII4740 Electric Scissor Lift

# Inspection Report

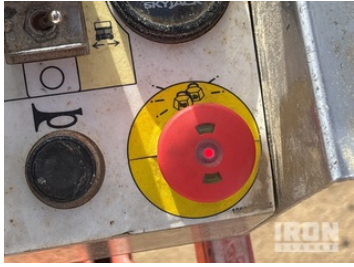
| Item | Assessment | Photo |
|---|---|---|
| Emergency Shut Off Switch | Operational | |

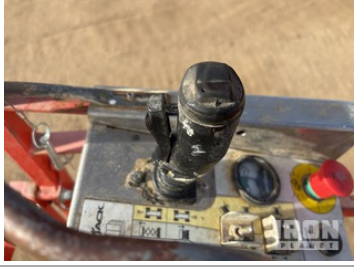
| Item | Assessment | Photo |
|---|---|---|
| Safety Control Hand/Foot Switch | ★★★★☆<br>Operational | |

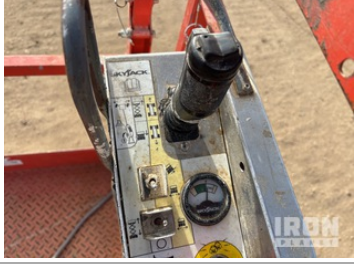
| Item | Assessment | Photo |
|---|---|---|
| Upper Function Controls | ★★★★☆ | |

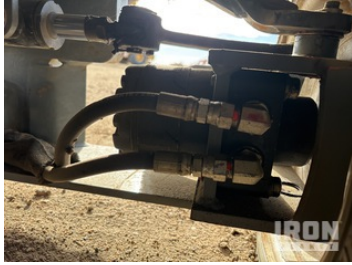
| Item | Assessment | Photo |
|---|---|---|
| Drive Motors | ★★★★☆ | |

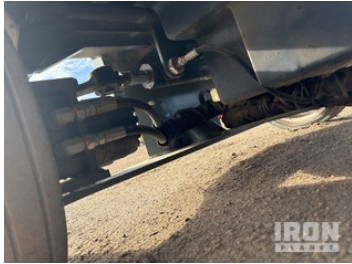
| Item | Assessment | Photo |
|---|---|---|
| Front Drive Axle | ★★★★☆ | |

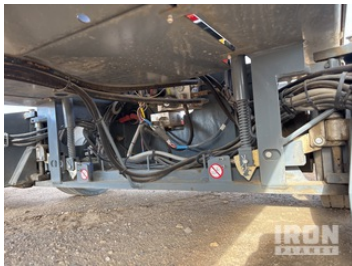
| Item | Assessment | Photo |
|---|---|---|
| Rear Drive Axle | ★★★★☆ | |

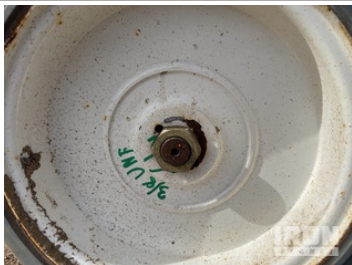
| Item | Assessment | Photo |
|---|---|---|
| Final Drives | ★★★★☆ | |

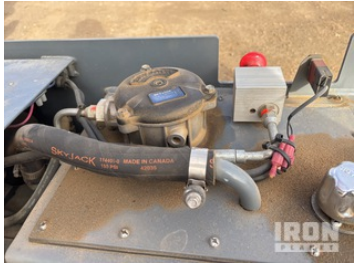
| Hydraulics | | |
|---|---|---|
| Pumps (Hydraulics) | ★★★★☆ | |

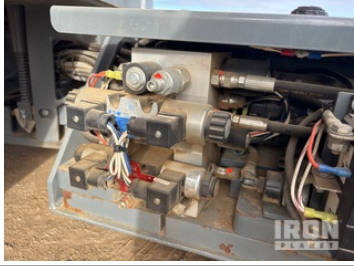
| Hydraulics | | |
|---|---|---|
| Valves | ★★★★☆ | |

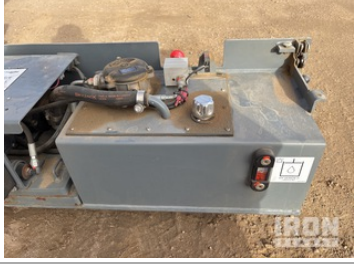
| Hydraulics | | |
|---|---|---|
| Hydraulic Tank | ★★★★☆ | |

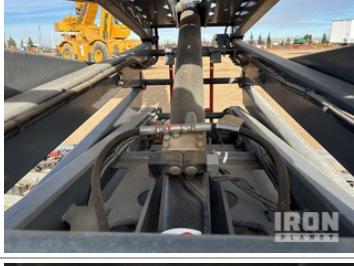
| Hydraulics | | |
|---|---|---|
| Lift Cylinders | ★★★★☆ | |

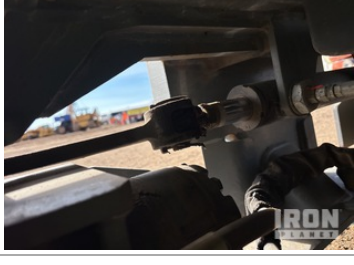
| Hydraulics | | |
|---|---|---|
| Steering Cylinder | ★★★★☆ | |

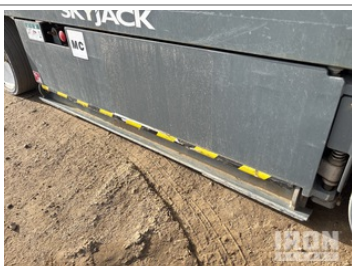
| Pothole Protection Bars | ★★★★☆<br>Functional | |
