## Item #14301271 - 2018 JLG 4069LE Electric Scissor Lift

# Inspection Report

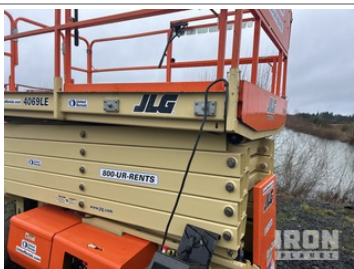
Basket / Safety Railing	No visible damage or missing components	
General Appearance #1

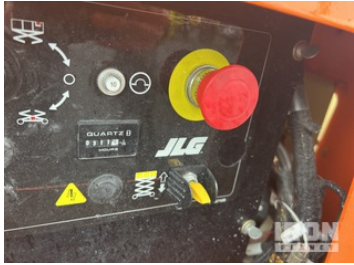
Limited Function Check	The main components are in place and operational as noted.	
Control Station Ground #1

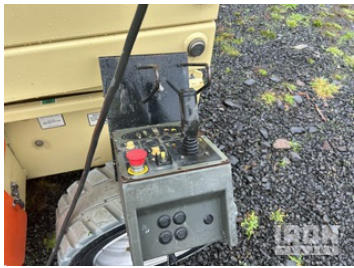
<b>Control Station Upper</b>		
Pin connection pivot point wear inspections are limited to sound, sight and feel observations. Dial indicator testing is not performed.		
<b>Item</b>	<b>Assessment</b>	<b>Photo</b>
Control Console	No visible damage or missing components

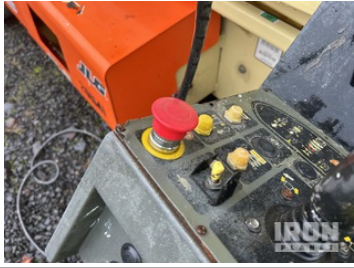
Emergency Shut Off Switch	Operational

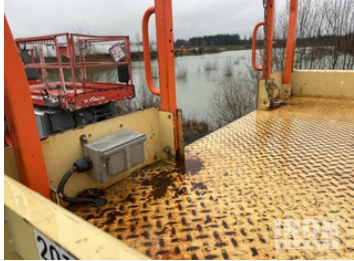
Limited Function Check	The main components are in place and operational as noted.	
Control Station Upper #1

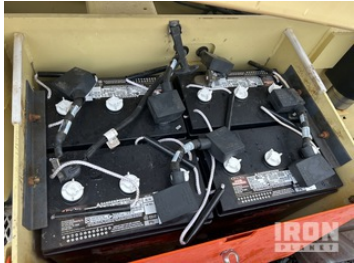
<b>Electrical Operating System</b>		
<b>Item</b>	<b>Assessment</b>	<b>Photo</b>
Operating Voltage	48 Volts	
Battery Condition	Functioned during the inspection	
Cables and Connections	No visible damage or missing components

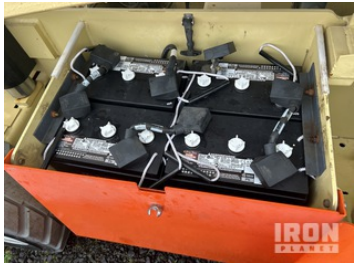
Limited Function Check	The electrical system was operational in a limited check.	
Electrical Operating System #1

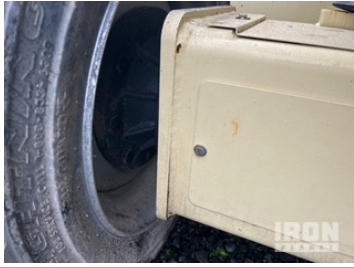
Limited Function Check	The drivetrain was operational.	
Drivetrain #1

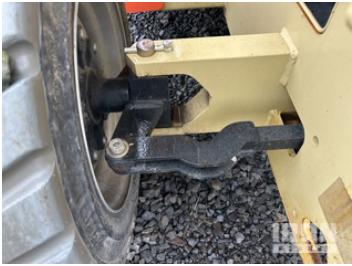
<b>Chassis</b>		
IronPlanet pin connection pivot point wear inspections are limited to sound, sight and feel observations. Dial indicator testing is not performed.		
<b>Item</b>	<b>Assessment</b>	<b>Photo</b>
Steering Linkage	☆☆☆☆

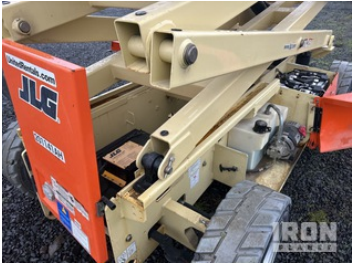
Frame Condition	☆☆☆☆

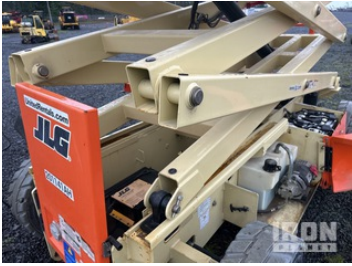
Scissor Linkage	☆☆☆☆

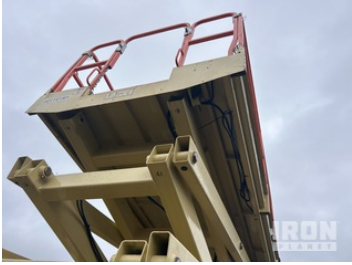
Platform Condition	☆☆☆☆

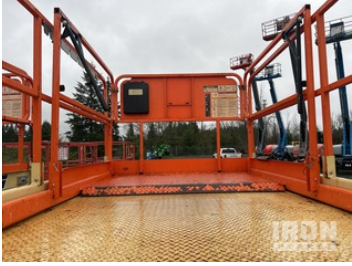
Platform Extension	☆☆☆☆

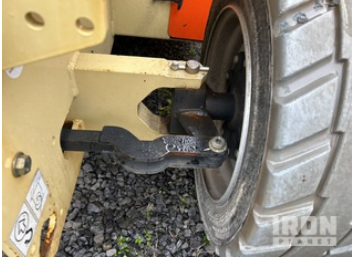
Wheel Studs	★★★★☆	
Limited Function Check (Scissor-lift)	The main components appear to be in place and operational.	
Chassis #1
