## Item #14340518 - 2016 Skyjack SJ9250 RT Dual Fuel 4x4 Scissor Lift

## Inspection Report

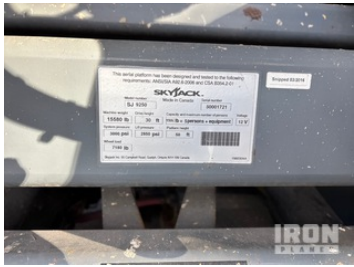
| Serial Number / VIN | 50001721 | |

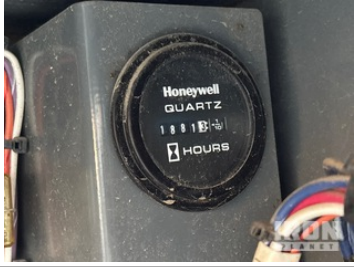
| Hour Meter / Odometer | 1881 hrs | |

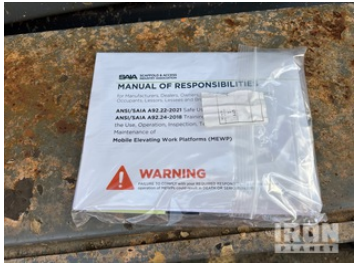
| Safety | | |
|---|---|---|
| ANSI Guidelines | Yes | |

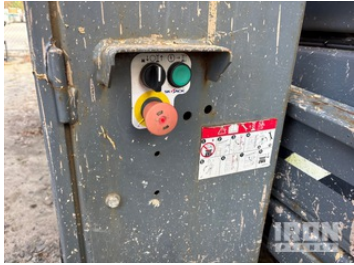
| Control Station Ground | | |
|---|---|---|
| Function Controls | ☆☆☆☆ | |

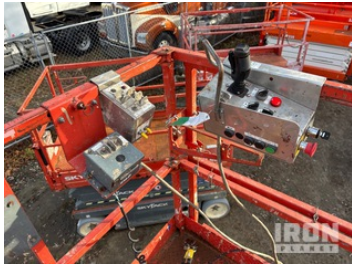
| Item | Assessment | Photo |
|---|---|---|
| Control Console | No visible damage or missing components | |

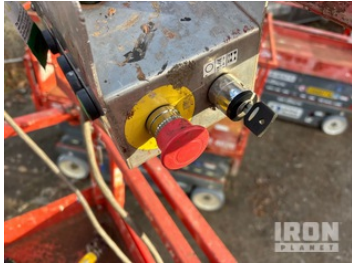
| Item | Assessment | Photo |
|---|---|---|
| Emergency Shut Off Switch | Operational | |

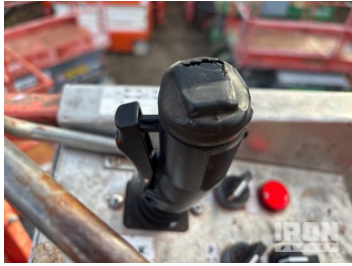
| Item | Assessment | Photo |
|---|---|---|
| Safety Control Hand/Foot Switch | ★★★★<br>Operational | |

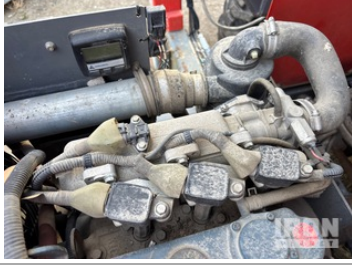
| Engine | | |
|---|---|---|
| Fuel System | Operational | |

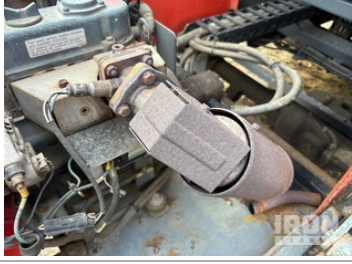
| Engine | | |
|---|---|---|
| Exhaust System | No visible damage or missing components | |

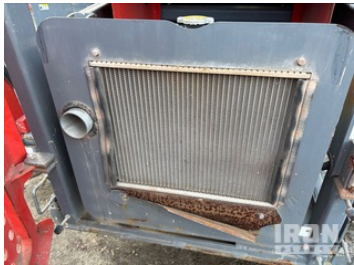
| Radiator | ★★★★☆ | |

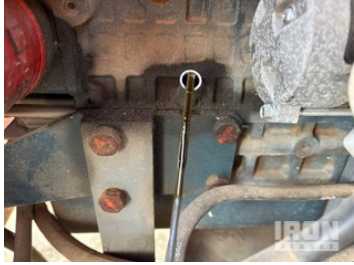
| Oil Leaks | No dripping leaks | |

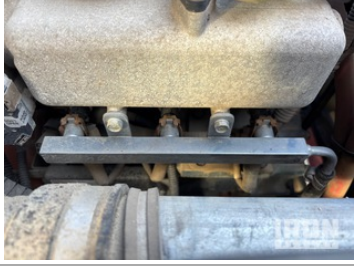
| Fuel Leaks | No dripping leaks | |

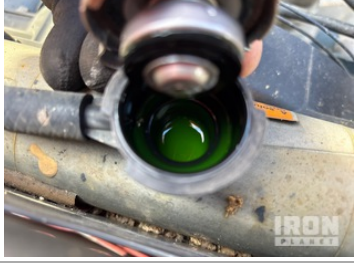
| Cooling System Leaks | No dripping leaks | |

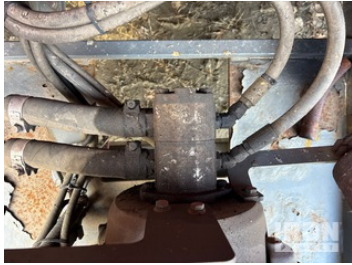
| Hydraulics | | |
|---|---|---|
| Pumps (Hydraulics) | ★★★★☆ | |

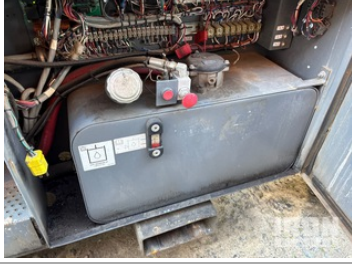
| Hydraulics | | |
|---|---|---|
| Hydraulic Tank | ★★★★☆ | |

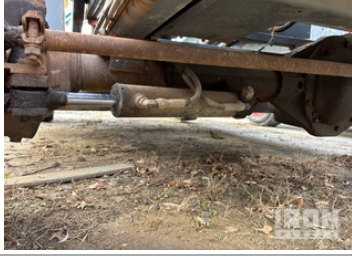
| Hydraulics | | |
|---|---|---|
| Steering Cylinder | ★★★★☆ | |

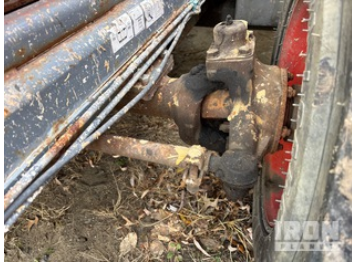
| Item | Assessment | Photo |
|---|---|---|
| Steering Linkage | ★★★★☆ | |

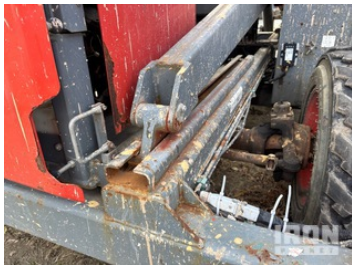
| Item | Assessment | Photo |
|---|---|---|
| Frame Condition | ★★★★☆ | |

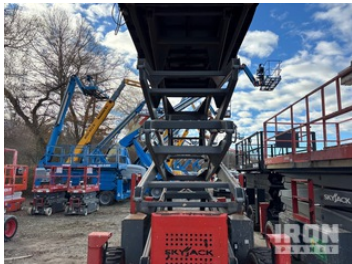
| Item | Assessment | Photo |
|---|---|---|
| Scissor Linkage | ★★★★☆ | |

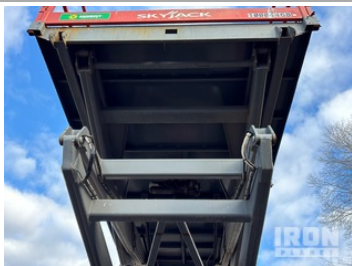
| Item | Assessment | Photo |
|---|---|---|
| Platform Condition | ★★★★☆ | |

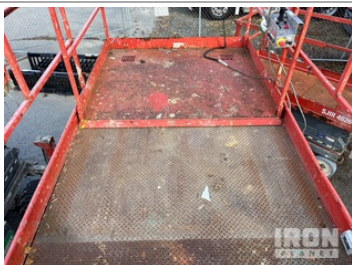
| Item | Assessment | Photo |
|---|---|---|
| Platform Extension | ★★★★☆ | |

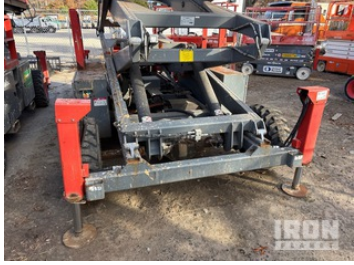
| Outriggers / Stabilizers | ★★★★☆ | |
