## Item #14095051 - 2017 Genie Z45/25 4WD Diesel Articulating Boom Lift

- Features: 46 ft 1 in Max Platform Height, 500 lb Max Weight Capacity, Jib, Power to Platform, Onboard Generator, Tier 4, 2017 US EPA Label, CARB Compliant, Deutz 4 Cylinder Diesel Engine, 315/55D 20 Tires
- Meter Reading: 2,625 Miles
- Serial # : Z4525N-58458
- Inspection Completed: 10/8/25

# Inspection Report

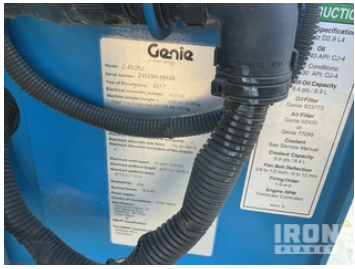
| Serial Number / VIN | Z4525N-58458 | |

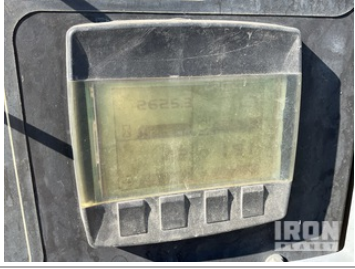
| Hour Meter / Odometer | 2625 mi | |

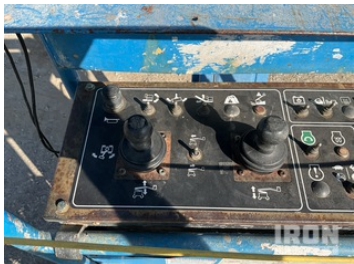
| Item | Assessment | Photo |
|---|---|---|
| Function Controls | ☆☆☆☆ | |

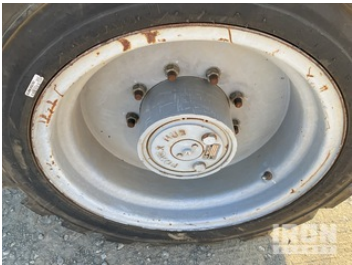
| Right Front Final Drive | ☆☆☆☆ | |

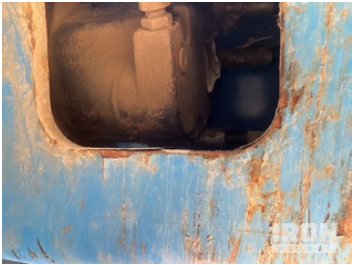
| Right Front Drive Motor | ☆☆☆☆ | |

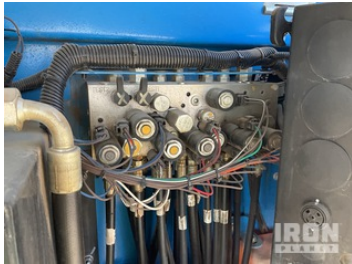
| Hydraulics | | |
|---|---|---|
| Valves | ★★★★☆ | |

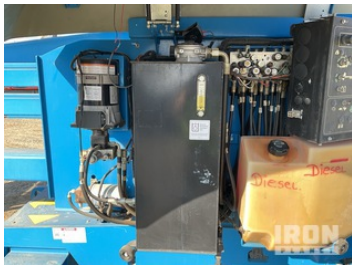
| Hydraulics | | |
|---|---|---|
| Hydraulic Tank | ★★★★☆ | |

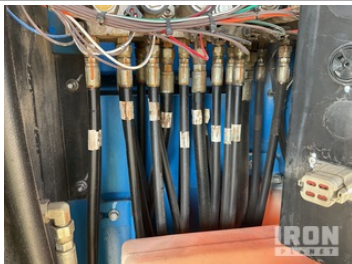
| Hydraulics | | |
|---|---|---|
| Hoses (Hydraulic) | ★★★★☆ | |

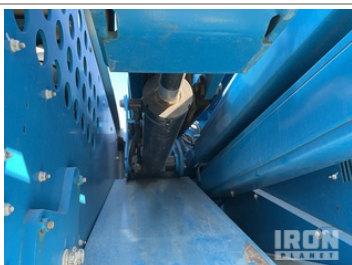
| Hydraulics | | |
|---|---|---|
| Boom Lift Cylinder | ★★★★☆ | |
