## Item #13869127 - 2017 Genie Z60/37FE 4WD Diesel Articulating Boom Lift

# Inspection Report

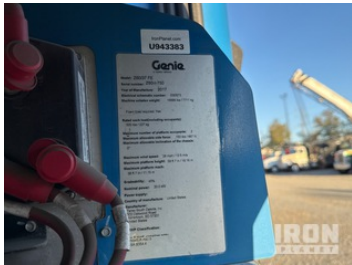
| Serial Number / VIN | Z60H-750 | |

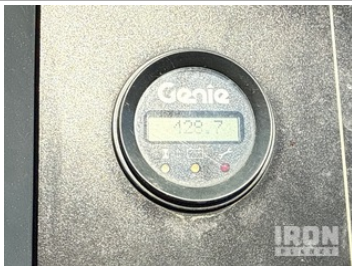
| Hour Meter / Odometer | 428 mi | |

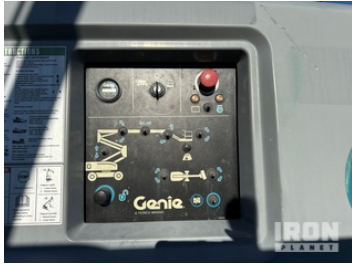
| Control Station Ground | | |
|---|---|---|
| Function Controls | ★★★★☆ | |

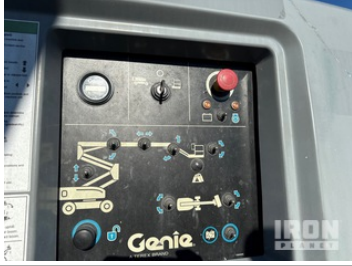
| Control Station Ground | | |
|---|---|---|
| Warning Lights | Operational | |

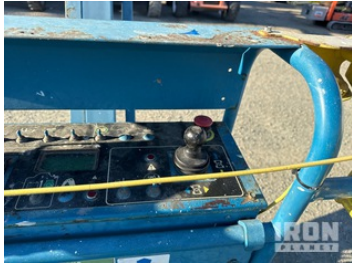
| Control Station | | |
|---|---|---|
| Emergency Shut Off Switch | Operational | |

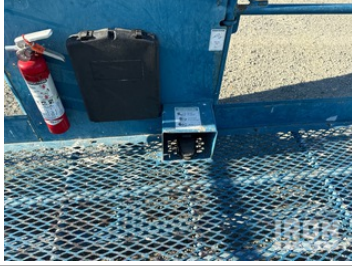
| Control Station | | |
|---|---|---|
| Safety Control Foot Switch | ☆☆☆☆ | |

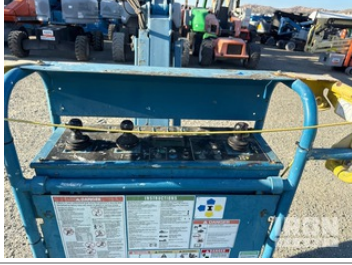
| Control Station | | |
|---|---|---|
| Function Controls | ☆☆☆☆ | |

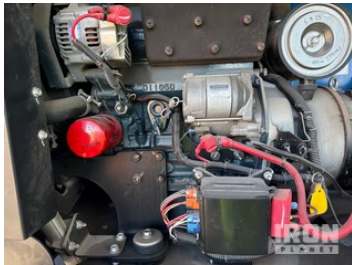
| Engine | | |
|---|---|---|
| Fuel System | Operational | |

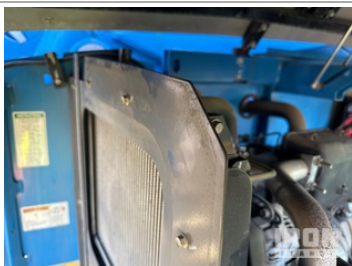
| Engine | | |
|---|---|---|
| Radiator | ★★★★☆ | |

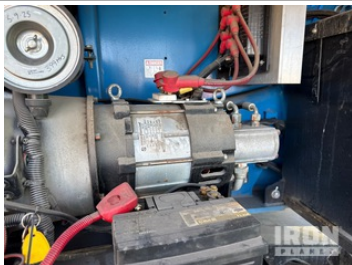
| Engine | | |
|---|---|---|
| Onboard Generator | Operational | |

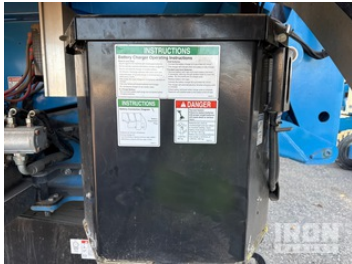
| Electrical Operating System | | |
|---|---|---|
| Battery Charger | Appears normal - Not operationally checked | |

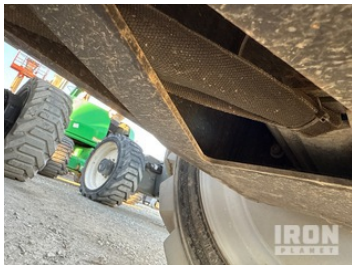
| Item | Assessment | Photo |
|---|---|---|
| Left Front Drive Motor | ★★★★☆ | |

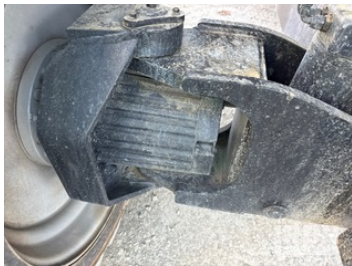
| Item | Assessment | Photo |
|---|---|---|
| Left Rear Drive Motor | ★★★★☆ | |

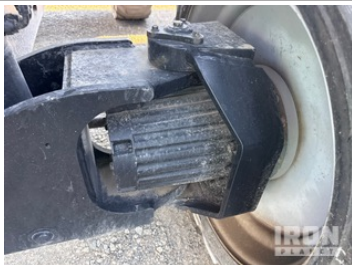
| Item | Assessment | Photo |
|---|---|---|
| Right Rear Drive Motor | ★★★★☆ | |

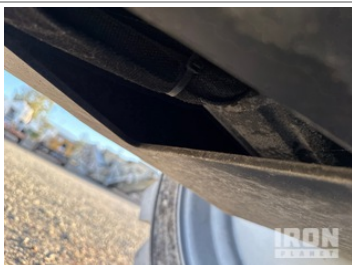
| Item | Assessment | Photo |
|---|---|---|
| Right Front Final Drive | ★★★★☆ | |

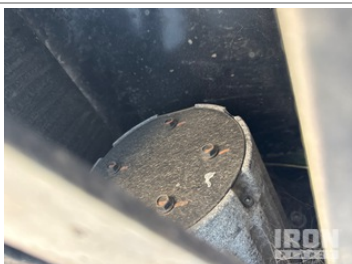
| Item | Assessment | Photo |
|---|---|---|
| Right Front Drive Motor | ★★★★☆ | |

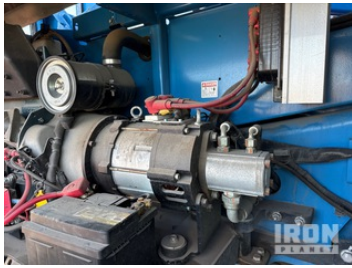
| Hydraulics | | |
|---|---|---|
| Pumps (Hydraulics) | ★★★★☆ | |

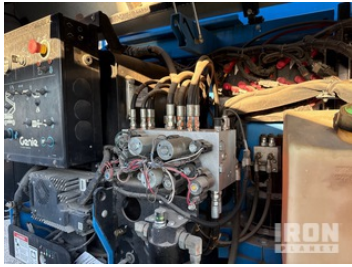
| Hydraulics | | |
|---|---|---|
| Valves | ★★★★☆ | |

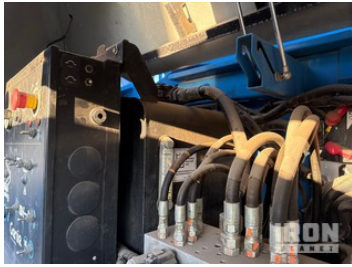
| Hydraulics | | |
|---|---|---|
| Hydraulic Tank | ★★★★☆ | |

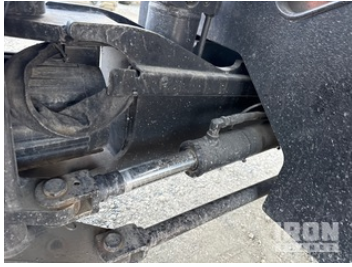
| Hydraulics | | |
|---|---|---|
| Steering Cylinders | ★★★★☆ | |

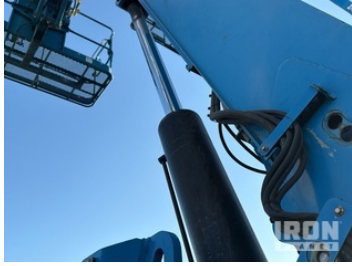
| Hydraulics | | |
|---|---|---|
| Boom Lift Cylinder | ★★★★☆ | |

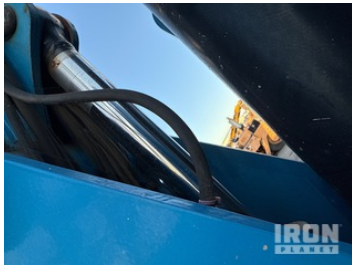
| Secondary Boom Cylinder | ★★★★☆ | |

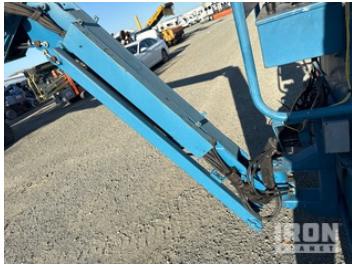
| Jib Cylinder | ★★★★☆ | |

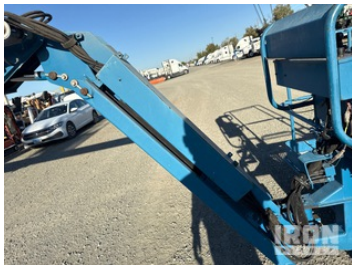
| Basket Tilt Cylinder | ★★★★☆ | |

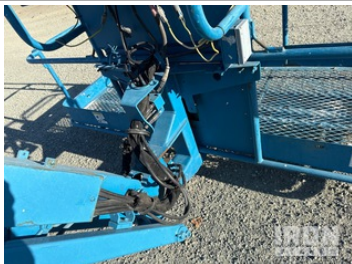
| Basket Rotator Motor | ★★★★☆ | |

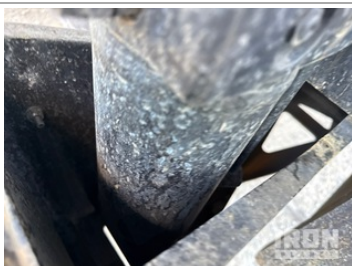
| Frame Leveling Cylinders | ★★★★☆ | |

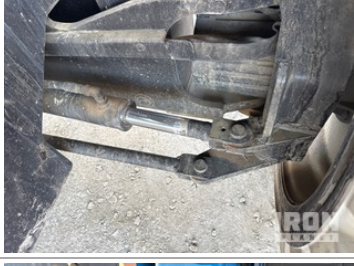
| Chassis | | |
|---|---|---|
| Steering Linkage | ★★★★☆ | |

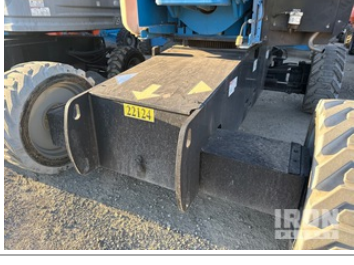
| Chassis | | |
|---|---|---|
| Frame Condition | ★★★★☆ | |

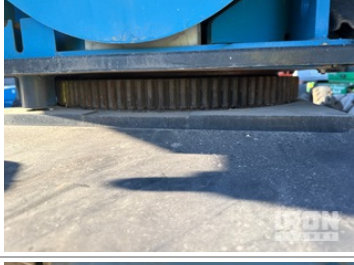
| Turntable Bearing | ★★★★☆ | |

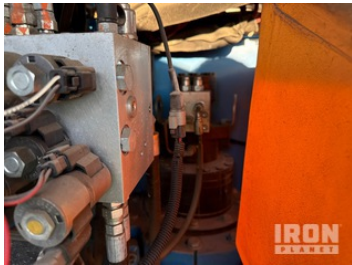
| Swing Motor | ★★★★☆ | |

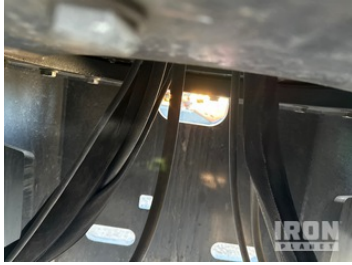
| Hydraulic Center Swivel | ★★★★☆ | |

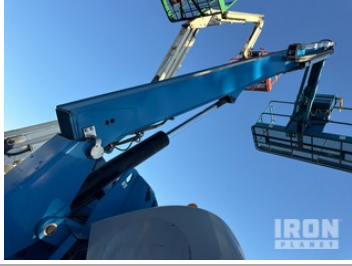
| Boom Condition | ★★★★☆ | |

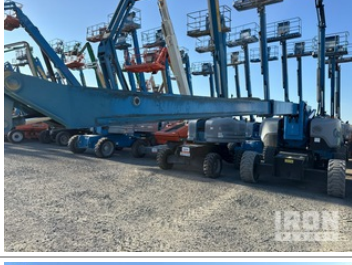
| Boom Wear Guides | ★★★★☆ | |

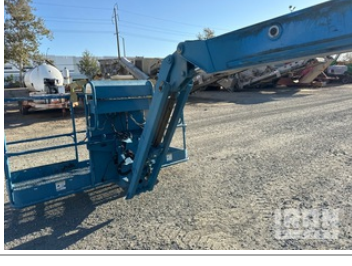
| Jib Condition | ★★★★☆ | |
