## Item #14177561 - 2022 Skyjack SJ45 AJ 4WD Diesel Articulating Boom Lift

# Inspection Report

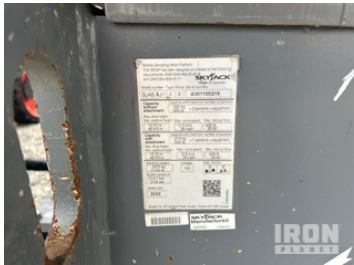
| Serial Number / VIN | A301100219 | |

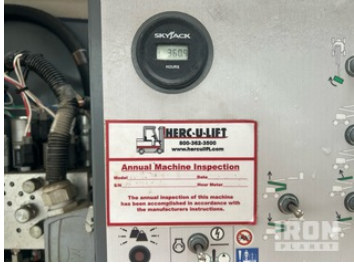
| Hour Meter / Odometer | 360 hrs | |

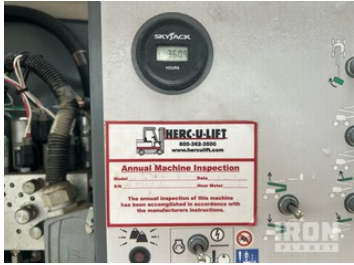
| Control Station Ground | | |
|---|---|---|
| Gauges | Operational | |

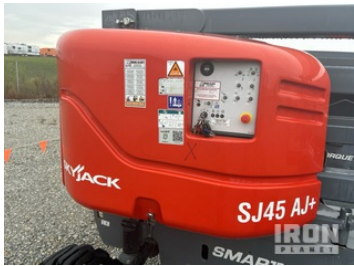
| Control Station Ground | | |
|---|---|---|
| Warning Lights | Operational | |

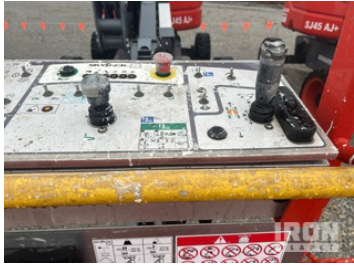
| Item | Assessment | Photo |
|---|---|---|
| Emergency Shut Off Switch | Operational | |

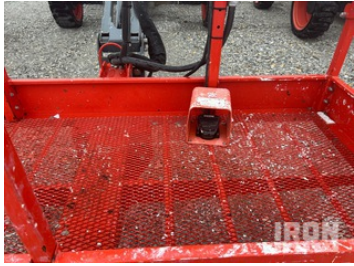
| Item | Assessment | Photo |
|---|---|---|
| Safety Control Hand/Foot Switch | ☆☆☆☆<br>Operational | |

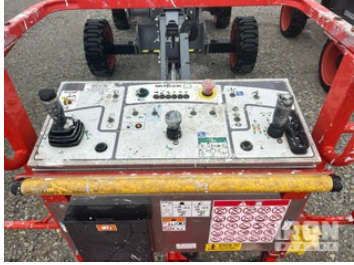
| Item | Assessment | Photo |
|---|---|---|
| Function Controls | ☆☆☆☆ | |

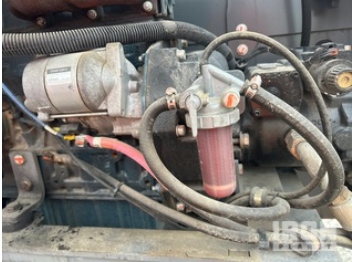
| Engine | | |
|---|---|---|
| Fuel System | Operational | |

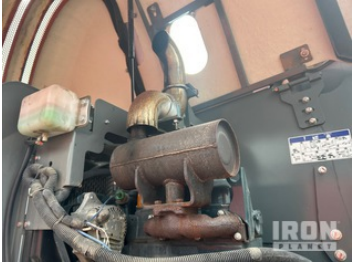
| Engine | | |
|---|---|---|
| Exhaust System | No visible damage or missing components | |

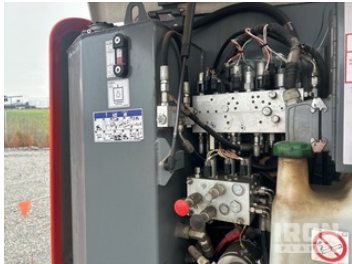
| Hydraulics | | |
|---|---|---|
| Valves | ★★★★☆ | |

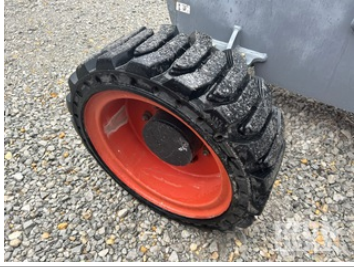
| Left Front Tire | No visible defects | |

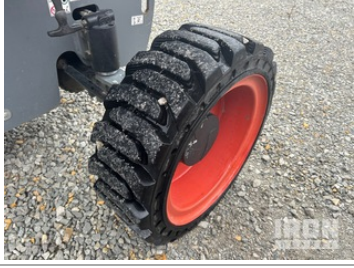
| Left Rear Tire | No visible defects | |

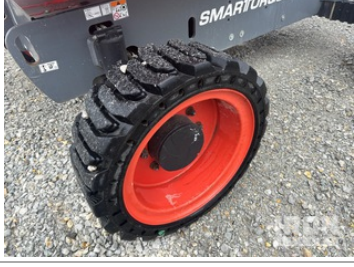
| Right Rear Tire | No visible defects | |

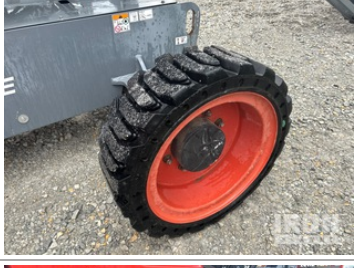
| Right Front Tire | No visible defects | |

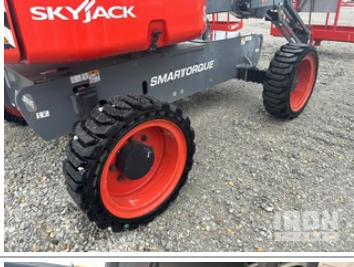
| Wheel Condition | No visible damage or missing components | |

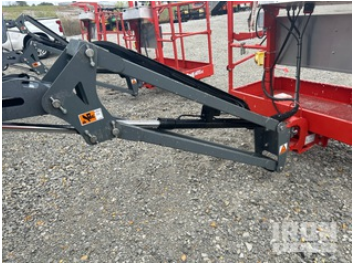
| Jib Condition | ☆☆☆☆ | |
