## Item #13810727 - 2016 JLG 800 AJ 4WD Diesel Articulating Boom Lift

# Inspection Report

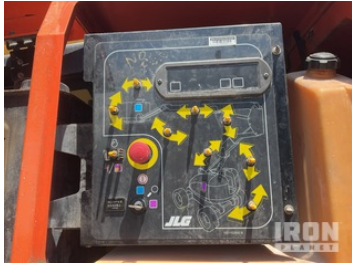
| Control Station Ground | | |
|---|---|---|
| Function Controls | ★★★★☆ | |

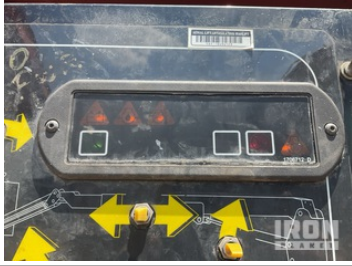
| Control Station Ground | | |
|---|---|---|
| Oil Pressure | The fault indicator shuts off after the engine oil pressure rises. | |

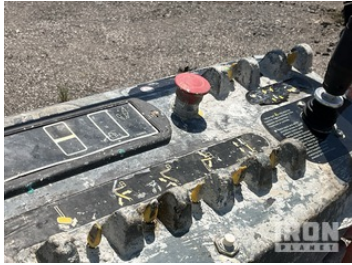
| Item | Assessment | Photo |
|---|---|---|
| Emergency Shut Off Switch | Operational | |

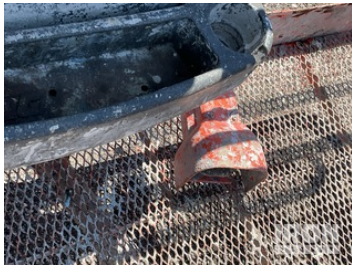
| Item | Assessment | Photo |
|---|---|---|
| Safety Control Foot Switch | ☆☆☆☆<br>Operational | |

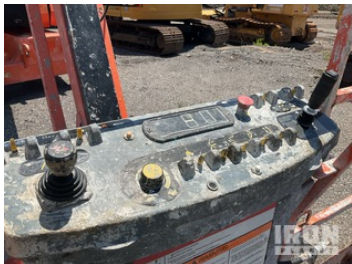
| Item | Assessment | Photo |
|---|---|---|
| Function Controls | ☆☆☆☆ | |

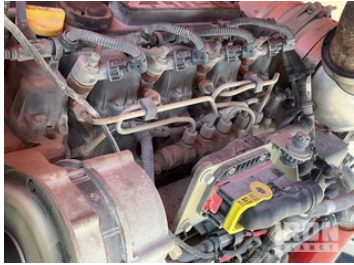
| Engine | | |
|---|---|---|
| Fuel System | Operational | |

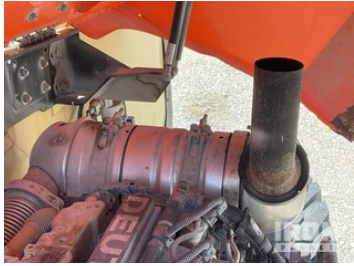
| Engine | | |
|---|---|---|
| Exhaust System | No visible damage or missing components | |

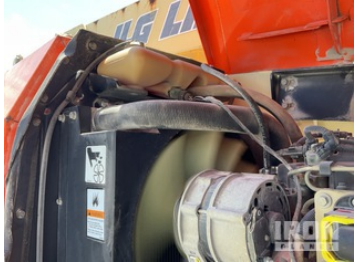
| Engine | | |
|---|---|---|
| Radiator | ★★★★☆ | |

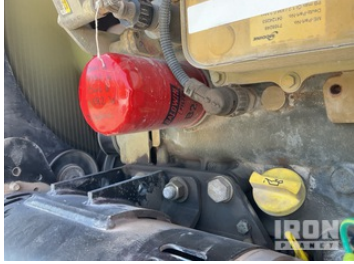
| Engine | | |
|---|---|---|
| Oil Leaks | No dripping leaks | |

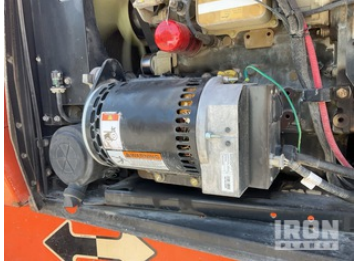
| Engine | | |
|---|---|---|
| Onboard Generator | Not operationally checked | |

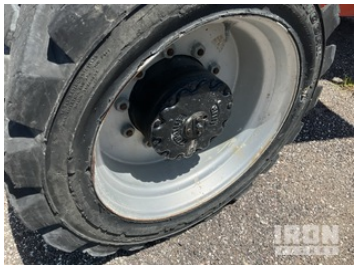
| Item | Assessment | Photo |
|---|---|---|
| Left Front Final Drive | ★★★★☆ | |

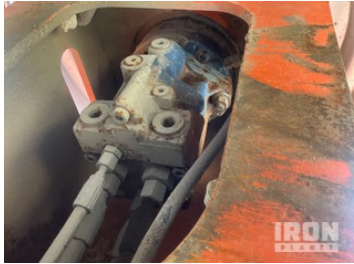
| Item | Assessment | Photo |
|---|---|---|
| Left Front Drive Motor | ★★★★☆ | |

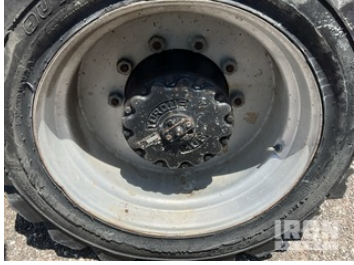
| Item | Assessment | Photo |
|---|---|---|
| Left Rear Final Drive | ★★★★☆ | |

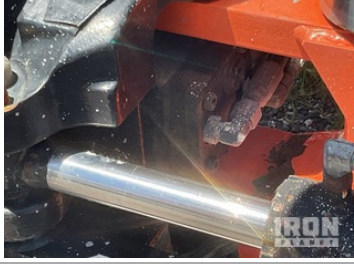
| Item | Assessment | Photo |
|---|---|---|
| Left Rear Drive Motor | ★★★★☆ | |

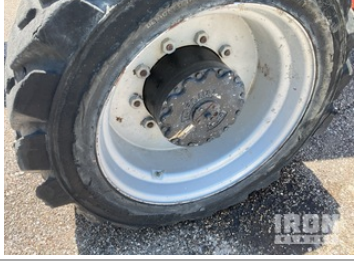
| Item | Assessment | Photo |
|---|---|---|
| Right Rear Final Drive | ★★★★☆ | |

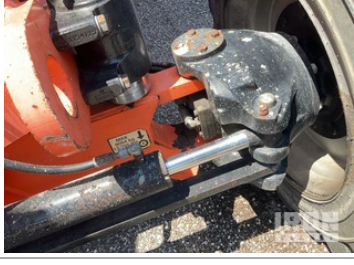
| Item | Assessment | Photo |
|---|---|---|
| Right Rear Drive Motor | ★★★★☆ | |

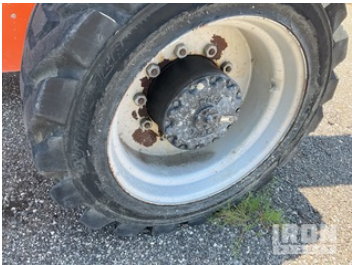
| Right Front Final Drive | ☆☆☆☆ | |

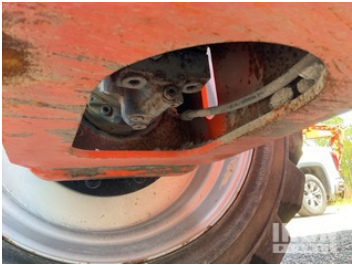
| Right Front Drive Motor | ☆☆☆☆ | |

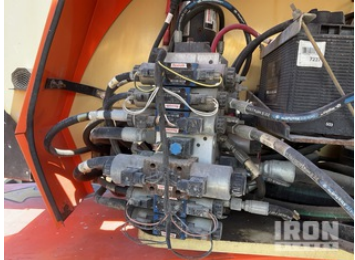
| Hydraulics | | |
|---|---|---|
| Valves | ★★★☆ | |

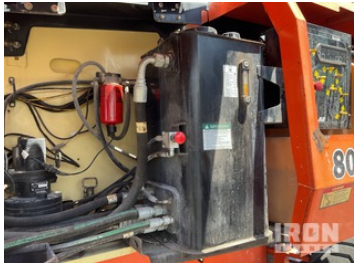
| Hydraulics | | |
|---|---|---|
| Hydraulic Tank | ★★★☆ | |

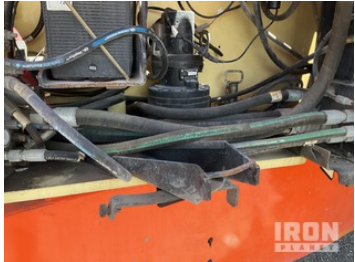
| Hydraulics | | |
|---|---|---|
| Hoses (Hydraulic) | ★★★☆ | |

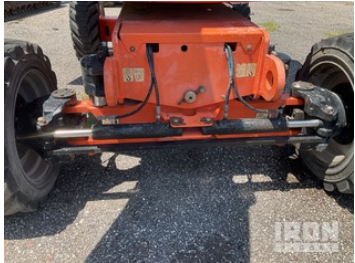
| Hydraulics | | |
|---|---|---|
| Steering Cylinders | ★★★☆ | |

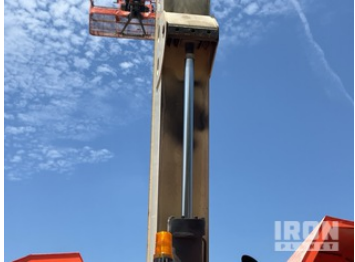
| Hydraulics | | |
|---|---|---|
| Boom Lift Cylinder | ★★★☆ | |

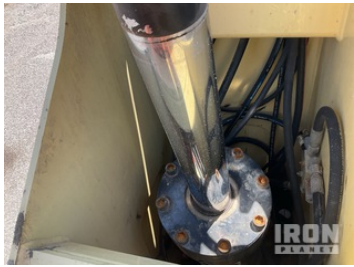
| Secondary Boom Cylinder | ★★★★☆ | |

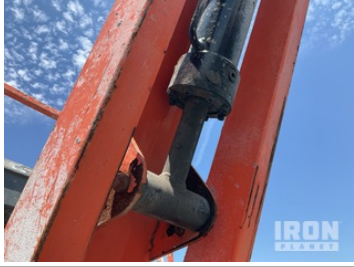
| Jib Cylinder | ★★★★☆ | |

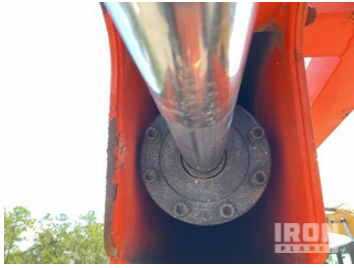
| Basket Tilt Cylinder | ★★★★☆ | |

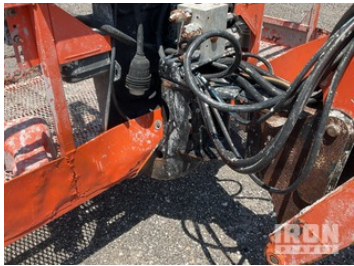
| Basket Rotator Motor | ★★★★☆ | |

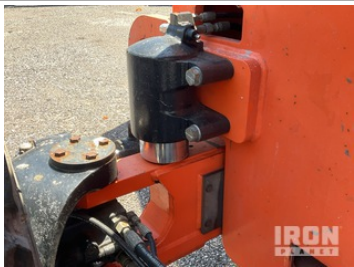
| Frame Leveling Cylinders | ★★★★☆ | |

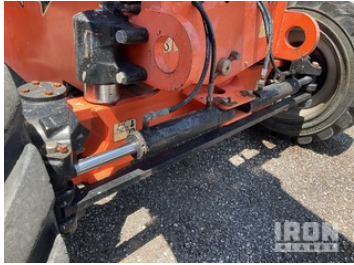
| Chassis | | |
|---|---|---|
| Steering Linkage | ★★★★☆ | |

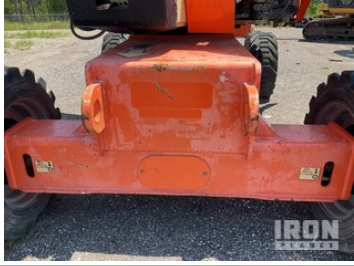
| Chassis | | |
|---|---|---|
| Frame Condition | ★★★★☆ | |

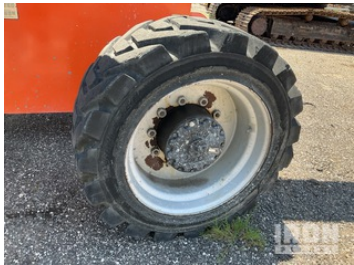
| Wheel Condition | No visible damage or missing components | |

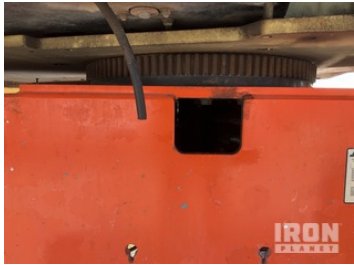
| Turntable Bearing | ★★★★☆ | |

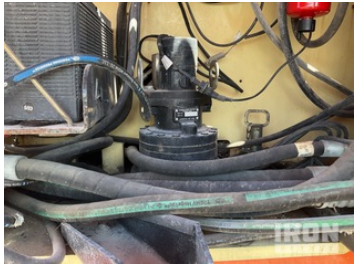
| Swing Motor | ★★★★☆ | |

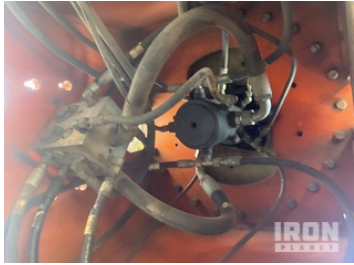
| Hydraulic Center Swivel | ★★★★☆ | |

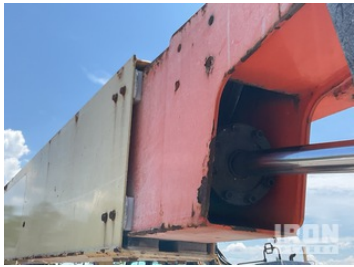
| Boom Wear Guides | ★★★★☆ | |

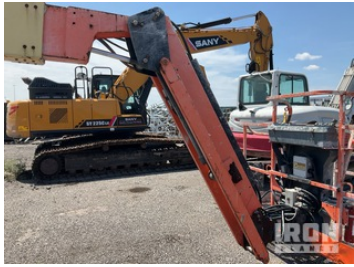
| Jib Condition | ★★★★☆ | |
